PROTECTION MEASURES FOR TAMILNADU COAST

Final Report

PUBLIC WORKS DEPARTMENT

PROF. V. SUNDAR

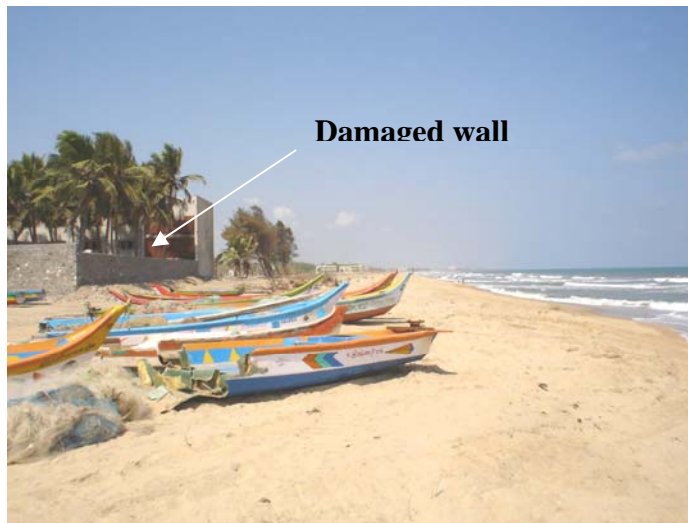
Photo 2.19. Damaged compound wall due to tsunami being rebuilt

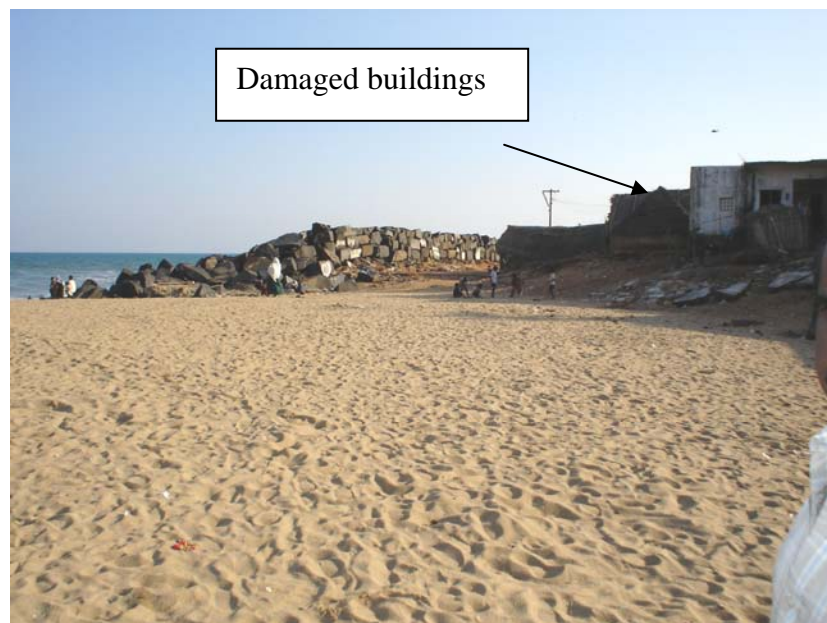
Photo 2.24. Damaged buildings due to tsunami in Sodanaikuppam

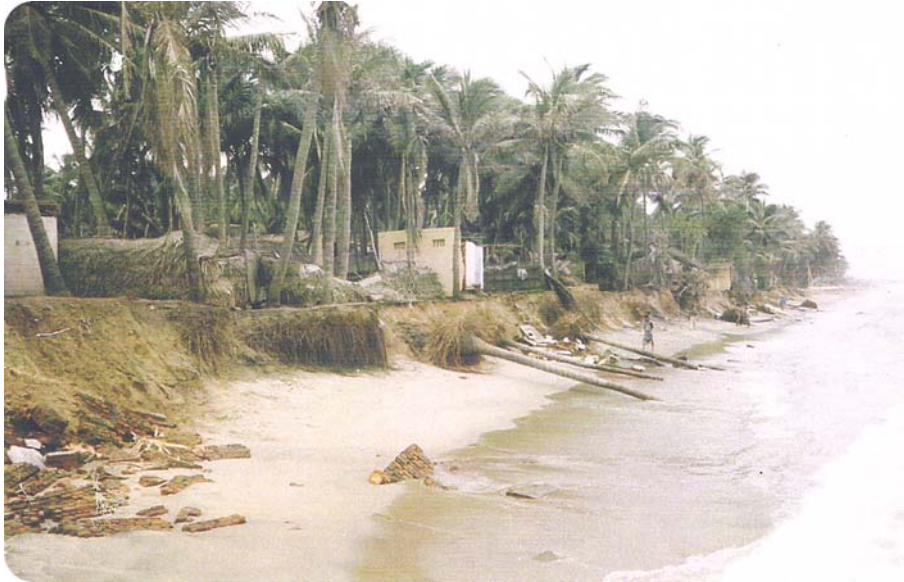
Photo 2.25. View of coastal erosion at Rahamathnagar

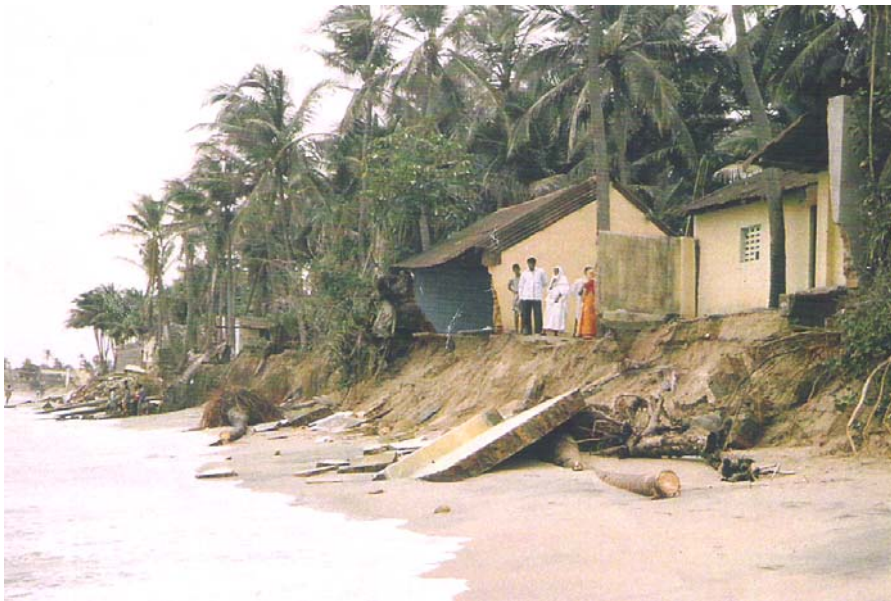
Photo 2.26. Damaged buildings due to coastal erosion at Rahamathnagar

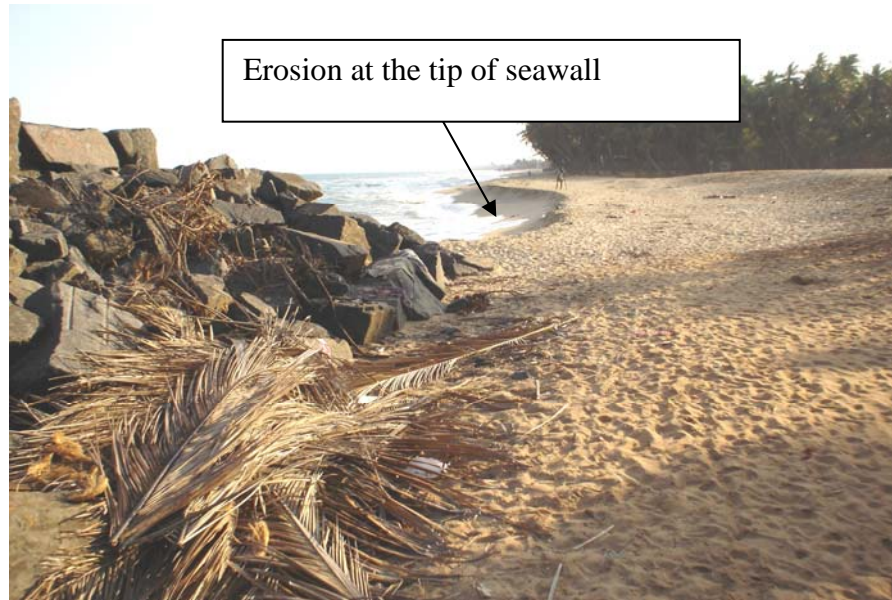
Photo 2.27. Erosion near the seawall at Nadukuppam

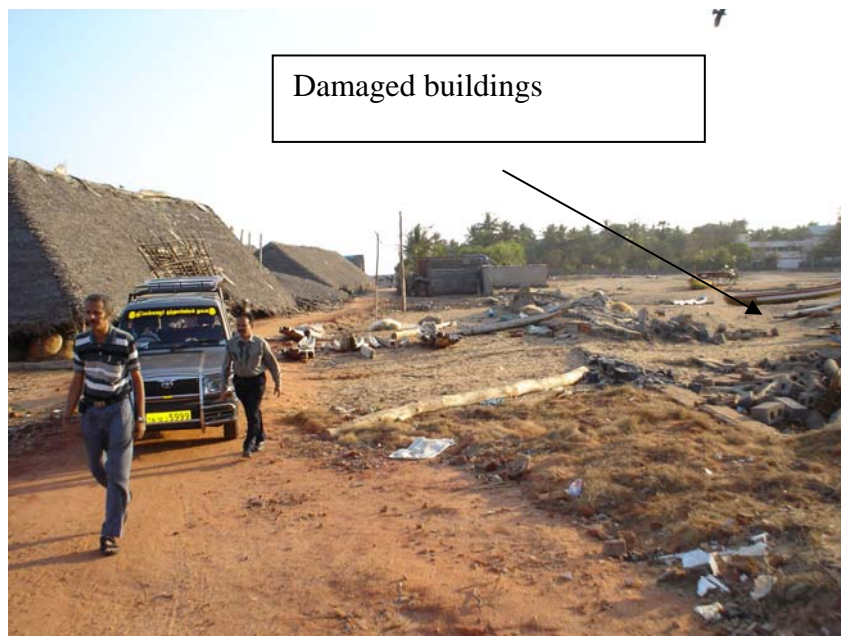
The damages near this village are shown in **photo.2.28**. From this village, a stretch of about 3.5km north of this village (Muthialpet, Mudaliarchavadi, Bommayapalyam) is densely populated and hence need to be protected with a groin field (**fig.2.15**). **The groin field will consist of 9 groins with an average length of 150m. Sandy beaches are also available at a few pockets, where, plantations can be done** as a long-term measure for the protection of the coast. The width of the beach from Muttukaadu Azhagankuppam to Mudaliar Chavadi in Villupuram district after the tsunami is provided in **Table. 2.1**.

Photo 2.28. Damaged buildings due to tsunami in Thandriyankuppam

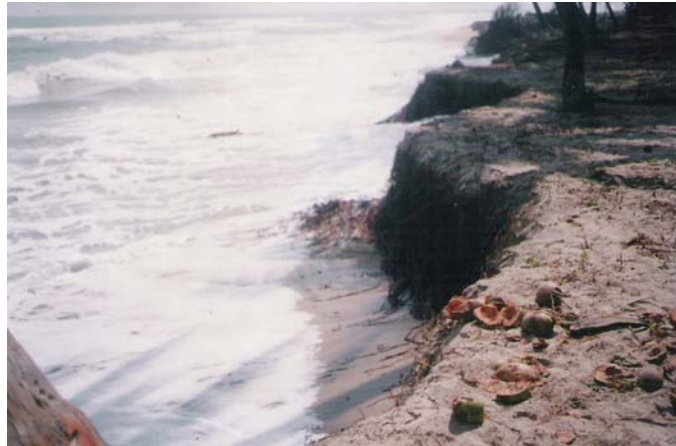
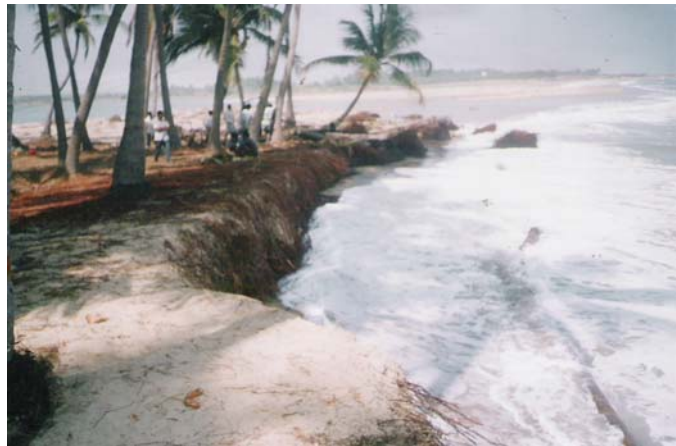
Photo 2.34 a & b . A view of damaged coconut trees at Thazhanguda due to tsunami

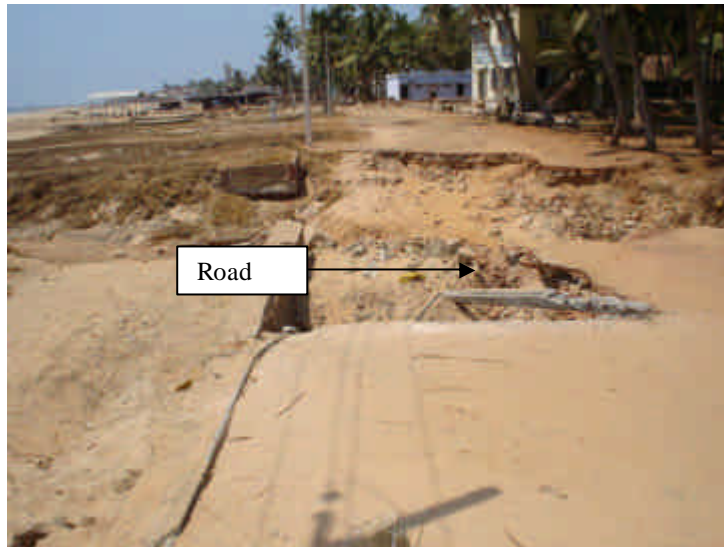
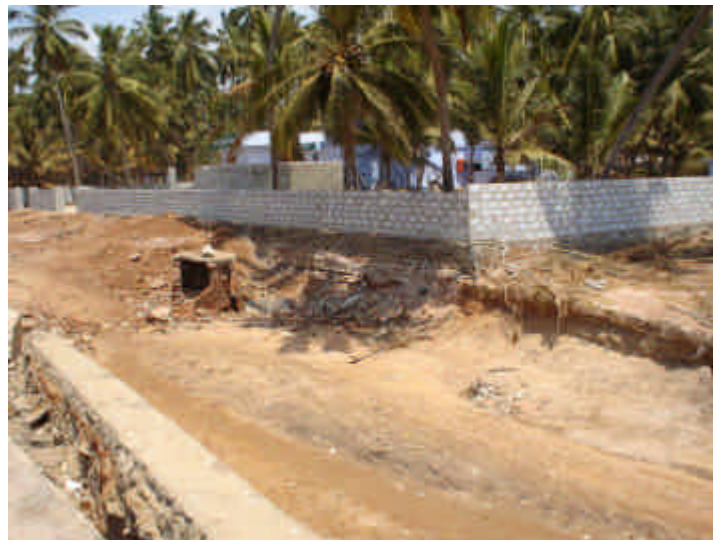
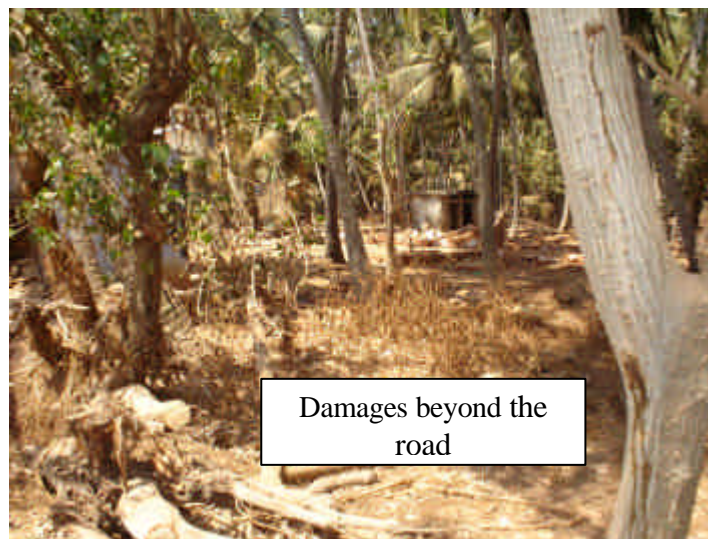
Photo 3.11, 3.12 & 3.13 Views of the damage caused due to penetration of tsunami

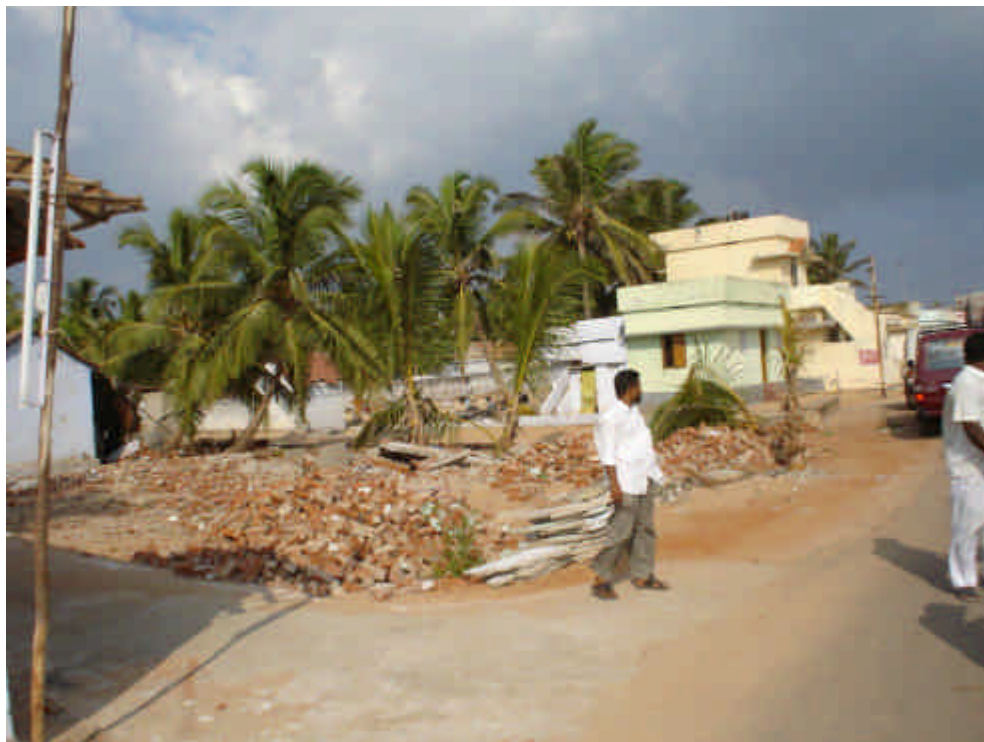
Damages to the houses land ward side of the shore is shown in **photo 3.19**. The beach which is formed, where the catamarans are parked as can be seen in **photo 3.20**, is of

Photo 3.19 The damaged houses due to tsunami at Pallanthurai

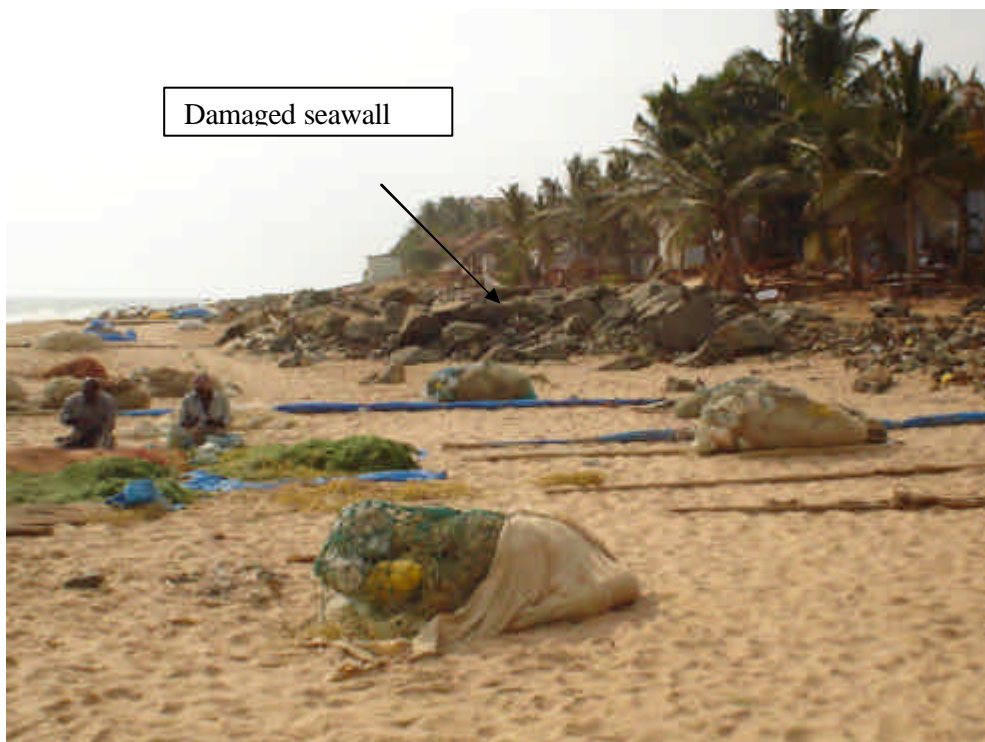
Photo 3.21 The damaged existing seawall at Pallanthurai

temporary nature, as it gets eroded during the monsoon months. It is found that the land is at a lower elevation. The damage to the existing seawall is shown in **photo 3.21**. It is recommended to raise the crest elevation of the seawall by 2.0 m. Further, two groins are recommended. The average length of the groins will be about 300 m which is included in the above figure. These two groins will act as protective measure only for the Pallanthurai stretch against erosion. Also, it is recommended to immediately stop the sand quarrying at this stretch.

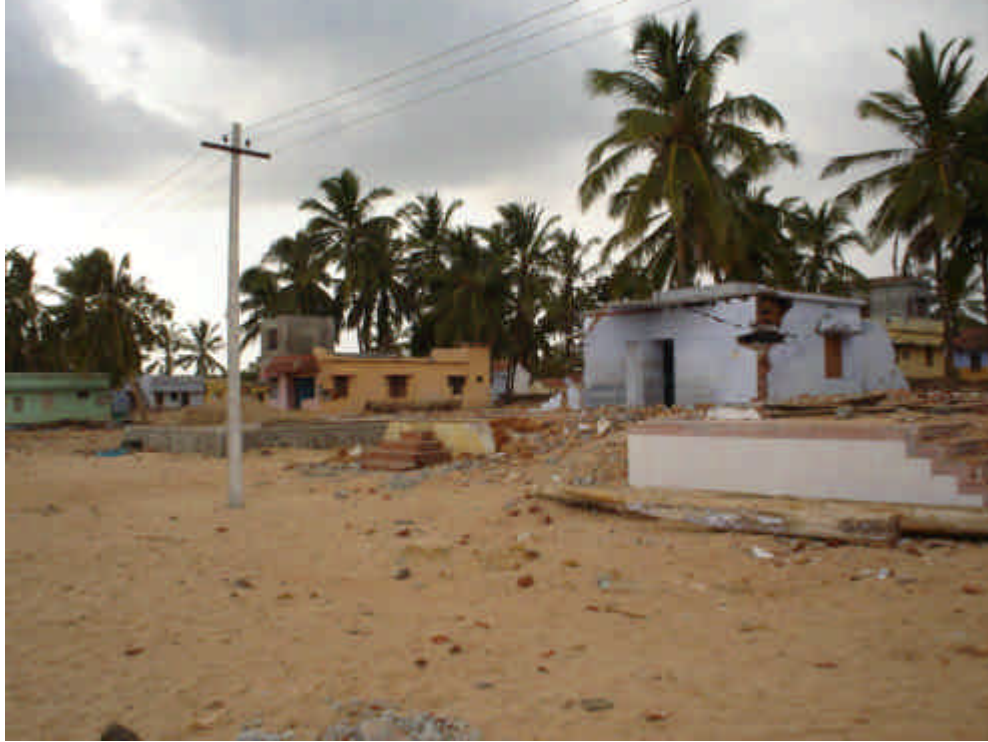
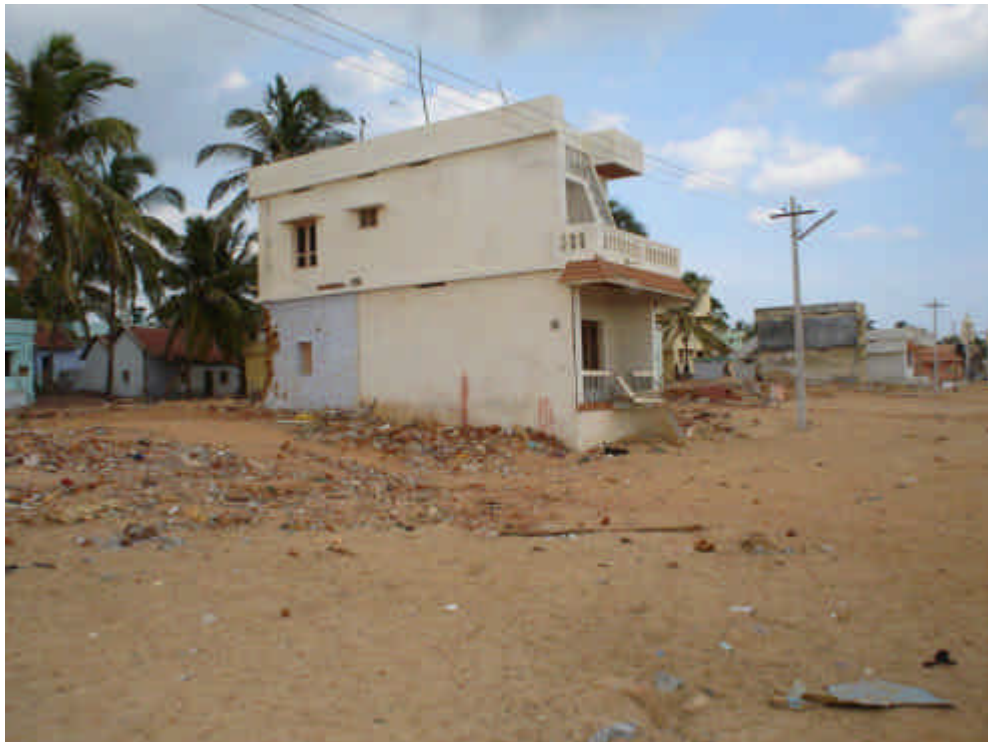
**Photo 3.23 a & b View of the damaged houses due to at
Mezhamanakudithurai**

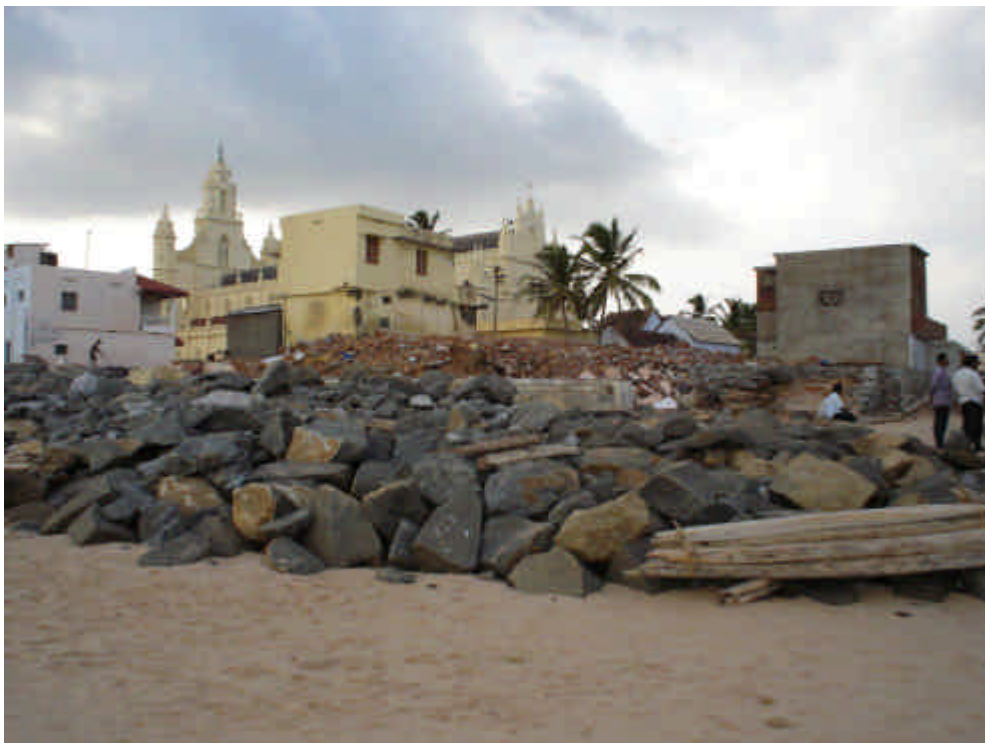
Photo 3.27. Damages on the leeward side of the seawall

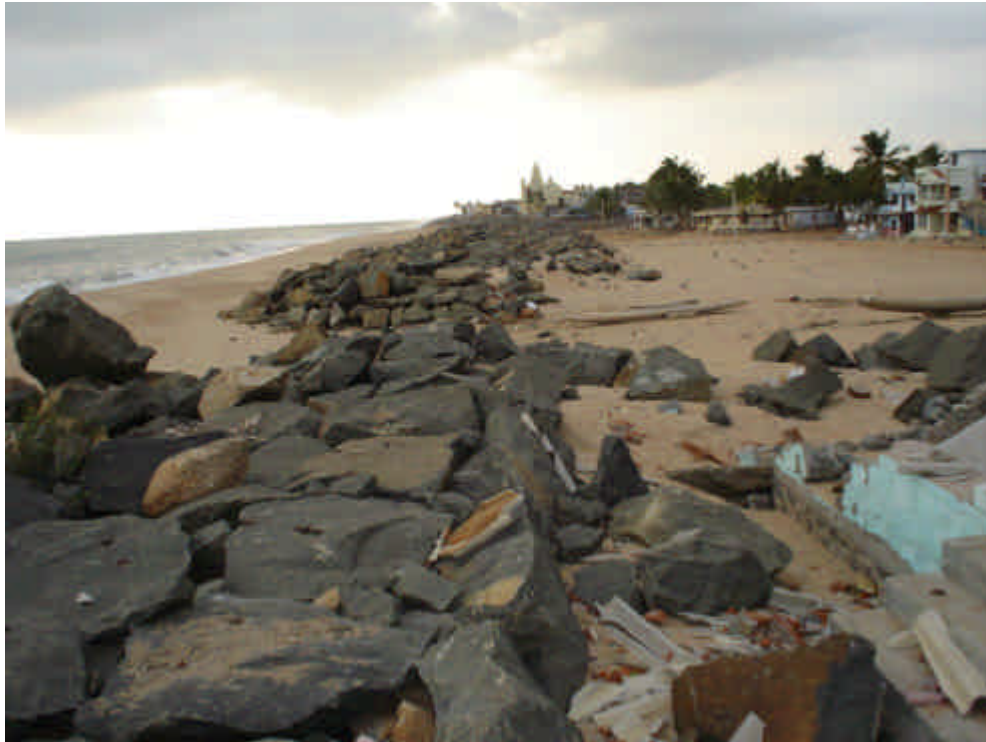
This village is located on the Eastern side of the river Palayar. The existing seawall completely disturbed is shown in **photo 3.28**. A number of dwelling units and churches got damaged as shown in **photo 3.29**. Hence, a groin field for upto distance of 1.5 Km is recommended. Further, it is also recommended to raise the crest elevation of the existing seawall by 2.0 m. The complete scheme of protection measure for these villages,

Photo 3.28. The damaged existing seawall at Keezhamanakudithurai

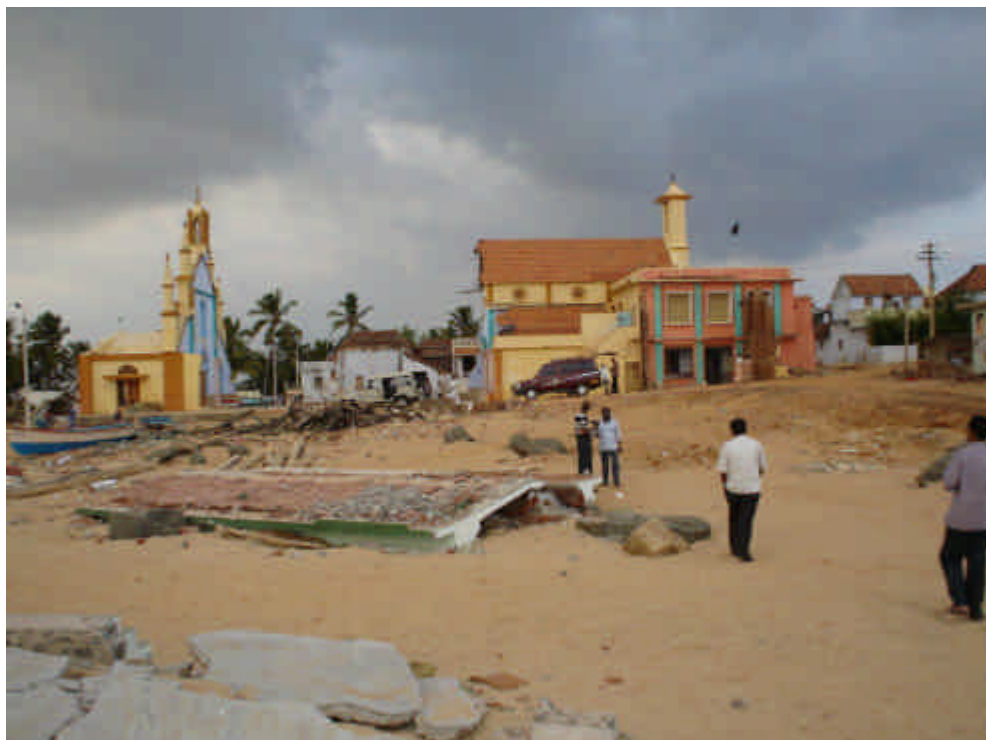
Photo 3.29. The damaged church and dwelling units

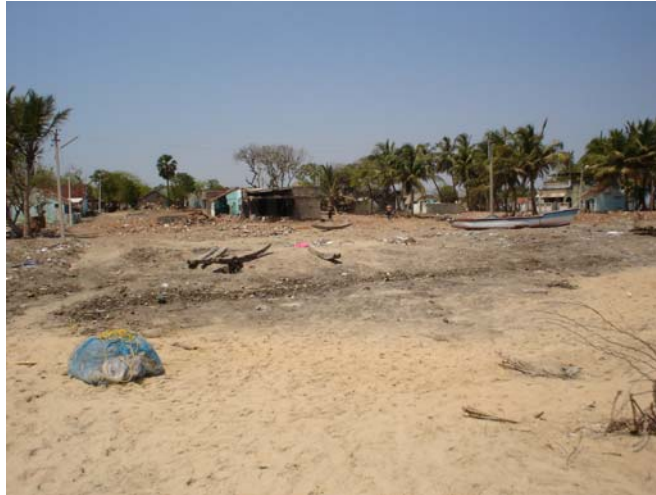
Photo 4.1 Damages to the property at Nagoor

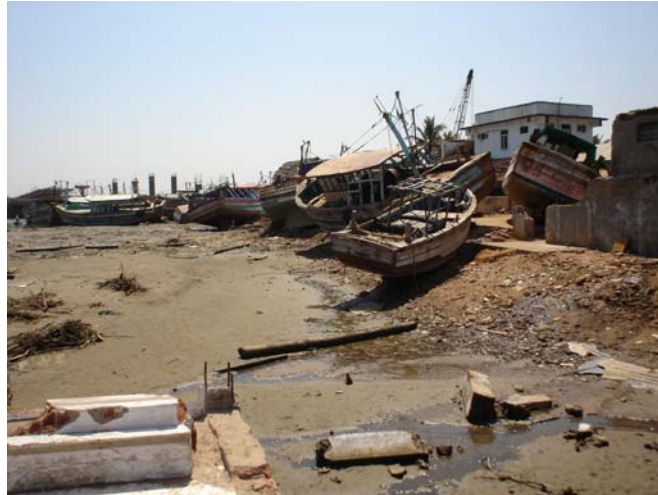
Photo 4.7 Damages to the boats on rear side of the vertical wall at Nagapattinam

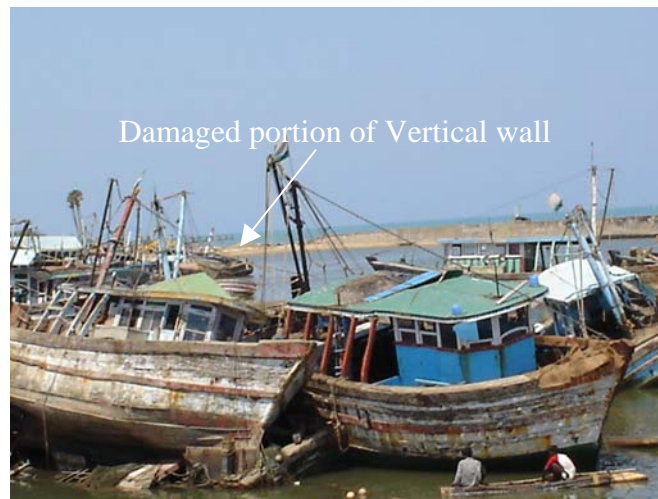
The barren land North of Nagapattinam port shown in **photo 4.5**, is an excellent place for dense plantations. The presence of the vertical wall (top level +2.7 m MSL) as shown in **photo 4.6**, constructed for the Nagapattinam port at a distance of about 60 m from the shoreline has acted as a barrier only marginally against the powerful tsunami. In spite of the presence of this wall, a number of boats were carried away to the land and water on its rear side has moved to a distance of 300 m and a height of about 8 m. The damaged boats behind the vertical wall are shown in **photo 4.7**, and the damaged portion of the vertical wall is shown in **photo 4.8**. The remedial measures are discussed in sec.4.1.2.

Photo 4.8 View showing the damaged portion of the vertical wall at Nagapattinam port

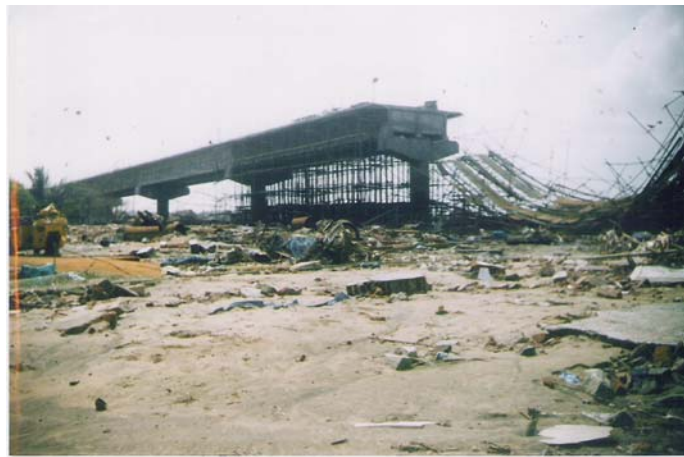
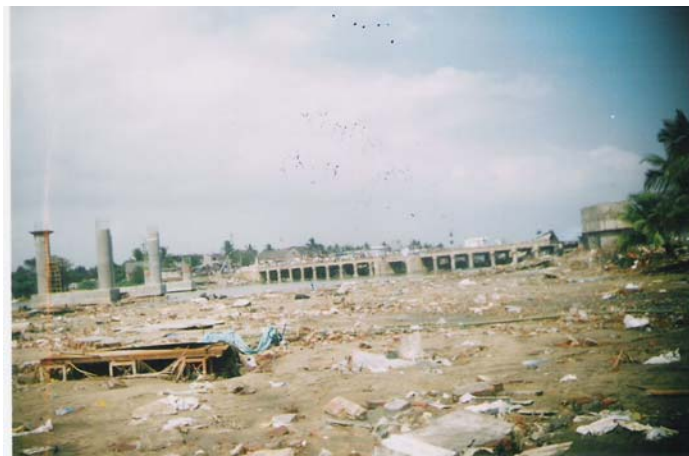
Photo 4.11 a & b Views of the damaged bridge connecting Nagapattinam and Kallar

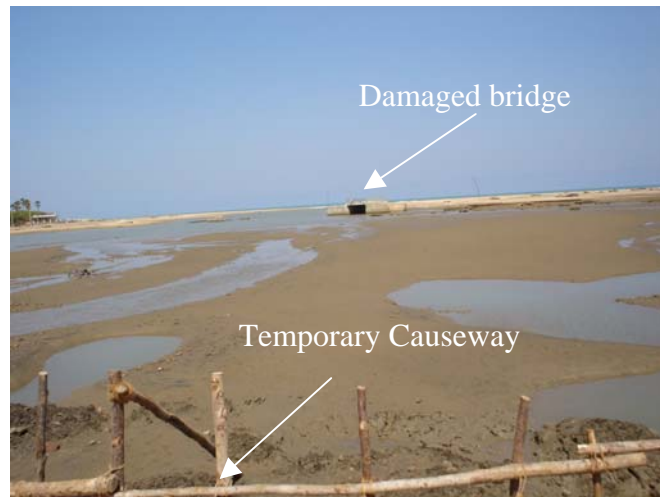
The damaged bridge connecting Nagapattinam and Kallar in the **stretch ‘B’** is shown in **photo 4.12.** The hutments close to the beach have been washed away by the recent tsunami. A clear width of beach is available as can be seen in **photo 4.13.** The river Vellayar (**photo 4.14**) joins the sea adjacent to this stretch of the coast and is shown in the above photo. **It is recommended to dredge the mouth of river Vellayar and nourish the beach on its Northern side as well as to construct a sand dune. Plantations backed up with sand dunes and masonry buffer blocks are recommended for this stretch of the coast as shown in the fig. 4.6.** Both plan and sectional elevation of the proposed are shown in the above figure. The buffer blocks may also serve as a relaxing facility for the pilgrims and locals. After monitoring the shoreline for a period of about 2 years, a decision can be taken up on the necessity of a hard measure.

Photo 4.12. The damaged bridge connecting Nagapattinam and Kallar

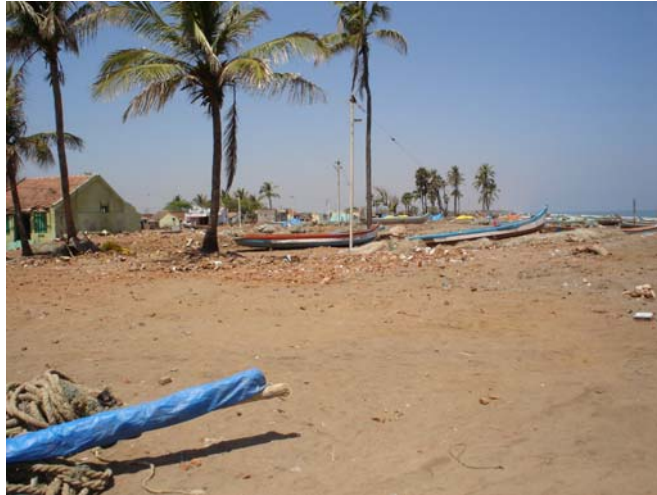
Photo 4.20. View of damages at Sathankudi after partial leveling of the debris

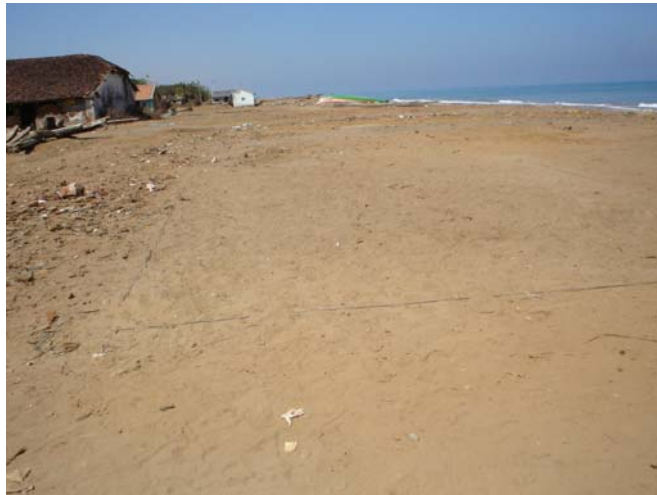
Photo 4.24. Damage to property North of Vaanagirikuppam

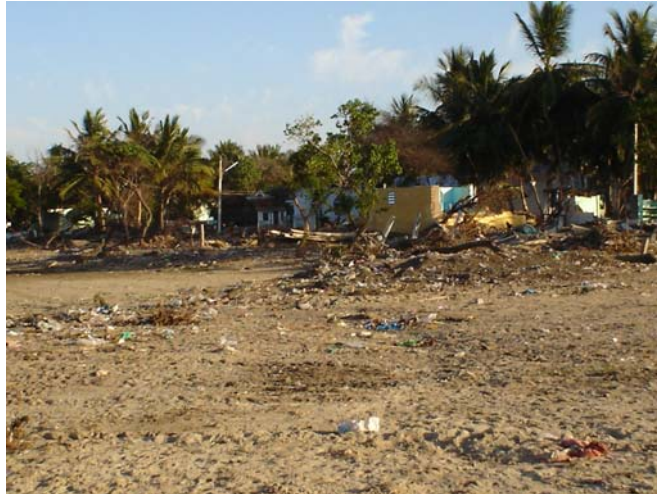
Photo 4.26. Typical damages to property due to tsunami at Palayur
