PLANNING OF COASTAL PROTECTION MEASURES ALONG KERALA COAST

Final Report

GOVERNMENT OF KERALA

DEPARTMENT OF OCEAN ENGINEERING
INDIAN INSTITUTE OF TECHNOLOGY MADRAS
CHENNAI - 600 036
AUGUST 2007

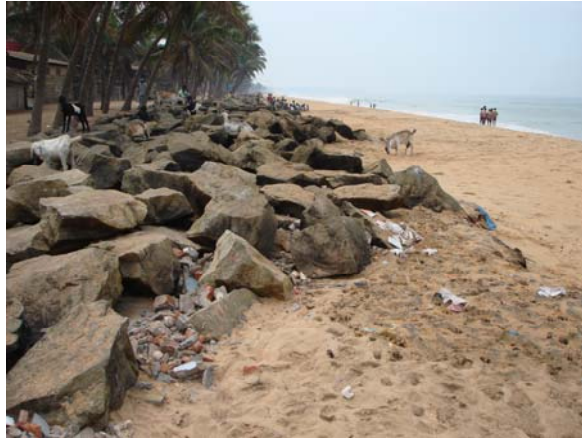
South of the above is a stretch of coastline with an existing seawall constructed by KID for about 1.5km. The present status of this seawall is shown in Photo.2.7. It is recommended that this area be protected by a combination of seawall (rehabilitation of the present seawall as Phase-I) Fig. A4 of Annexure A and groins (after monitoring littoral drift at proposed trial groins at Panathura), as shown in Fig: 2.6.

Photo 2.7. Damages to seawall at Beemapally

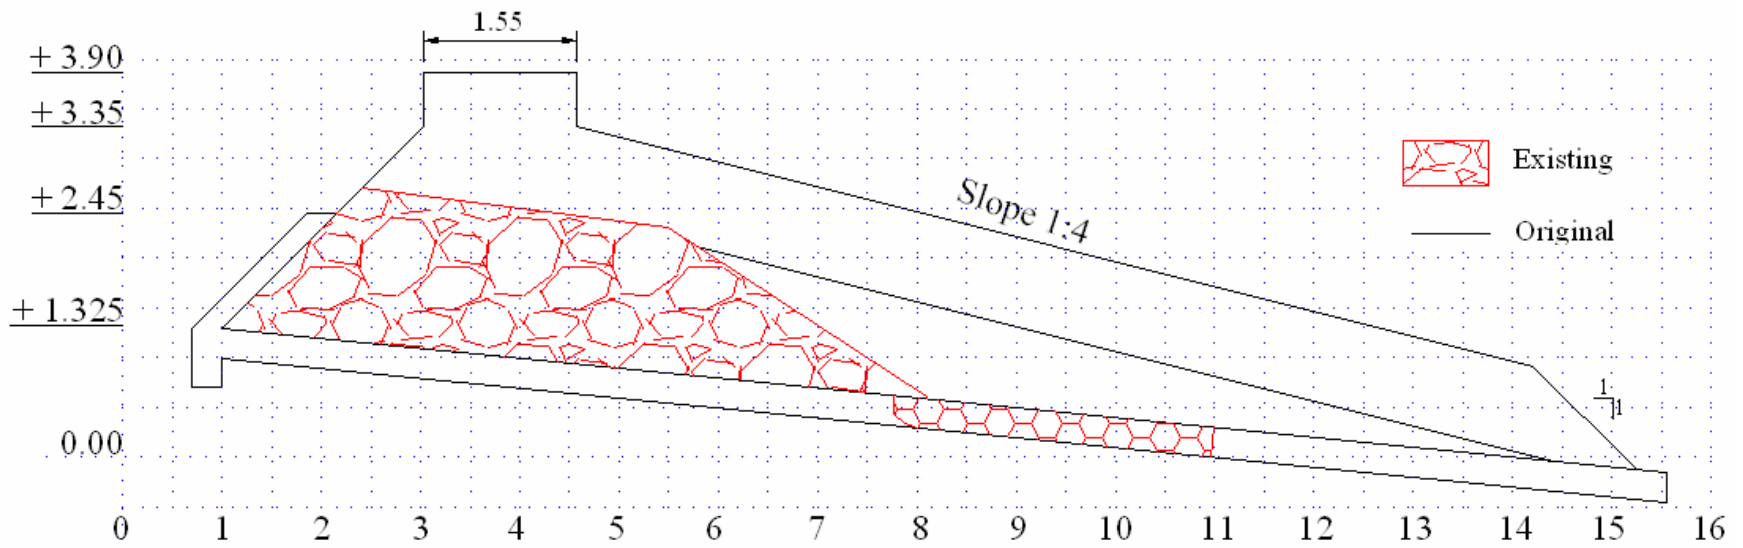
Fig. 2.7. Cross-section of the existing damaged seawall (as per KID) at Thazhampally

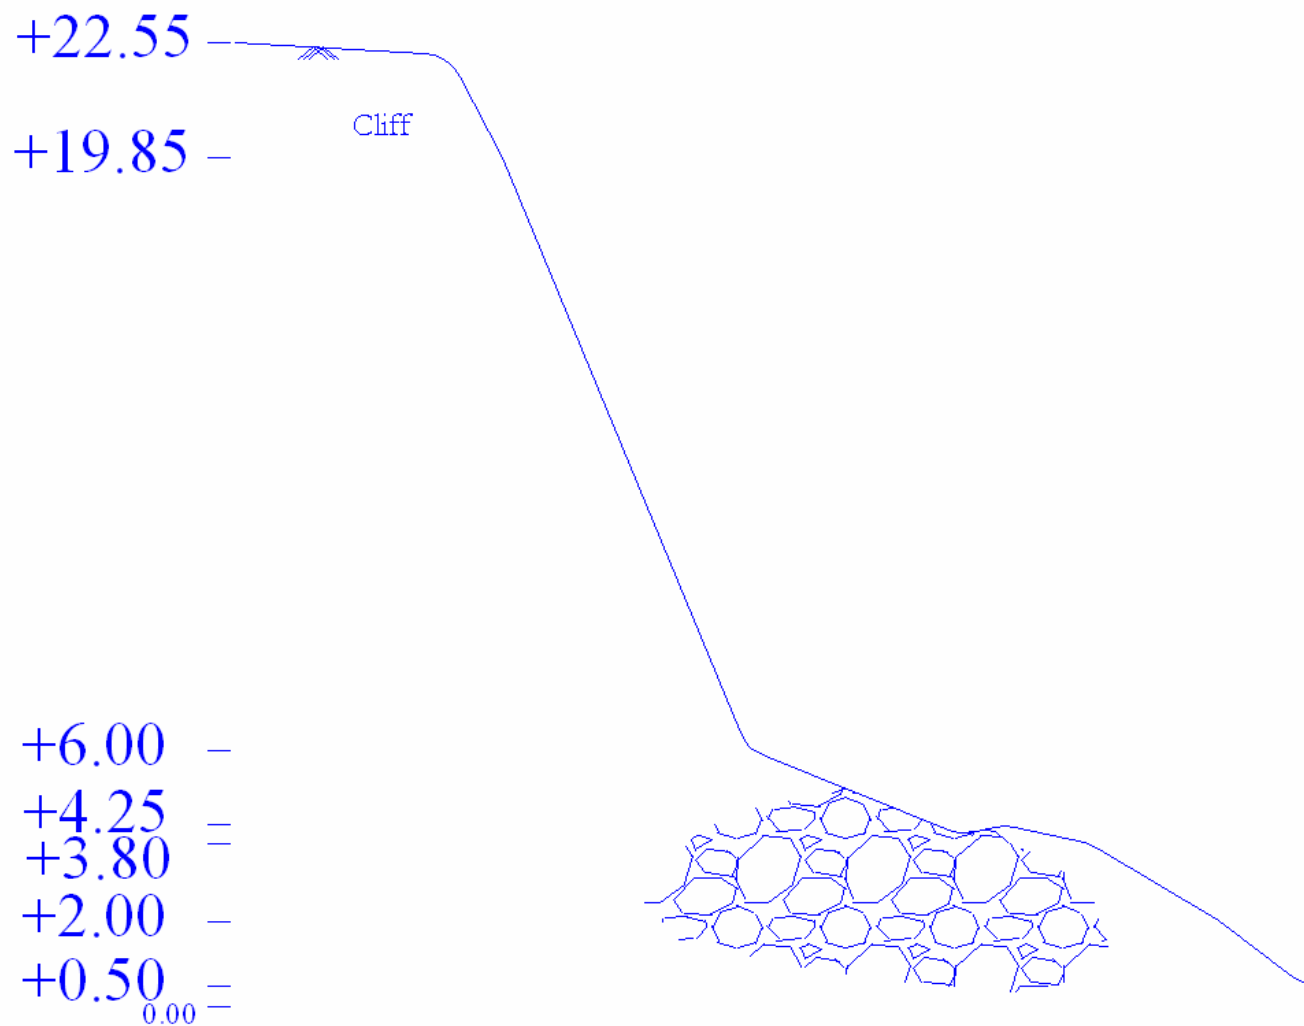
Fig. 2.8. Status of the seawall at Janarthanapuram

Fig. 2.9. Proposed cross section of seawall with gabions at Janarthanapuram

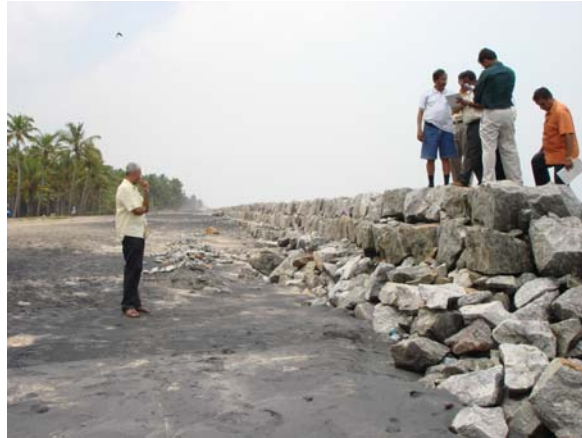
Photo 3.19. Damages to the seawall due to overtopping at Srayikadu

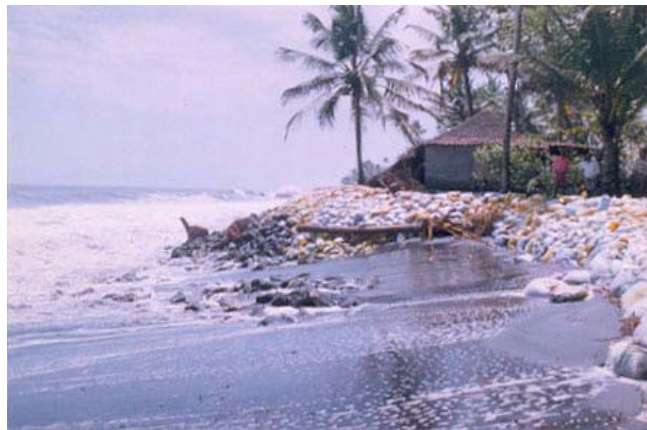
Photo.3.29 damage to existing seawall near Kayamkulam during storm

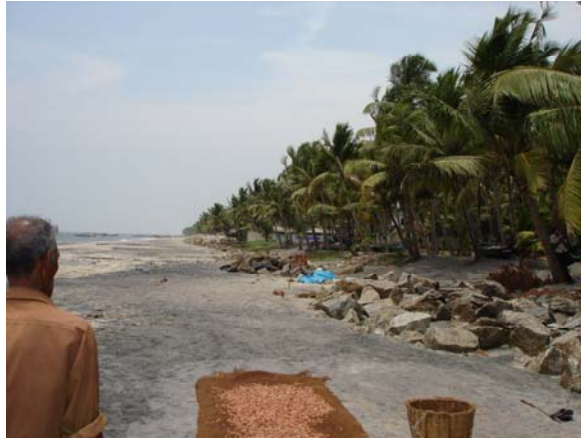
Photo 3.26. Extent of damage caused to the seawall North of Pathiankara

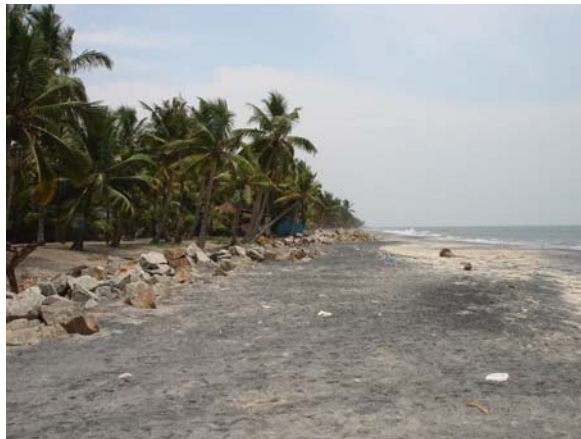
Photo 3.27. Extent of damage caused to the seawall South of Pathiankara

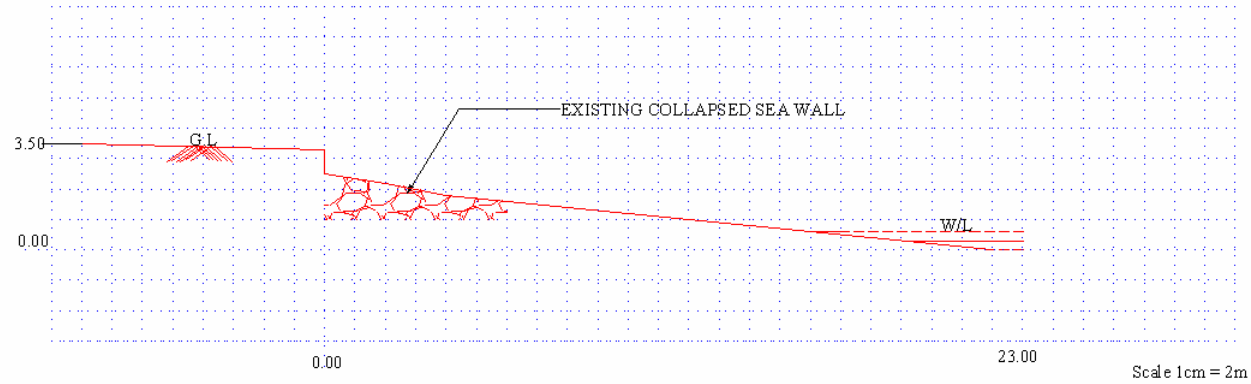
Fig. 3.2. Cross-section of the existing damaged seawall (as per KID) at Kappil

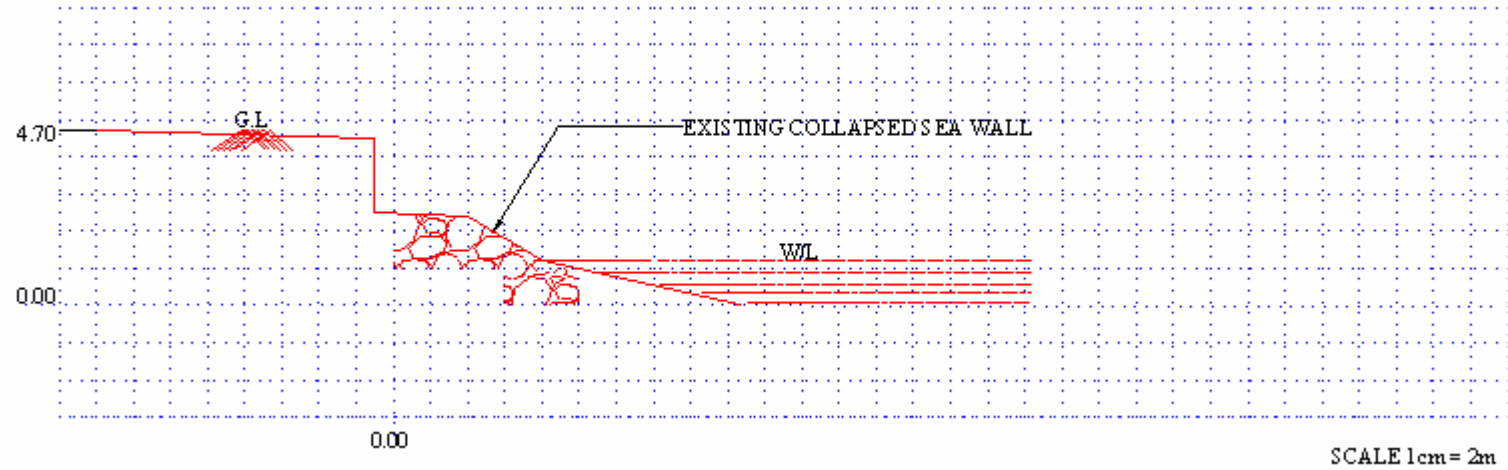
Fig. 3.5. Cross-section of the existing damaged seawall (as per KID) at Thanni

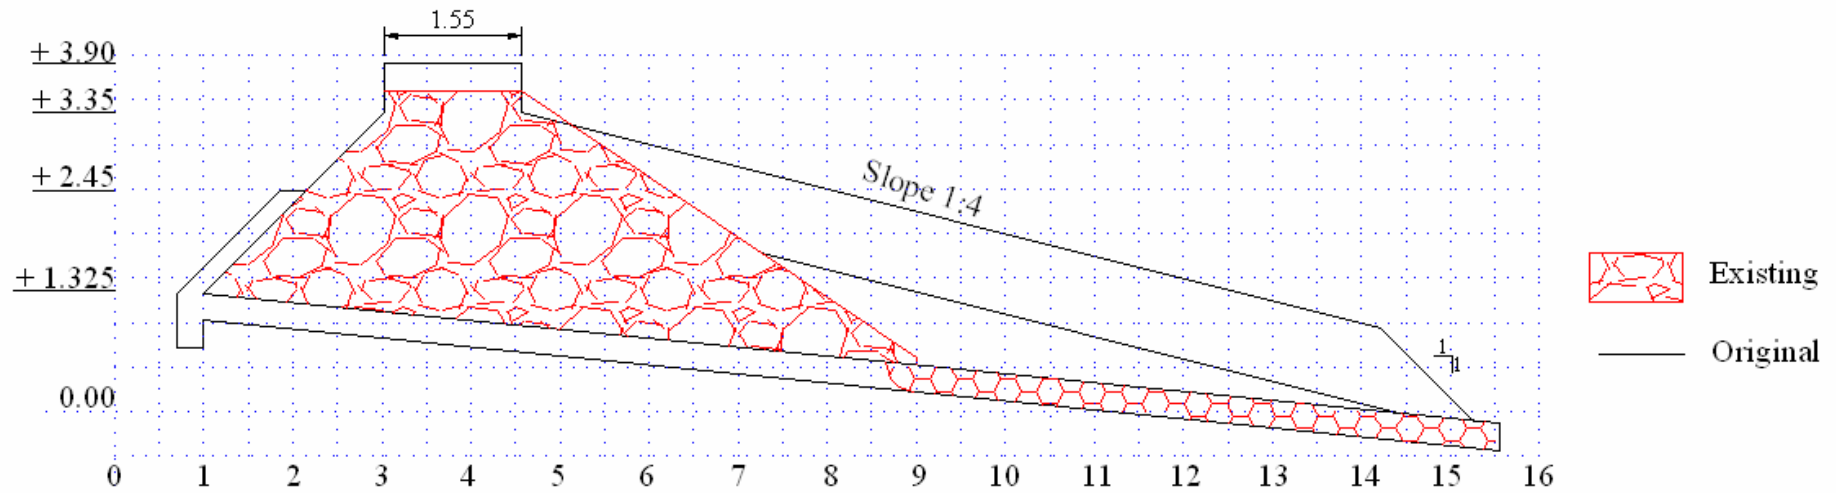
Fig. 3.7. Cross-section of the existing damaged seawall (as per KID) at Maruthadi

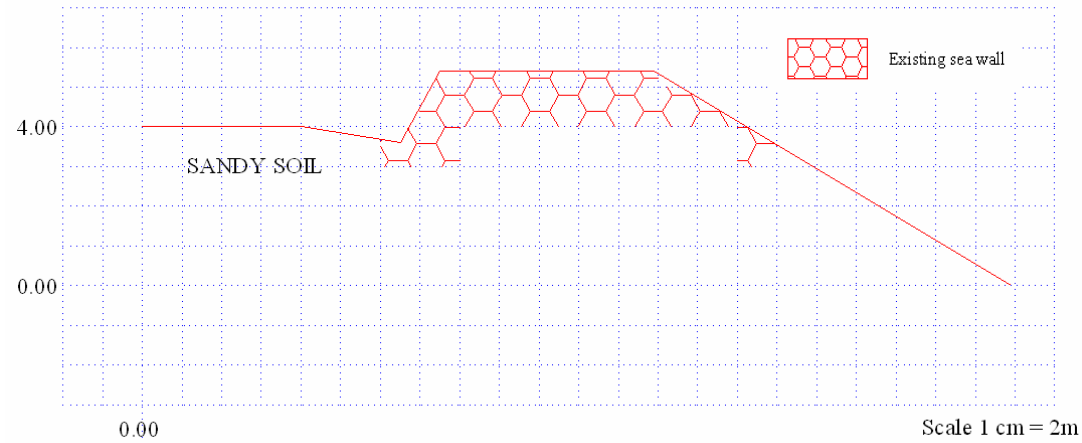
Fig. 3.9. Cross-section of the existing damaged seawall (as per KID) at Cheriyaazheekal

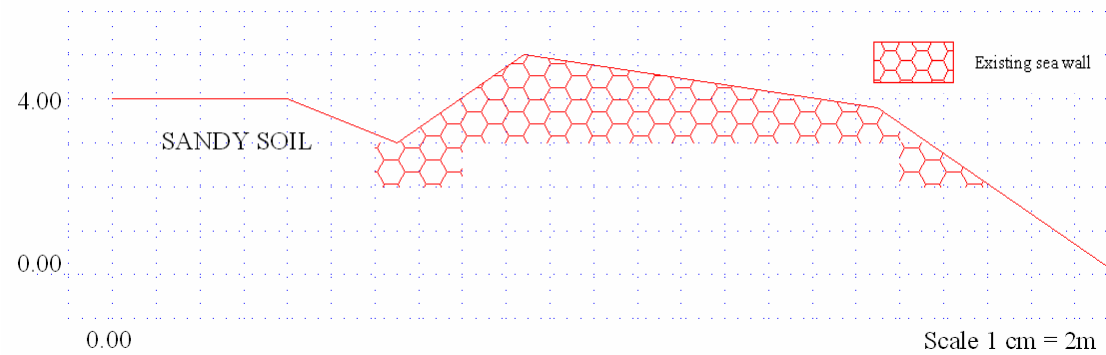
Fig. 3.10. Cross-section of the existing damaged seawall (as per KID) at Sraikkadu

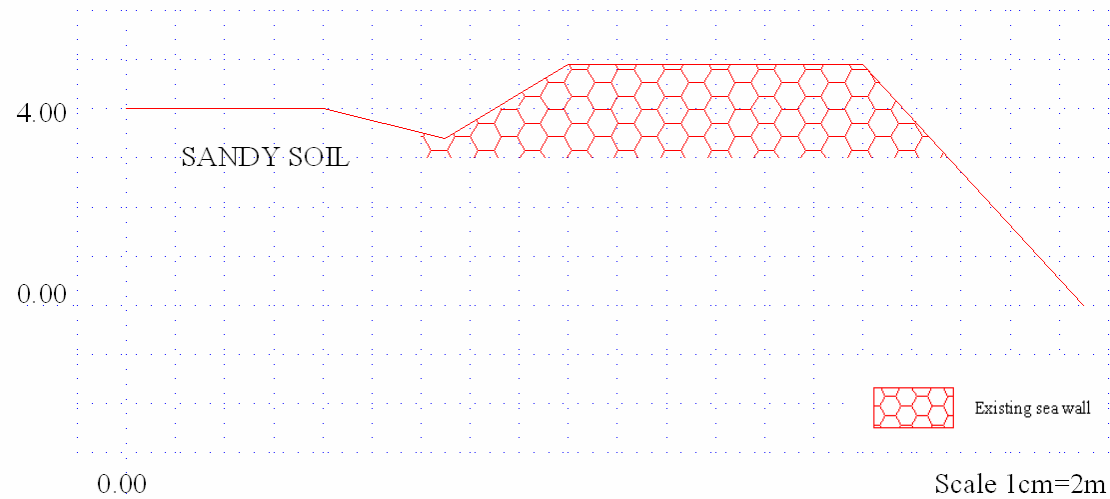
Fig. 3.11. Cross-section of the existing damaged seawall (as per KID) at Jayanthi Colony

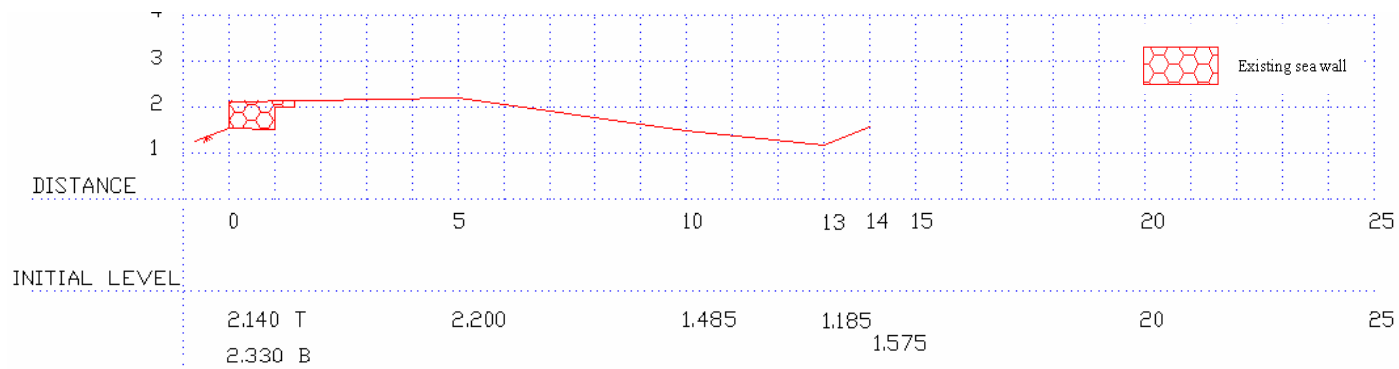
Fig. 4.3. Cross-section of the existing damaged seawall (as per KID) at Punnapra

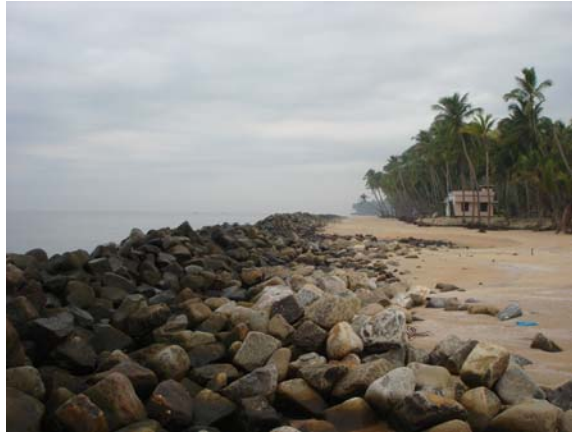
Photo 6.1 shows the existence of beach of width of about 25 m for a length of 1 km. During tsunami as well as during the monsoon period, this stretch of coast has suffered severe damage. The details of which can be seen in Photo 6.2. The original seawall cross-section designed by CWPRS which was adopted for a length of about 100m is shown in Fig. 6.2. The existing cross-section prepared by Kerala Irrigation Department (KID) as well as seen through the earlier photos is projected in Fig. 6.3. It is proposed that the existing cross-section of seawall needs to be reformed with the cross-section designed by IIT Madras for locations with beach width of 20-25m (Fig. A5 of Annexure A). Similarly, the locations along this stretch of coast which are unprotected (for a length of about 50m) should also be covered with the seawall as recommended above.

Photo 6.1. View showing the seawall at Anchangadi

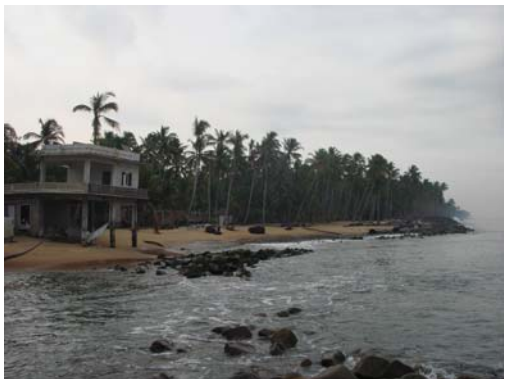
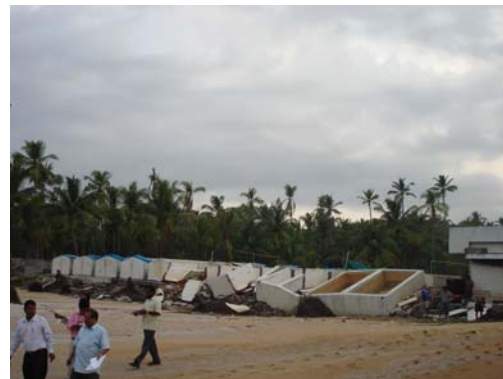
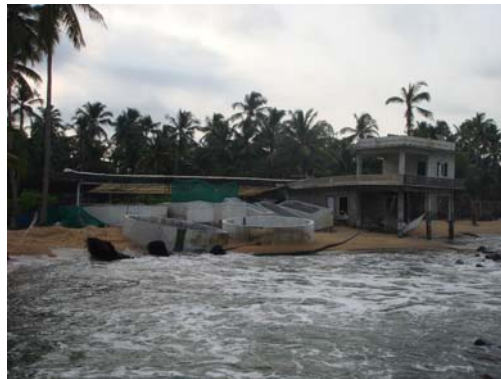
Photo 6.2. Views showing the damages to the private property at Anchangadi
