# India's Ageing Large Dams — Lessons from DRIP

Krishna Raja Sagar Dam

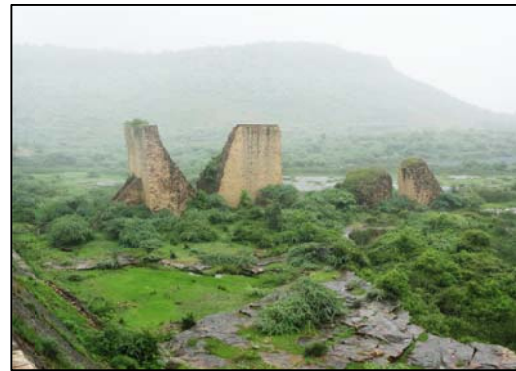
Loss of strength of the rock mass foundation of concrete and masonry dams has been the cause of major incidents and complete failures. The scenario may occur soon after the dam is put into operation (see the remnants of Tighra Dam in Figure 3), or it may take several years to develop.

Figure 3. Tighra Dam in Madhya Pradesh is a masonry gravity structure built in 1916 for agricultural irrigation and municipal water supply. The dam failed on the afternoon of Aug 4, 1917 during a large flood because of a weak foundation that could not resist the hydraulic pressure. The dam was repaired and is in operation today.

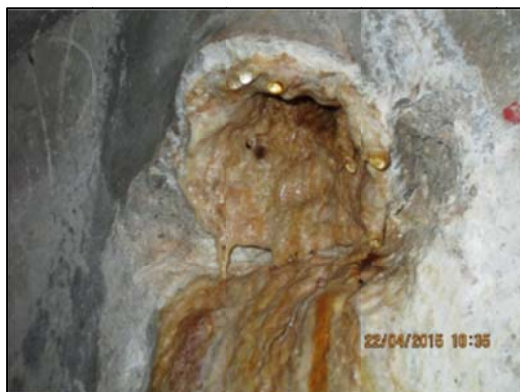
Figure 4. A clogged drain pipe at Ponnudi Dam in Kerala caused by increasing leakage and lack of maintenance. The reduction in flow through a pipe because of clogging can promote piping and lead to eventual collapse of a dam.

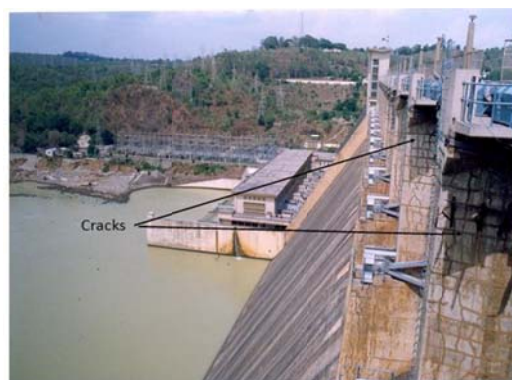
Swelling produced by the chemical reactions varies throughout the dam body and is strongly affected by the confinement of a particular location. Cracking will occur where expansion is large (Figure 5).

Figure 5. Large cracks have developed in Rihand Dam in Uttar Pradesh as the result of alkali-aggregate reaction.

No efficient remedial measure against swelling caused by chemical reaction is known. Measures to mitigate the effects of swelling have included cutting slots to relieve stresses, and by reinforcement or confinement of the concrete in critical zones.

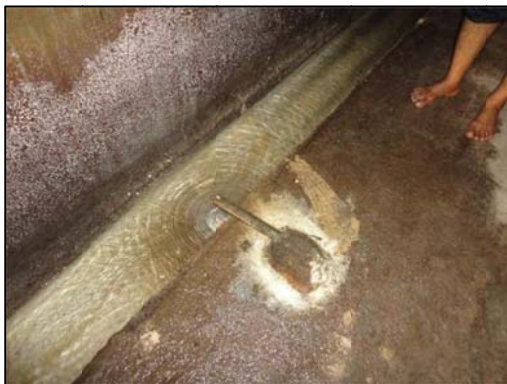
Figure 6. A flooded gallery and leachate stains at Karanja Dam in Karnataka. The presence of leachate indicates chemical reactions between reservoir water and dam body materials.

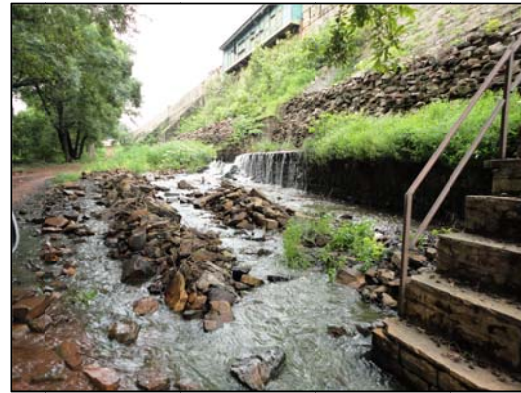
masonry dams is the growth of excessive vegetation over dam slopes, leading to opening of joints with consequential porosity and weakening of material strength in the dam body (Figure 7).

Figure 7. Masonry gravity dams are subject to leakage caused by failed mortar and construction joints, and by the growth of plant roots that create paths along which water can flow easily, such as at Chandpatha Dam in Madhya Pradesh. Large seepage flows can remove internal material, resulting in catastrophic failure.

Remedial measures for this scenario attempt to restore the water-tightness of the dam by modifications to its upstream face. Methods currently in use include 1) grouting of the upstream shell; 2) use of barrier coatings such as bitumen, mastic asphalt, resins, and reinforced gunite; 3) concrete or metal facings anchored to the dam body; and 4) installation of PVC membranes on the upstream face. Local patching is also applied where cracking has been caused by cyclical temperature variations. Regular measures for weed removal from the slopes of masonry dams are also required, else application of suitable chemicals prohibiting plant growth shall be considered.

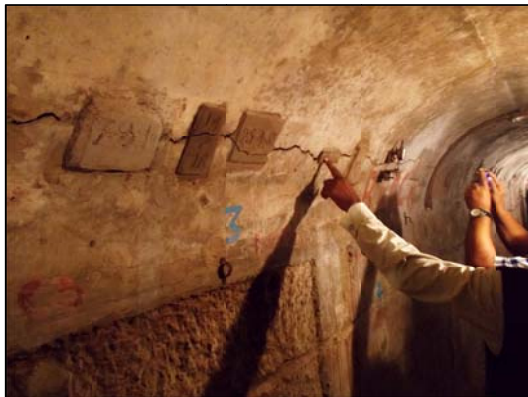
Figure 8. Cracking caused by repeated thermal stresses in the gallery of Konar Dam, a composite concrete-gravity/earthen-embankment dam located in Jharkhand.

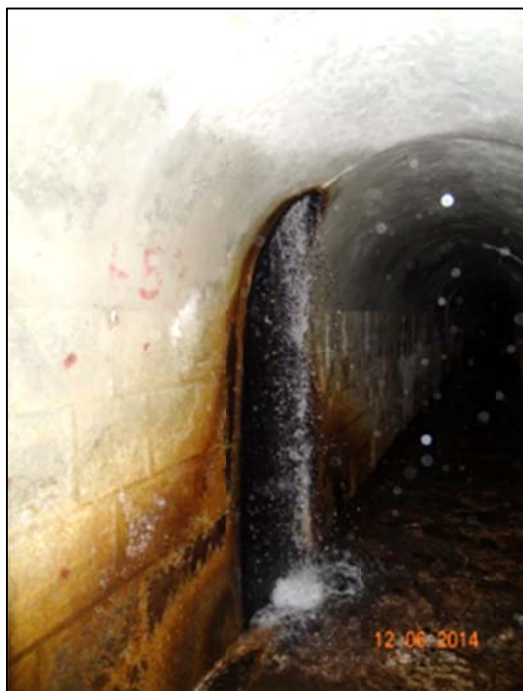
Figure 9. Leakage at contraction joints are typical in most masonry dams indicating failed or defective waterstops, such as shown here in the gallery of Upper Bhavani Dam in Tamil Nadu

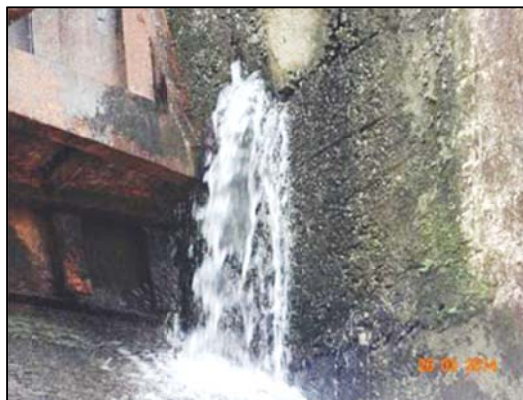
Figure 10. Leakage downstream of vertical lift gate coming from a deteriorated horizontal lift joint at Ichari Dam in Uttarakhand.

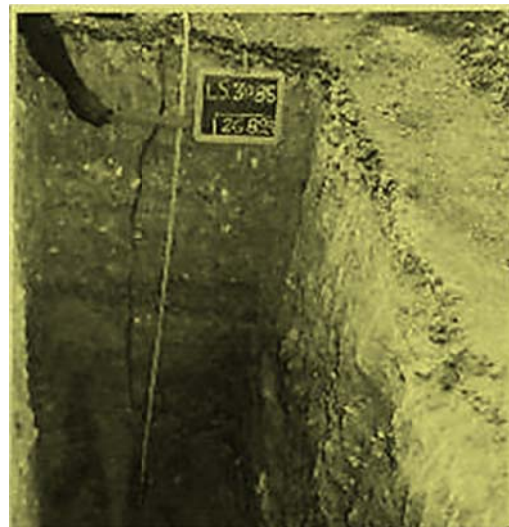
Figure 11. Differential settlement of impervious shoulder resulting in longitudinal crack forming at the dam top above the clay core as seen inside the trench; Upper Tiruppur Dam, Tamilnadu.

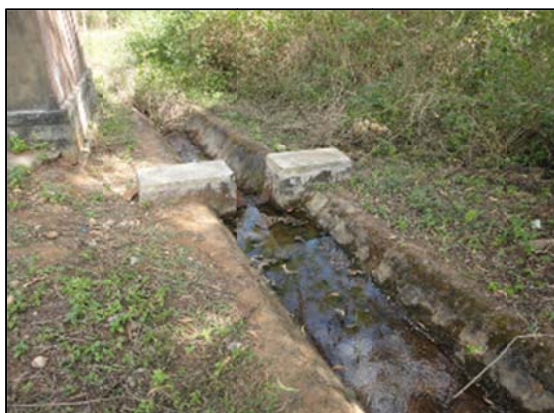
Figure 12. Leakage is monitored by collecting seepage water in discharge channels and measuring the flow using small weirs. At some DRIP dams measuring weirs have been damaged or removed making assessment of dam deterioration by internal erosion impossible. The measuring weir at Balimela Dam in Odisha shown in the photograph is open to the environment, unprotected, and vulnerable to damage.

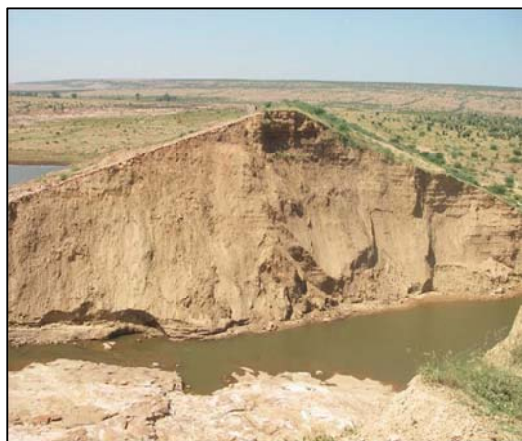
Figure 13. Gararda Dam in Rajasthan breached during the very first filling on Aug 15, 2010 because of internal erosion along the embankment/foundation interface.

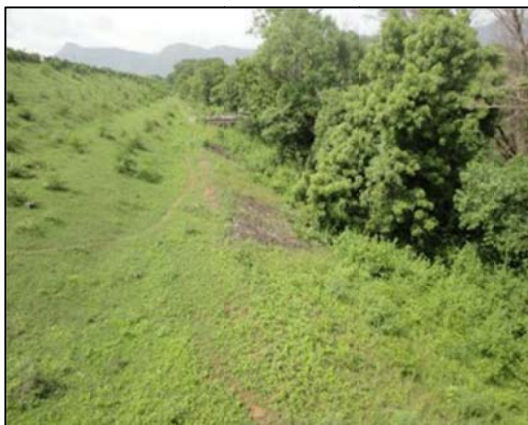
Figure 14 Large trees allowed to grow on the downstream embankment slope of Meenkara Dam in Kerala make visual detection of seepage difficult and can promote leakage along the paths of roots extending into the dam.

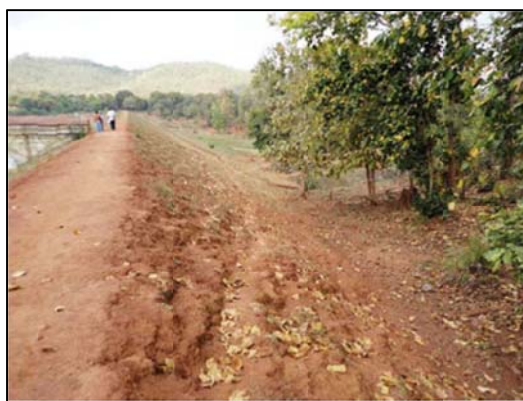
Figure 15. Surface erosion on downstream embankment of Balaskumpa Dam in Odisha. Note the absence of grass cover that would prevent soil erosion on the embankment slope.

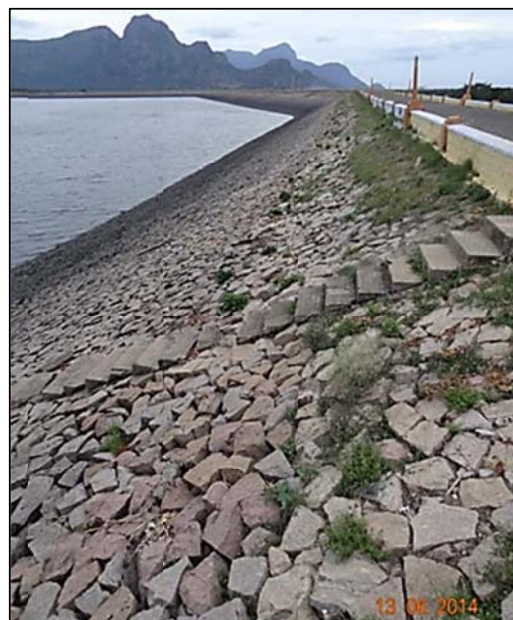
Figure 16. Displaced riprap caused by wave action on the upper slope of Thirumurthy Dam in Tamil Nadu.

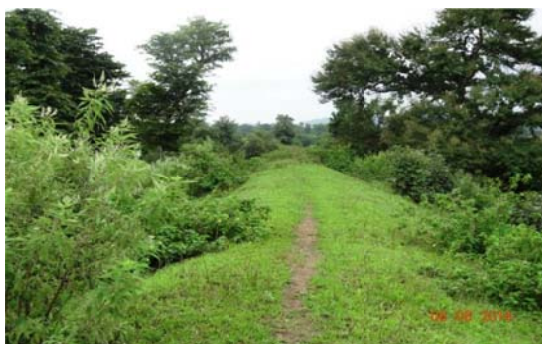
Figure 17. Woody vegetation inhibits dam safety inspection of Dhuty Weir located in Madhya Pradesh. Uprooted trees on the waterside of the dyke have over steepened the waterside slope resulting in large voids and reduced freeboard; and have reduced necessary x-section of the dyke for maintaining stability.

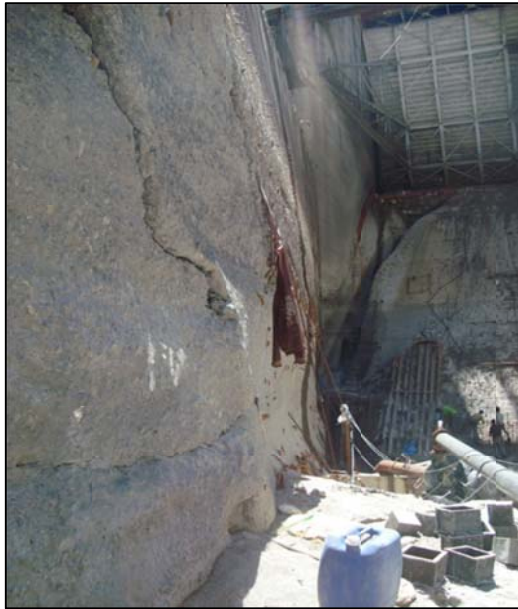
Figure 18. Energy dissipation erosion in overflow spillway at Maneri Dam in Uttarakhand. The spillway was eroded approximately five meters and set the stage for heavy remedial works.

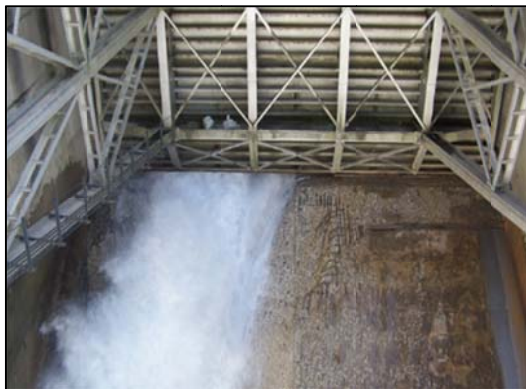
Figure 19. Spillway glacis beneath a radial gate at Ichari Dam in Uttarakhand has been eroded by abrasion from sediment resulting in significant leakage when the gate is fully closed.

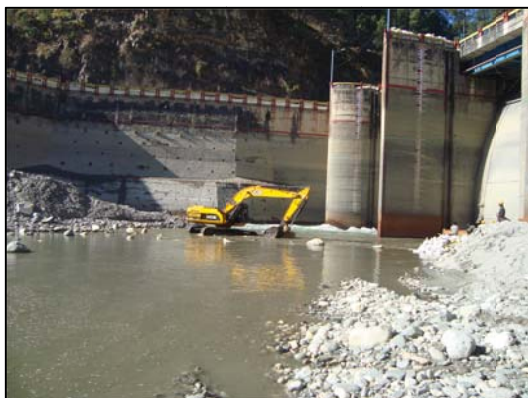
Figure 20. Excessive sediment accumulation in reservoirs, particularly near the intakes of bottom outlets, such as at Maneri Dam in Uttarakhand shown here, can be mobilized quickly when gates are opened and obstruct flow through the outlet.

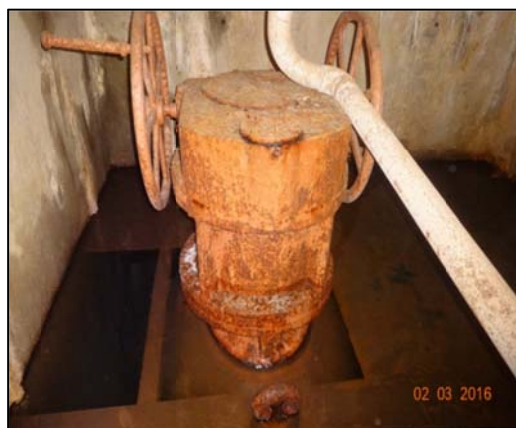
Figure 21. A sluice gate valve at Barna Dam in Madhya Pradesh that has not been operated in many years. Sediment deposits in the reservoir have blocked the sluice inlet.

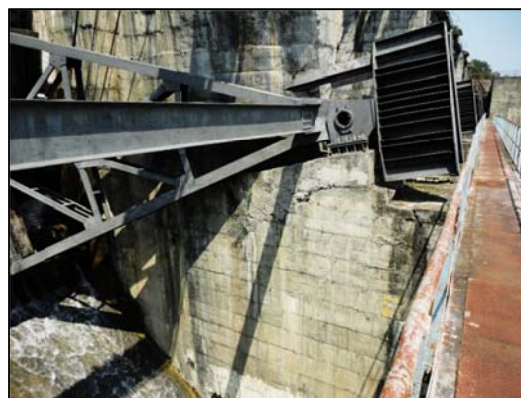
Figure 22. Leakage and flaking of concrete beneath the trunion of a radial gate at Bennithora Dam in Karnataka because of deterioration of lift joints from large daily temperature variations and chemical action.

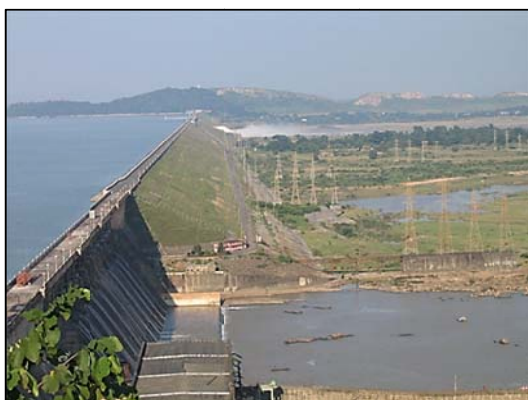
Figure 23. The revised inflow design flood for Hirakud Dam in Odisha requires and increased spillway capacity of 20,000 cubic metres per second.

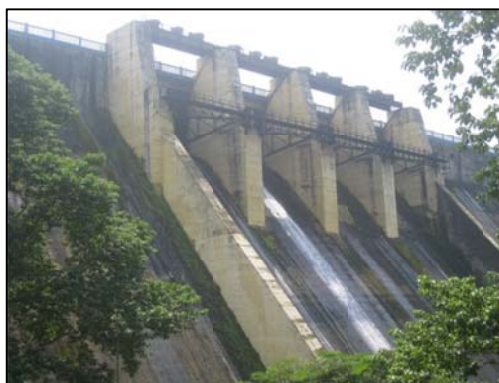
Figure 26. Chimoni Dam in Kerala has been thoroughly investigated for dam body seepage through 3D Sonic Tomography and is being rehabilitated by large scale grouting.

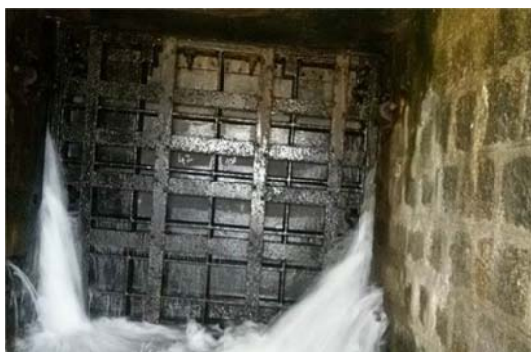
Figure 27. Profuse leakage from the aged gates of the Krishna Raja Sagar Dam, Karnataka
