## **AGENDA FOR 3<sup>rd</sup> MEETING OF THE NATIONAL COMMITTEE ON DAM SAFETY**

**DATE : 5<sup>th</sup> December, 2023**

### **Agenda Points 3.12: Dam Failure/Incidents reported during year 2023**

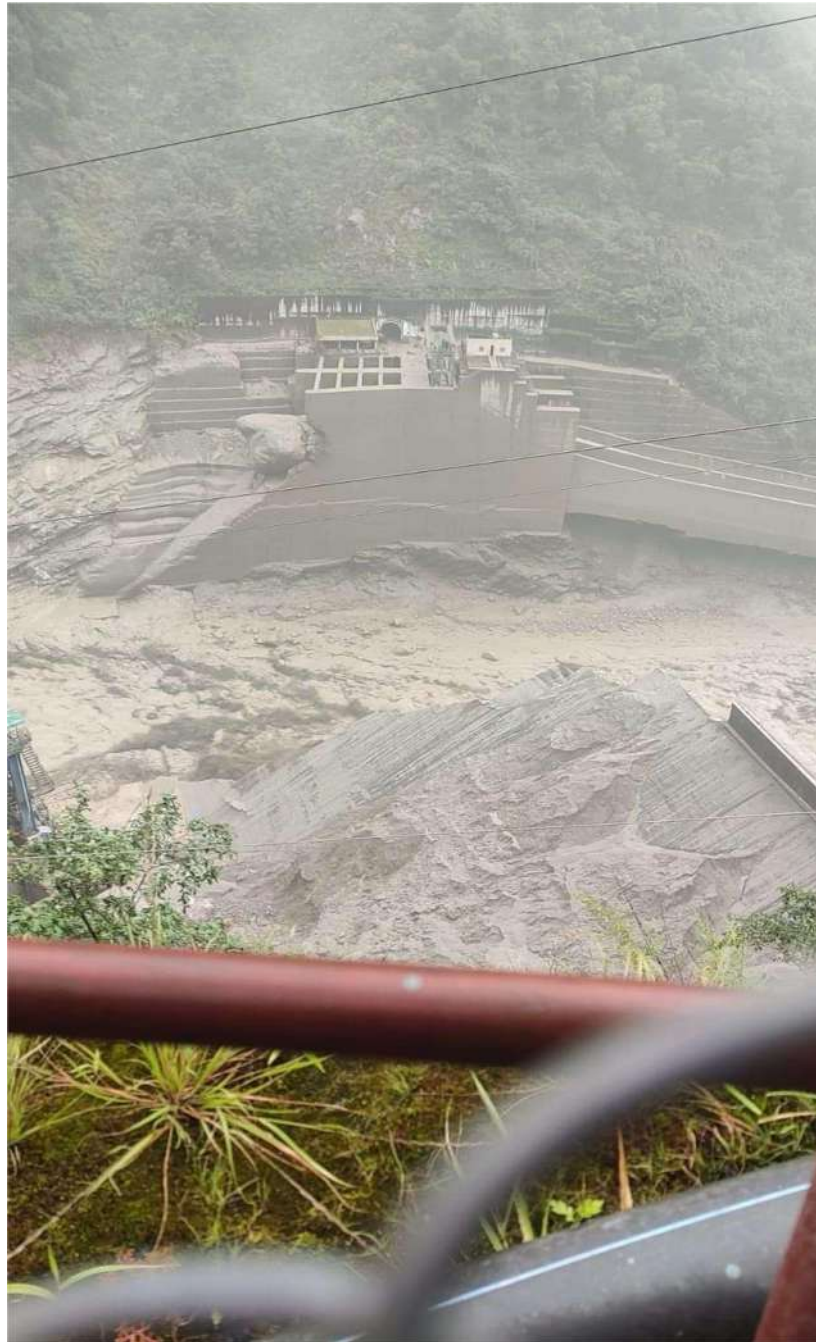
As per available information, the Teesta-III dam (about 40 km u/s of Teesta-V dam) overtopped, and a substantial portion of CFRD washed out during the flash floods.

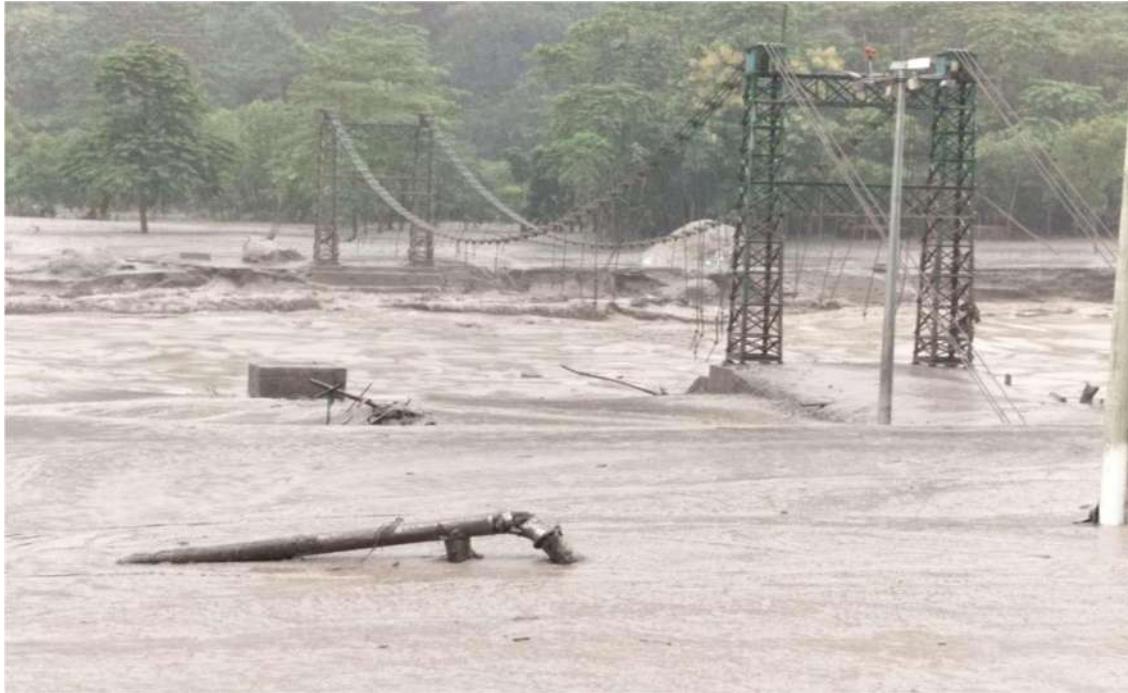
Bridge Connecting to Power House and Residential Complex

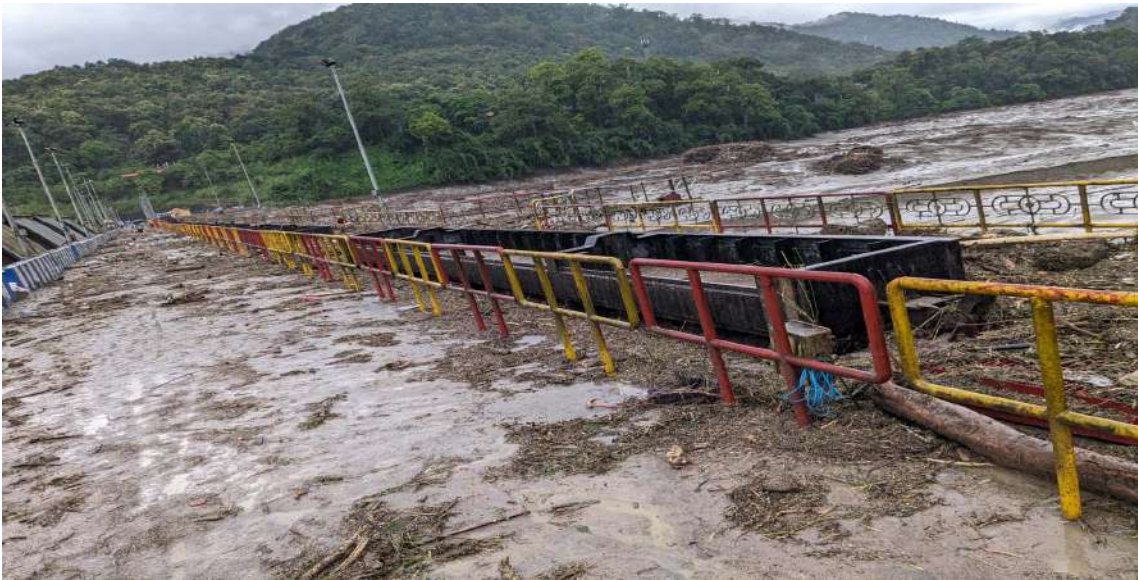
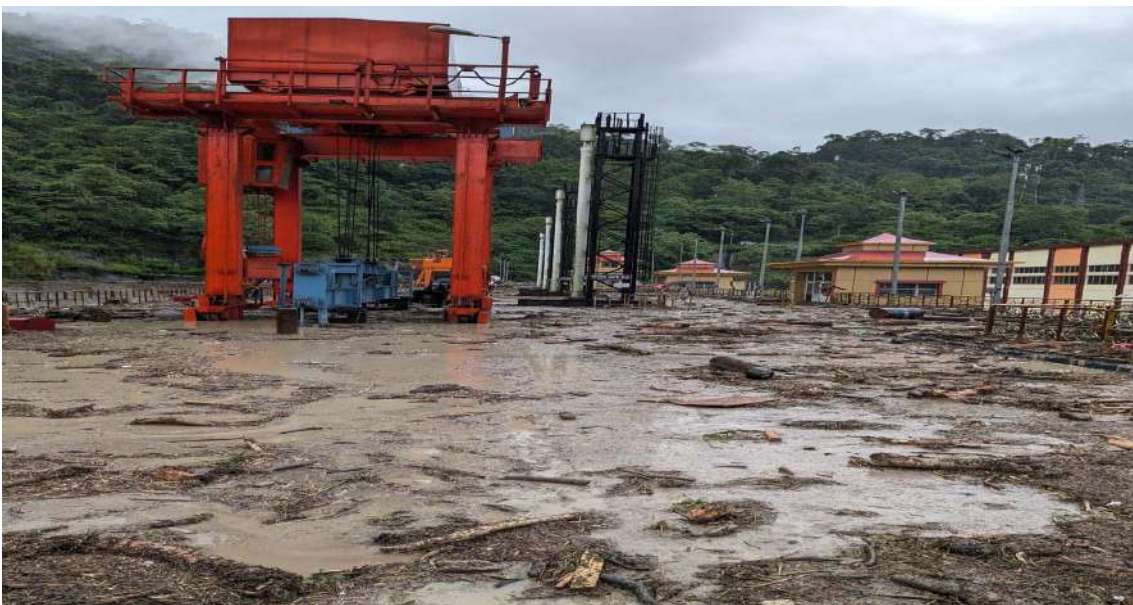
Fig 5: TLDP-IV heavy slush and bushes on Dam top

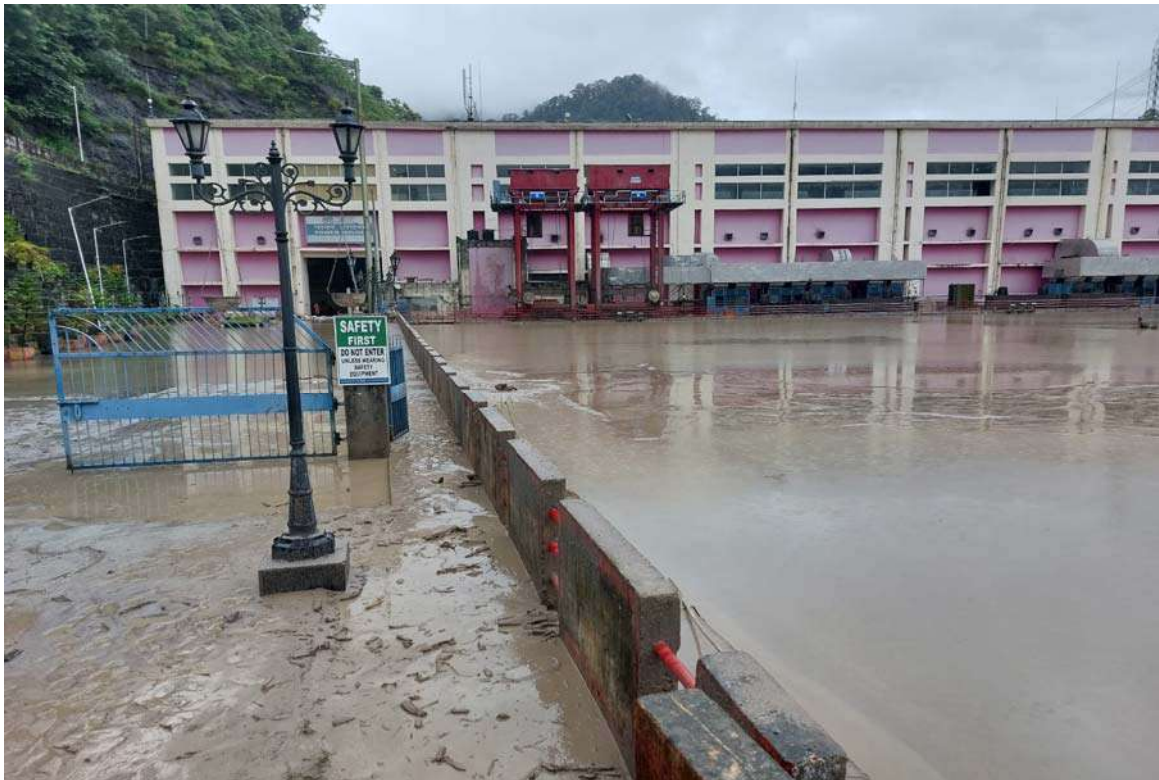
During the visit, it was observed that the Tail race channel of the powerhouse was filled with silt, which had to be removed before starting the powerhouse. A monorail crane for operating the stoplogs downstream of the radial gate is reportedly washed away.

Fig.-6 TLDP-III D/s view of power House. Silt and slush deposit on TRC

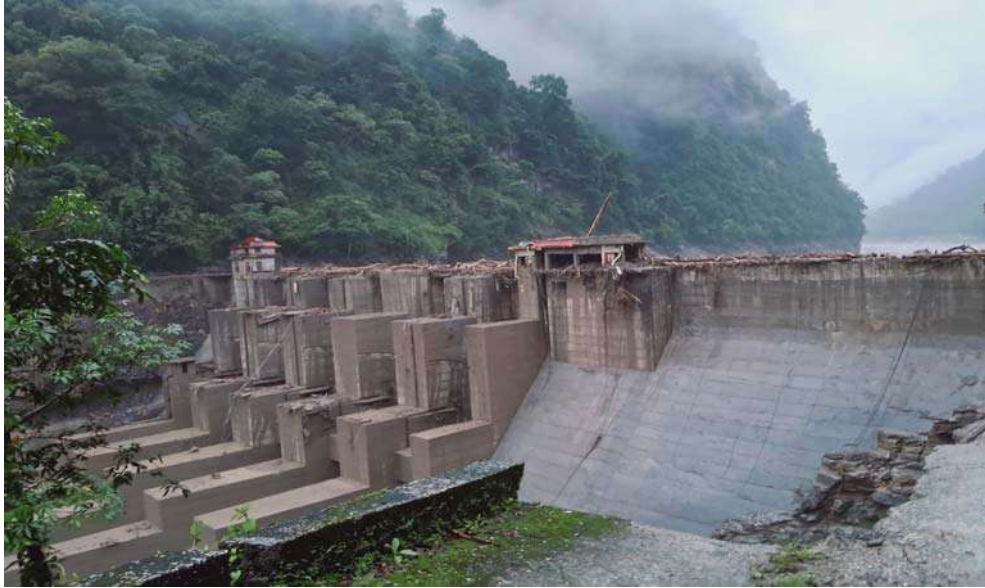
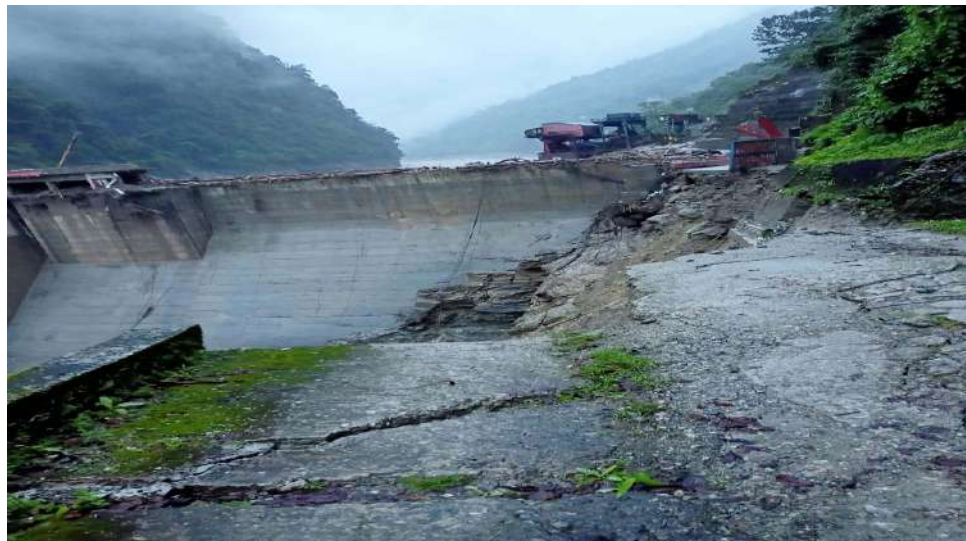
Fig.8: Teesta-V: Dam Downstream View

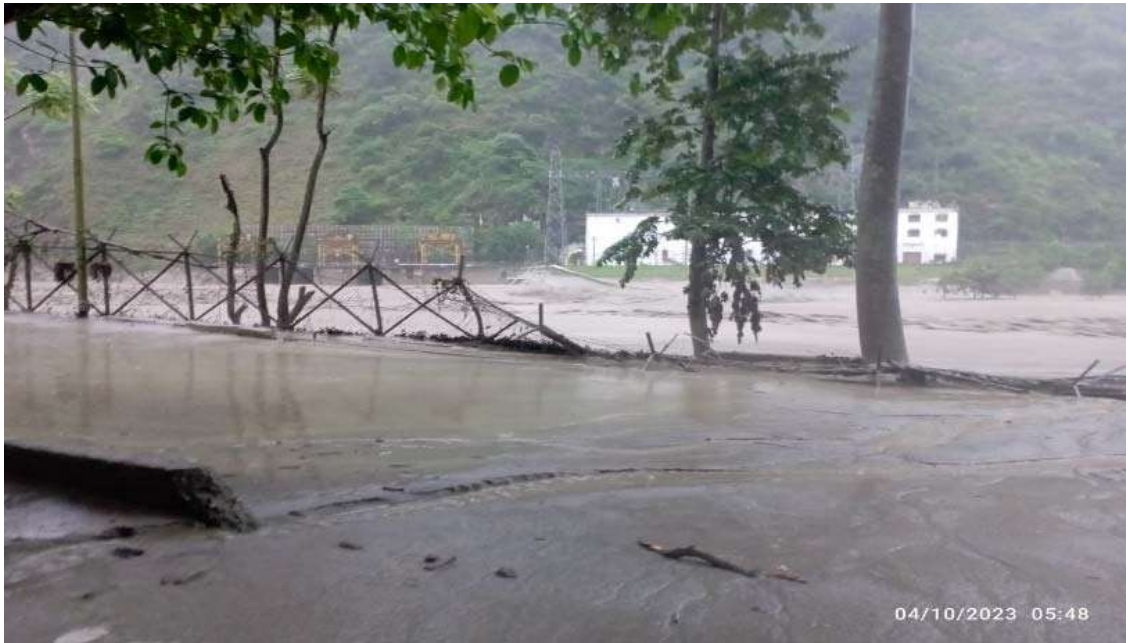
Fig.9 Teesta V Powerhouse Bridge collapse

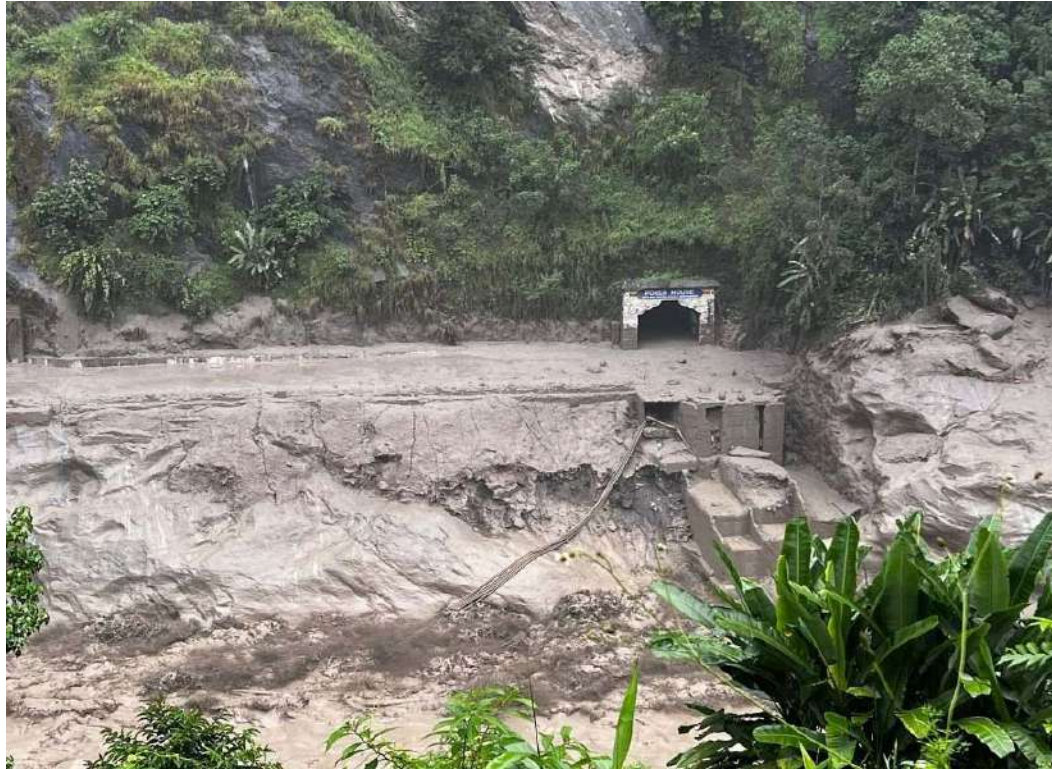
As per available information, the Teesta-III dam (about 40 km u/s of Teesta-V dam) overtopped, and a substantial portion of CFRD washed out during the flash floods. The water also entered the underground Powerhouse through MAT.

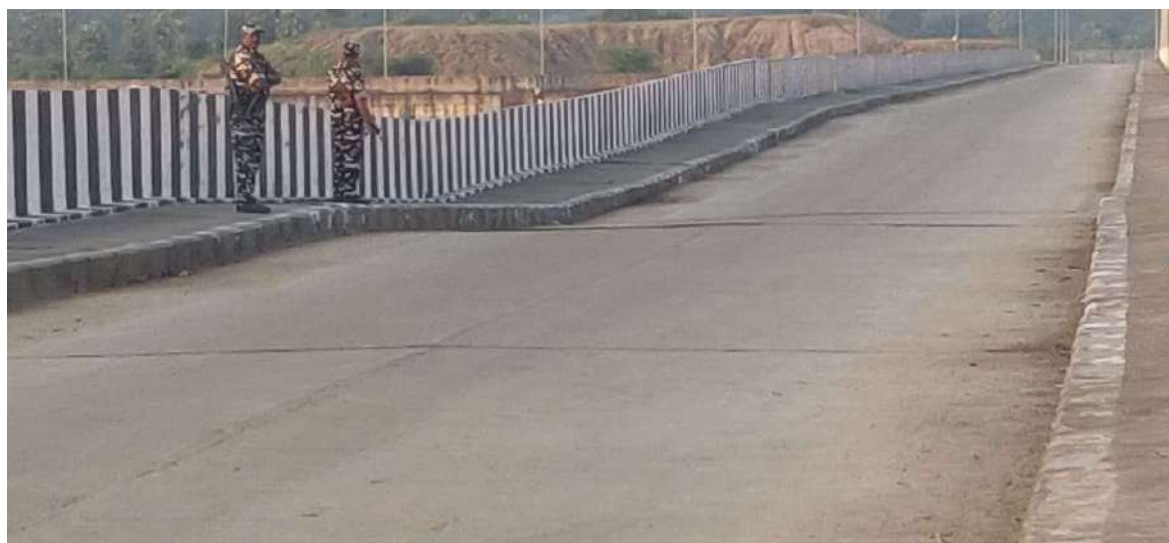
**Deck Slab Deflection at Pier 20 of 7<sup>th</sup> Block**

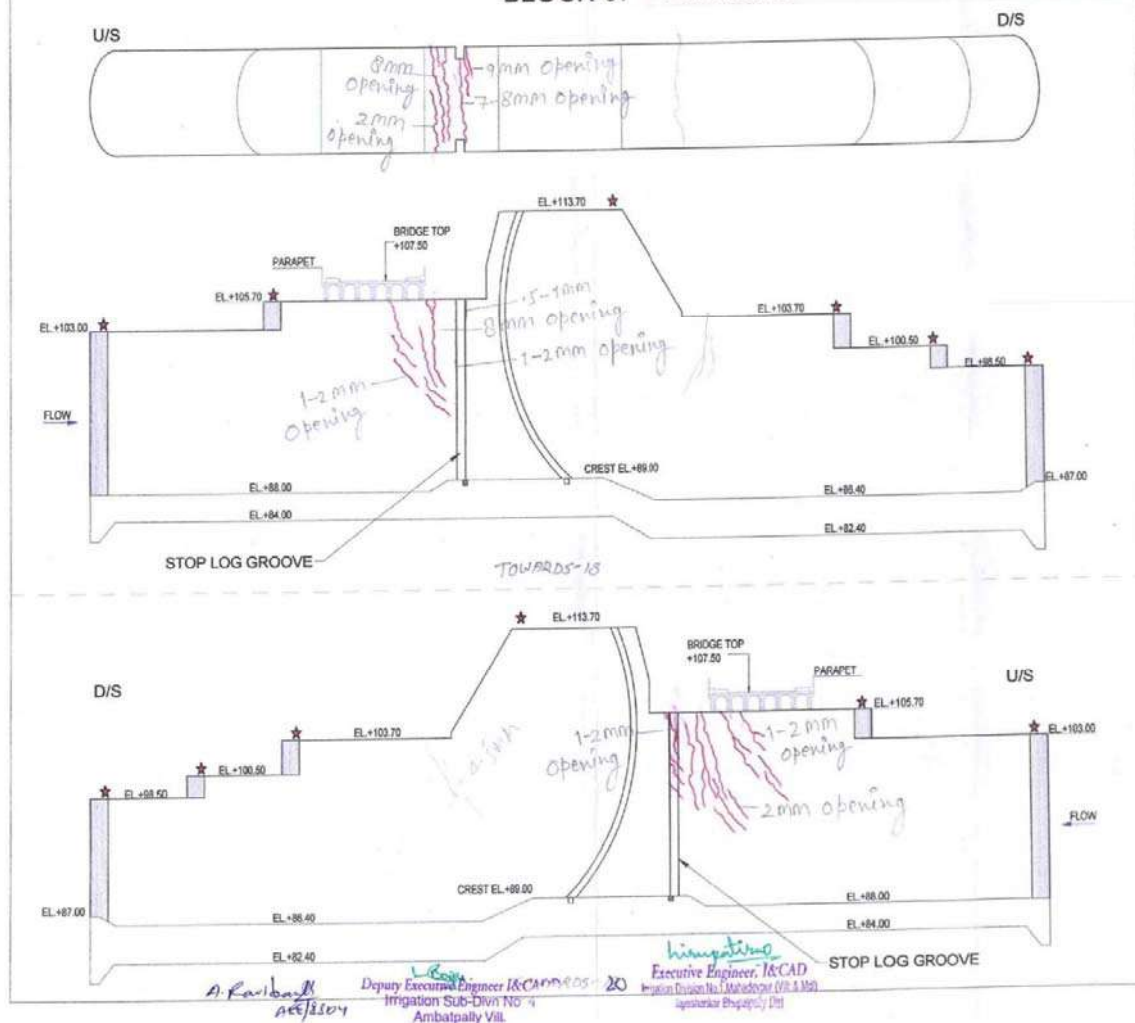
BLOCK-07

## CRACKS MAPPING

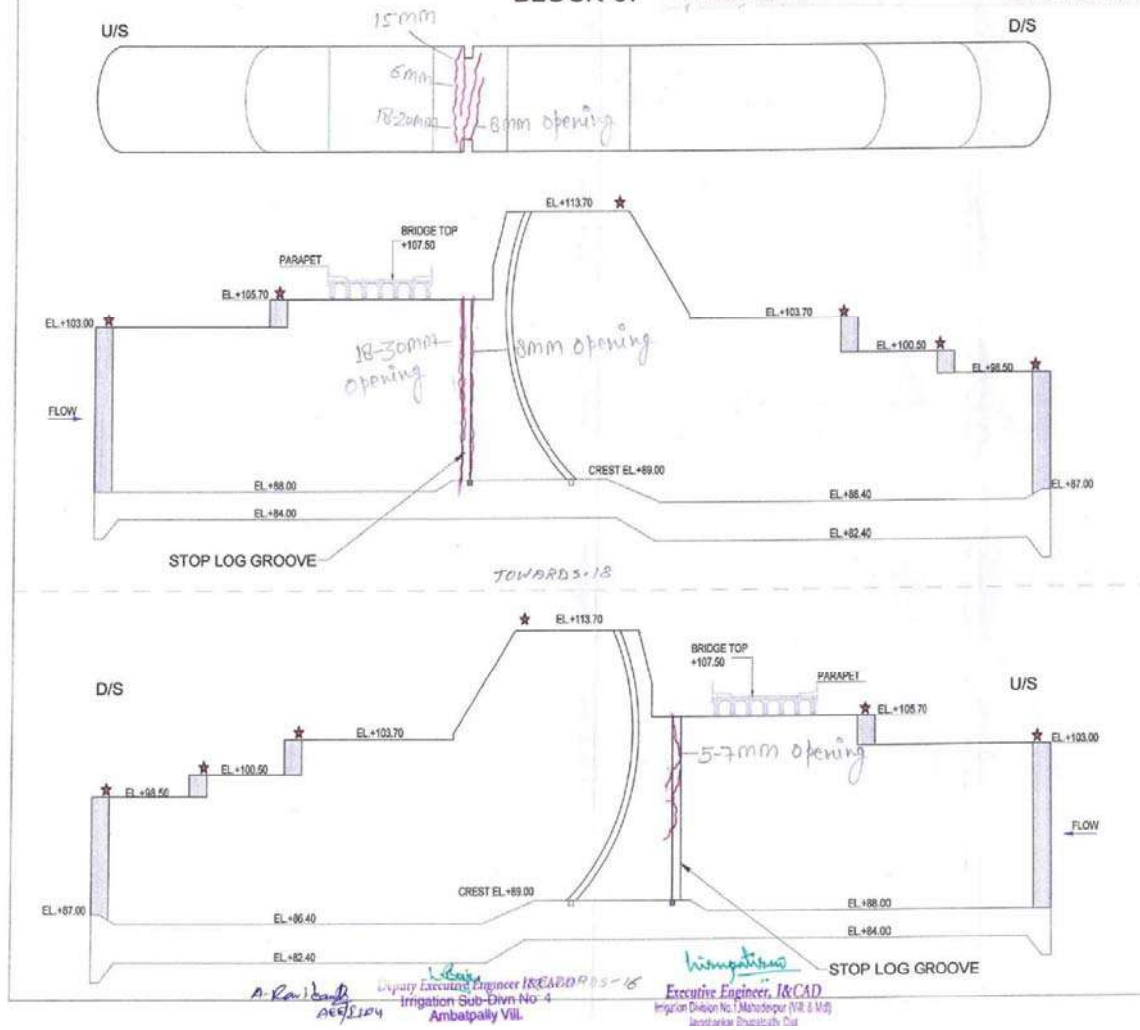
# BLOCK-07 PIER NO. 16

# CRACKS MAPPING
