REPORT ON
PILOT CENSUS OF SETHIATOPE IRRIGATION PROJECT

PILOT CENSUS OF SETHIATOPE IRRIGATION PROJECT

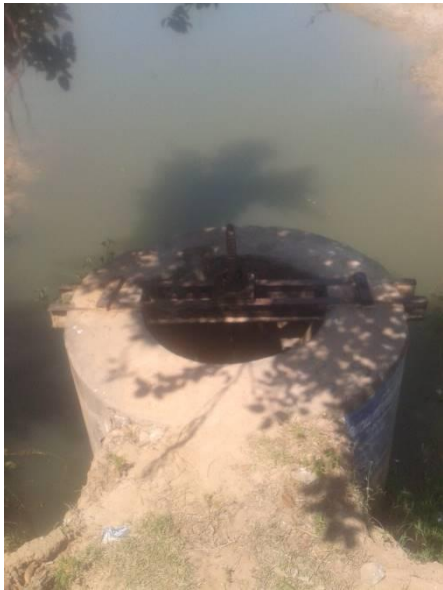
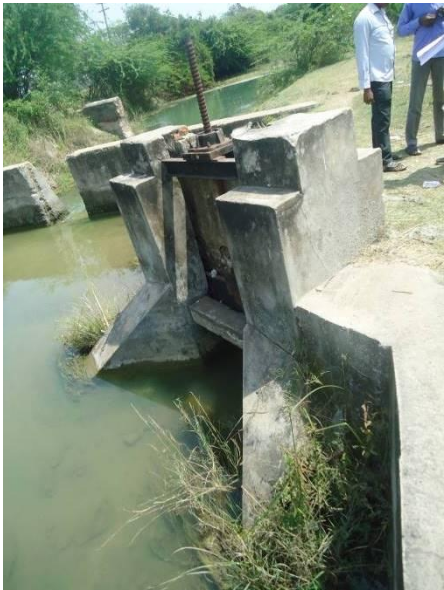
- Outlets are broken at many places (some typical illustrations are given in photograph section) due to which water divert and do not flow in the direction it was planned.

<p>Photograph Outlet No : Kalayankuppam Channel-07 (Broken)</p>	<p>Photograph Outlet No : Sirupalaiyur Channel-09 (Broken)</p>

- The Sethiatope Anicut system was commissioned in 1895. The system is in a dilapidated condition and needs restoration in the distribution system, outlets etc.

- Enhance role of Women in water management. It is essential for survival.
- Renovation of system is required. Repairs of lining of canal may be undertaken to reduce seepage.

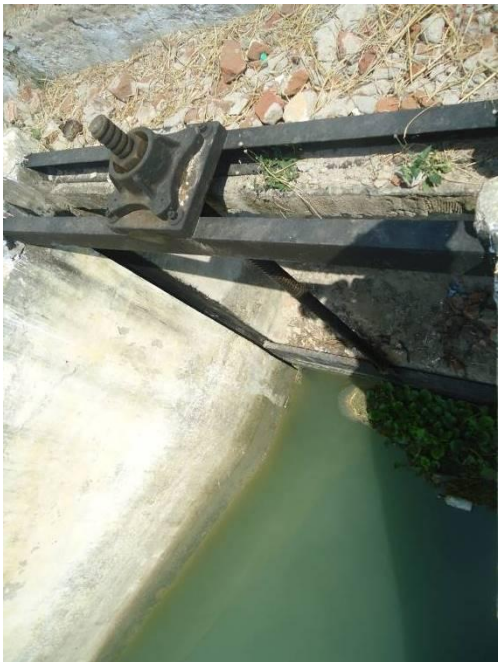
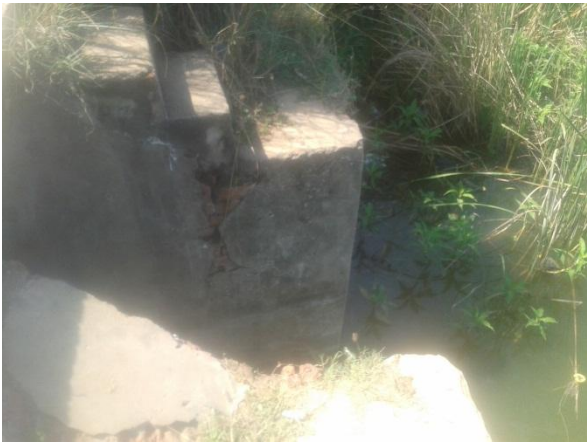
<p>Photograph Outlet No : Threerthanagiri Channel-06 (Broken)</p>	<p>Photograph Outlet No : Old Thannur channel-07 (Broken)</p>

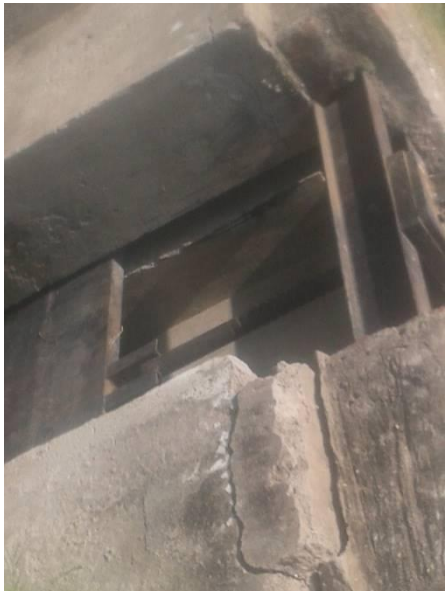
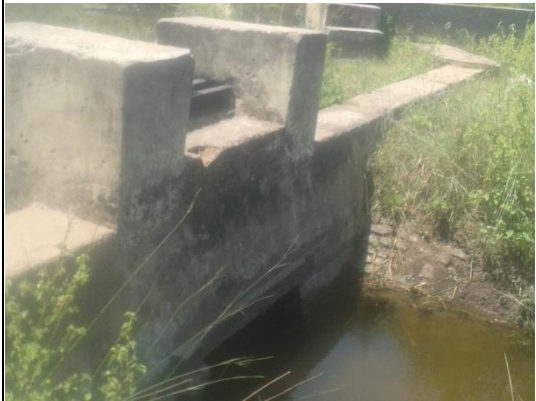
<p>Photograph Outlet No : New Thannur Channel-09 (Broken)</p>	<p>Photograph Outlet No : Andarmullipalam Channel-14 (Broken)</p>

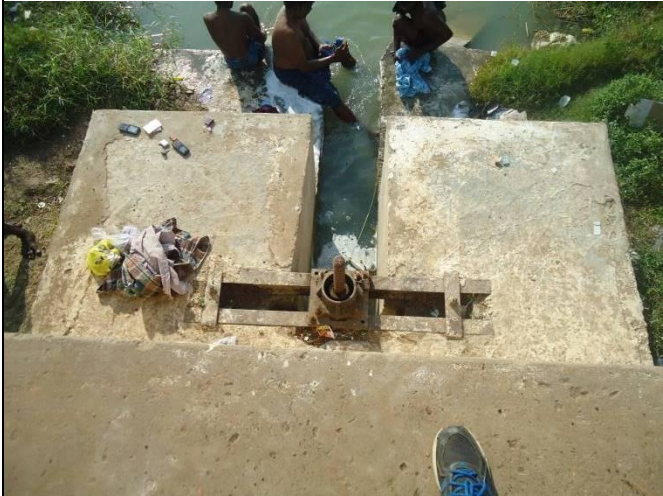
<p>Photograph Outlet No : Alapakkam Channel-20 (Broken)</p>	<p>Photograph Outlet No : Umaiyan-1 Channel-15 (Broken)</p>
