केन्द्रीय जल और विद्युत अनुसंधान शाला CENTRAL WATER AND POWER RESEARCH STATION

TECHNICAL REPORT NO. 5015
NOVEMBER 2012

MORPHOLOGICAL STUDIES OF RIVER GANDAK
USING SATELLITE AND SOI DATA

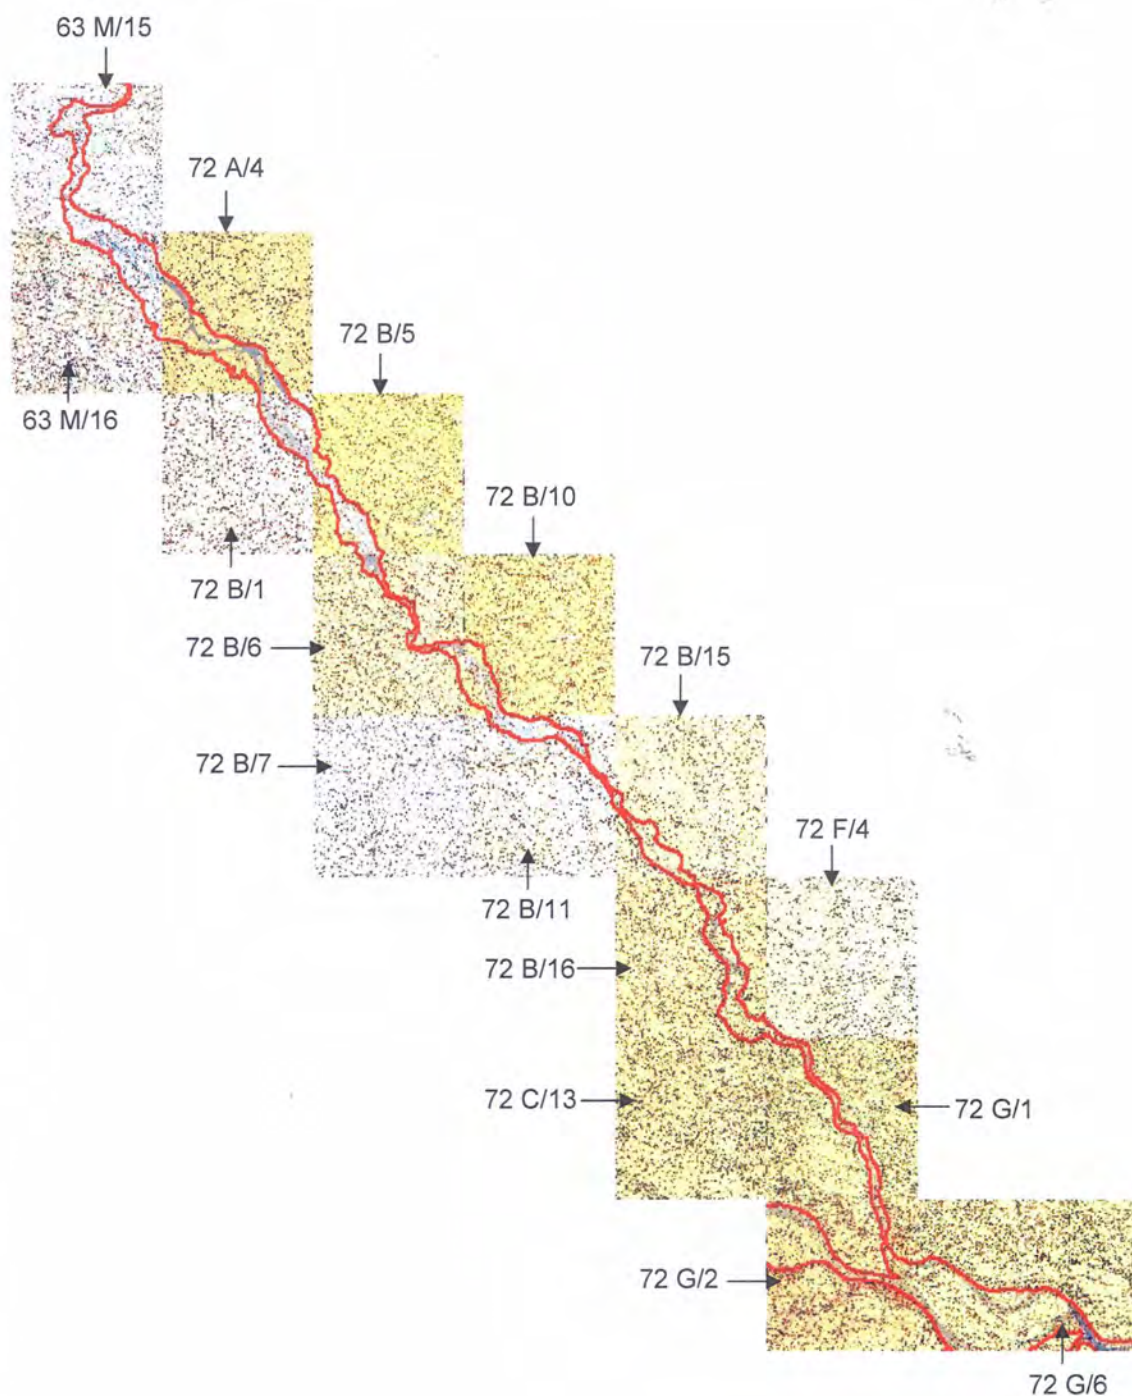
FIGURE 1: BANK LINES OF GANDAK RIVER - TOPOSHEET

Studies have been carried out using the bank line data of river Gandak extracted from Survey of India (SOI) Toposheets for the year(s) available at CWPRS. Further data of bank line was extracted from the Satellite data collected from the then National Remote Sensing Agency (NRSA), Hyderabad. Satellite data were collected at an interval between 4 to 6 years depending on the availability of colorful data. The Satellite data de-coded using the salient features available SOI Toposheets. The study area is covered in more than 15 Toposheets of SOI. The mosaic of the study area showing SOI Toposheets is shown in Figure 1.

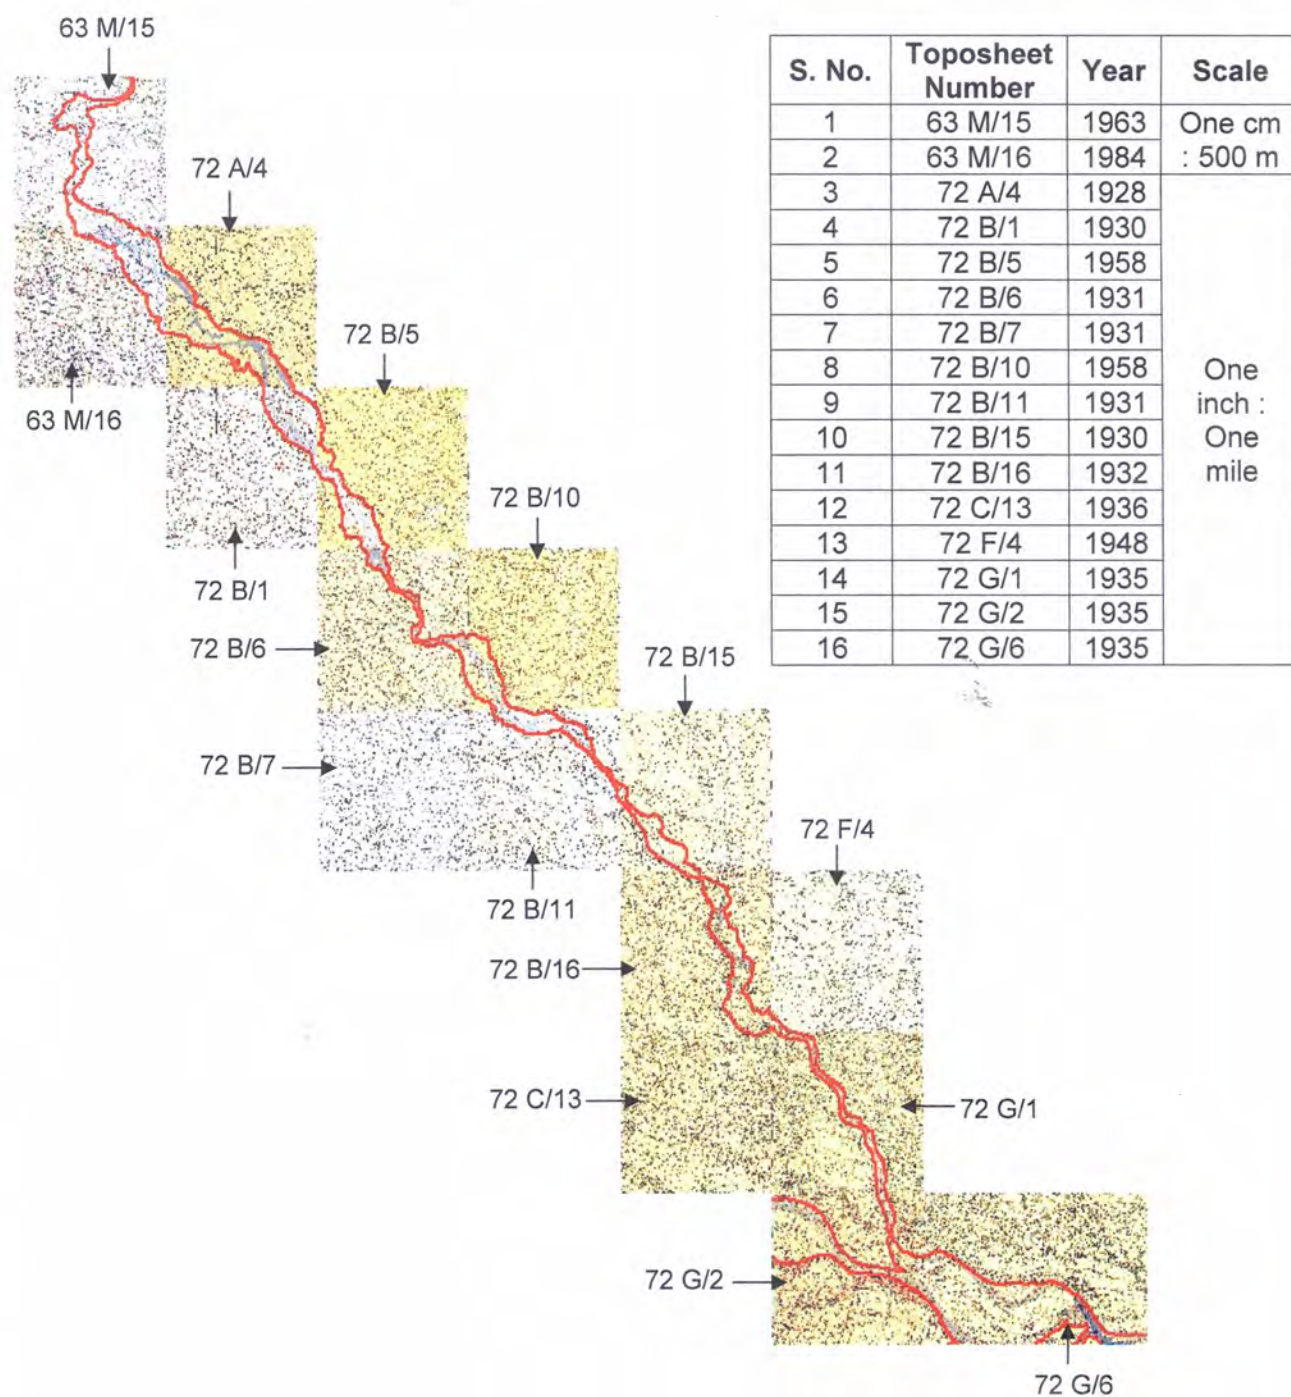
FIGURE 3.1: BANK LINES OF GANDAK RIVER - TOPOSHEET

3.2 As indicated above, the reach of river Gandak is covered in 15 toposheets. Out of these toposheets, 63M14 and 63M05 were not available at CWPRS as well as SOI office at Dehradun. The reach as could be delineated from SOI toposheets was identified and bank lines were marked as shown in Figure 3.1. These vectors were used later on for the purpose of superimposition.

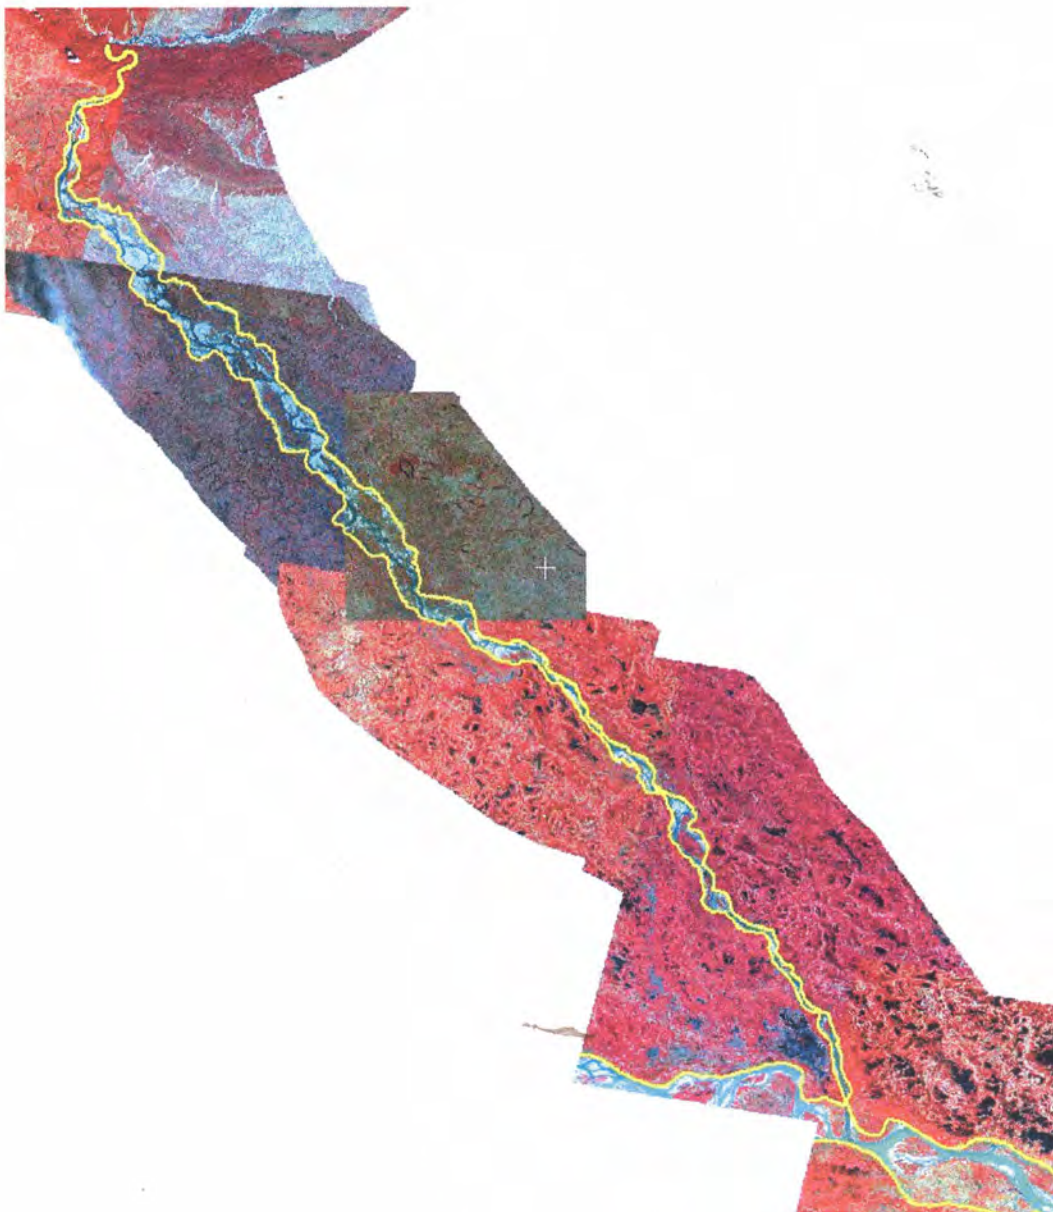
FIGURE 4.1: BANK LINES OF GANDAK RIVER – 1988

4.1 The first stage of the work was completed by delineating the bank line from the available toposheets of SOI. Thereafter the information from SOI toposheet was used for geocoding the satellite data received from NRSA. The bank lines of satellite data were delineated on each year. The bank lines for 1988, 1994, 1999 and 2004 are shown in Figures 4.1 to 4.4 respectively.

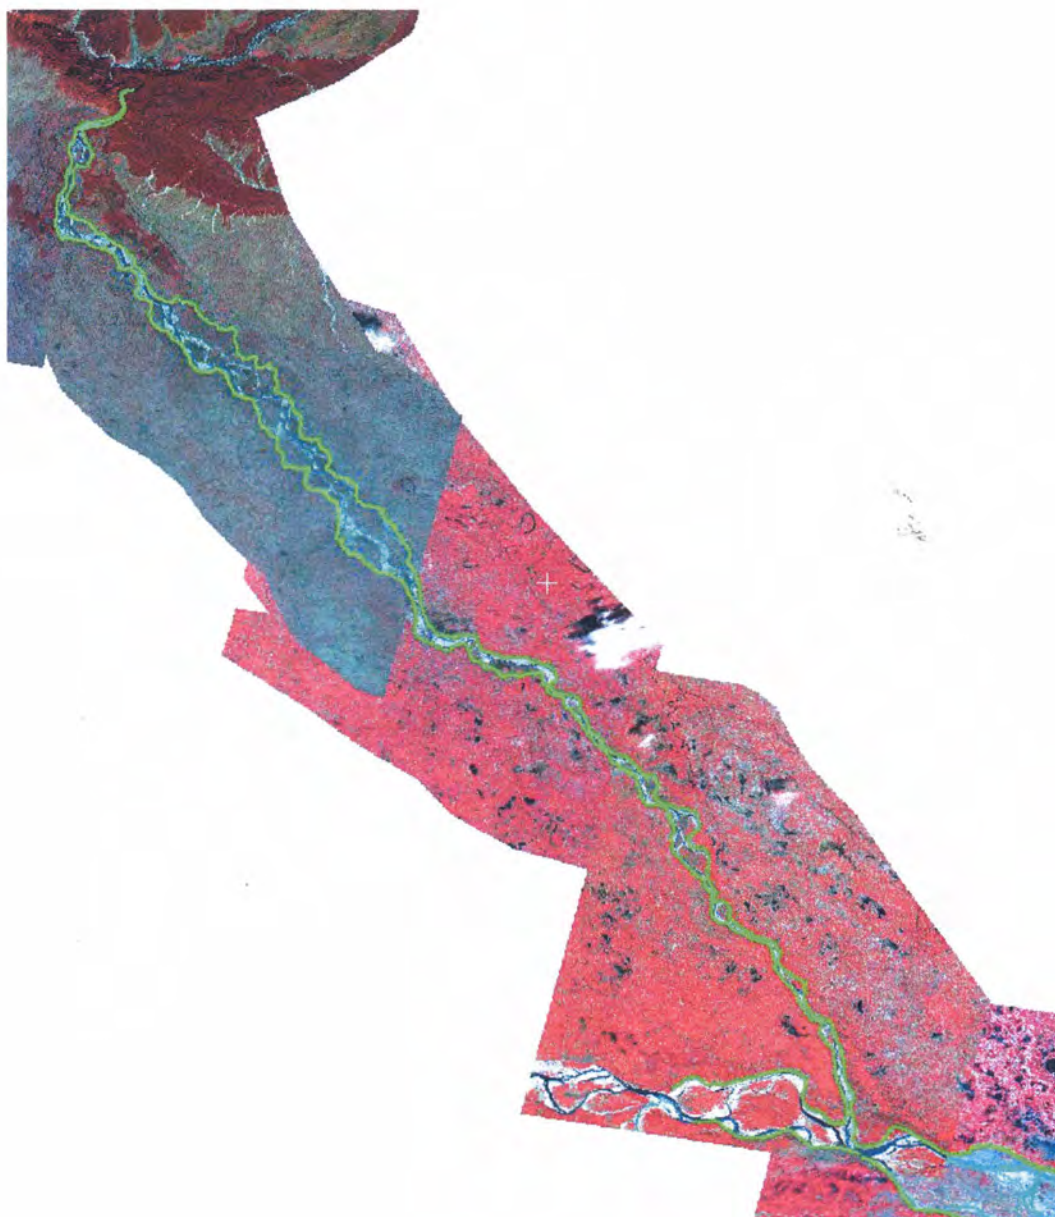
FIGURE 4.2: BANK LINES OF GANDAK RIVER – 1994

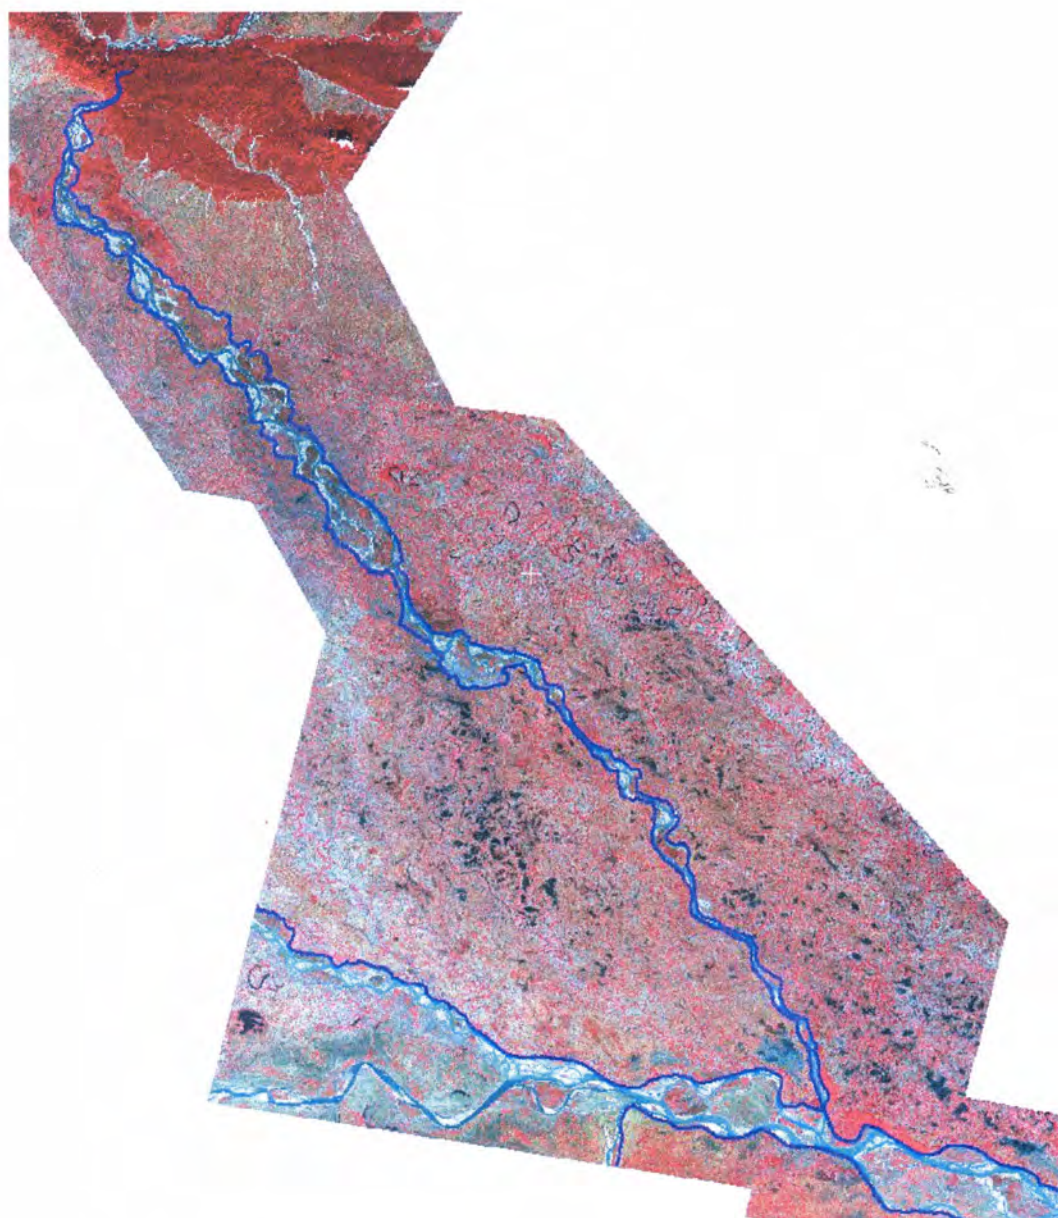
FIGURE 4.3: BANK LINES OF GANDAK RIVER – 1999

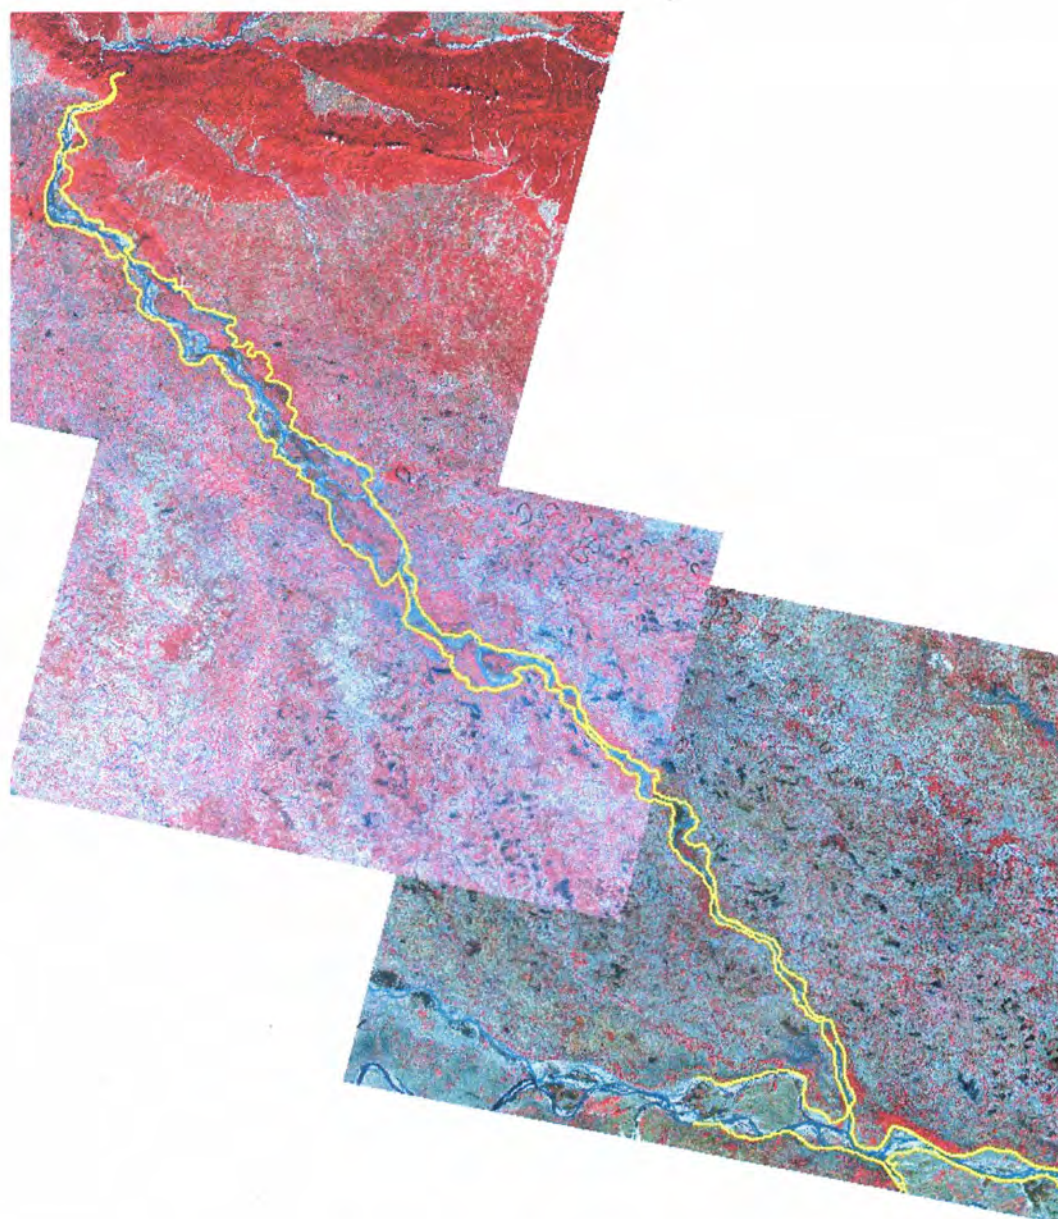
FIGURE 4.4: BANK LINES OF GANDAK RIVER – 2004

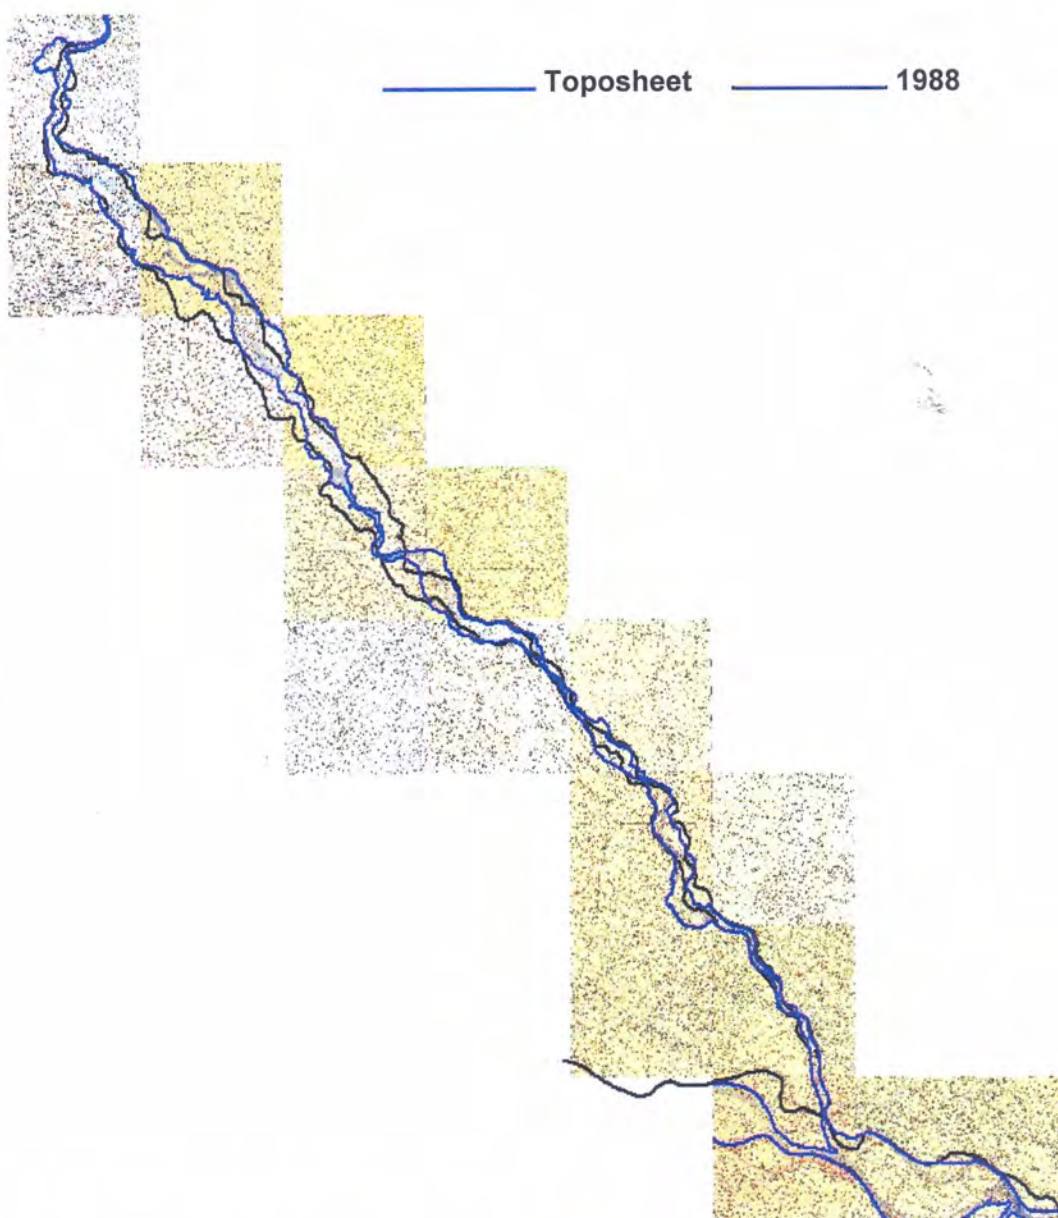
FIGURE 4.5: SUPERIMPOSED BANK LINES – TOPOSHEET & 1988

Sl. No.	Source	Comparison with bank line for the year	Figure No.
1	Toposheet	1988	4.5
2		1994	4.6
3		1999	4.7
4		2004	4.8
5	Toposheet	1988, 1994, 1999, 2004	4.9

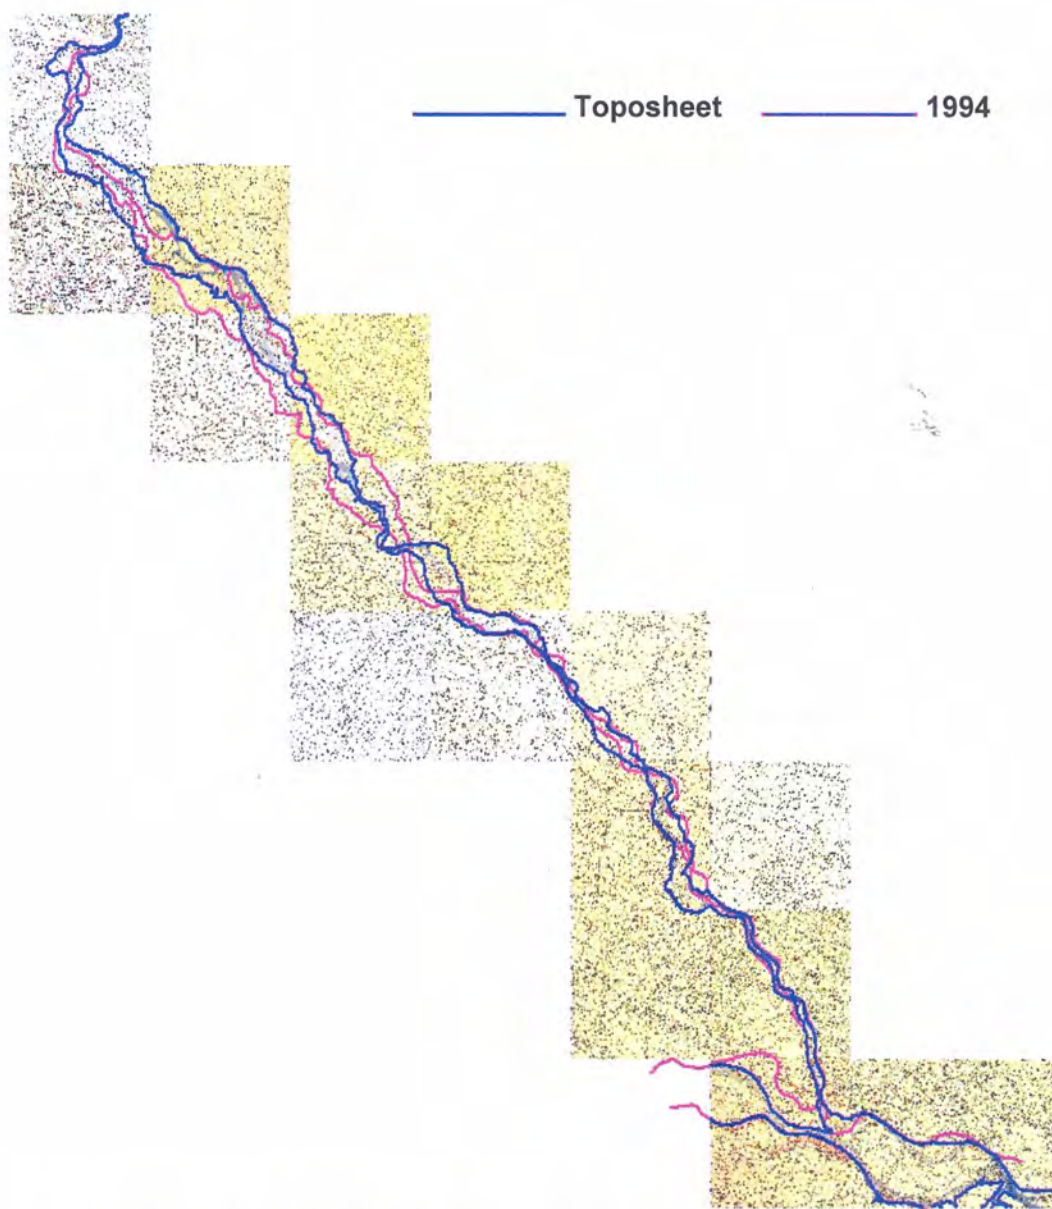
FIGURE 4.6: SUPERIMPOSED BANK LINES – TOPOSHEET & 1994

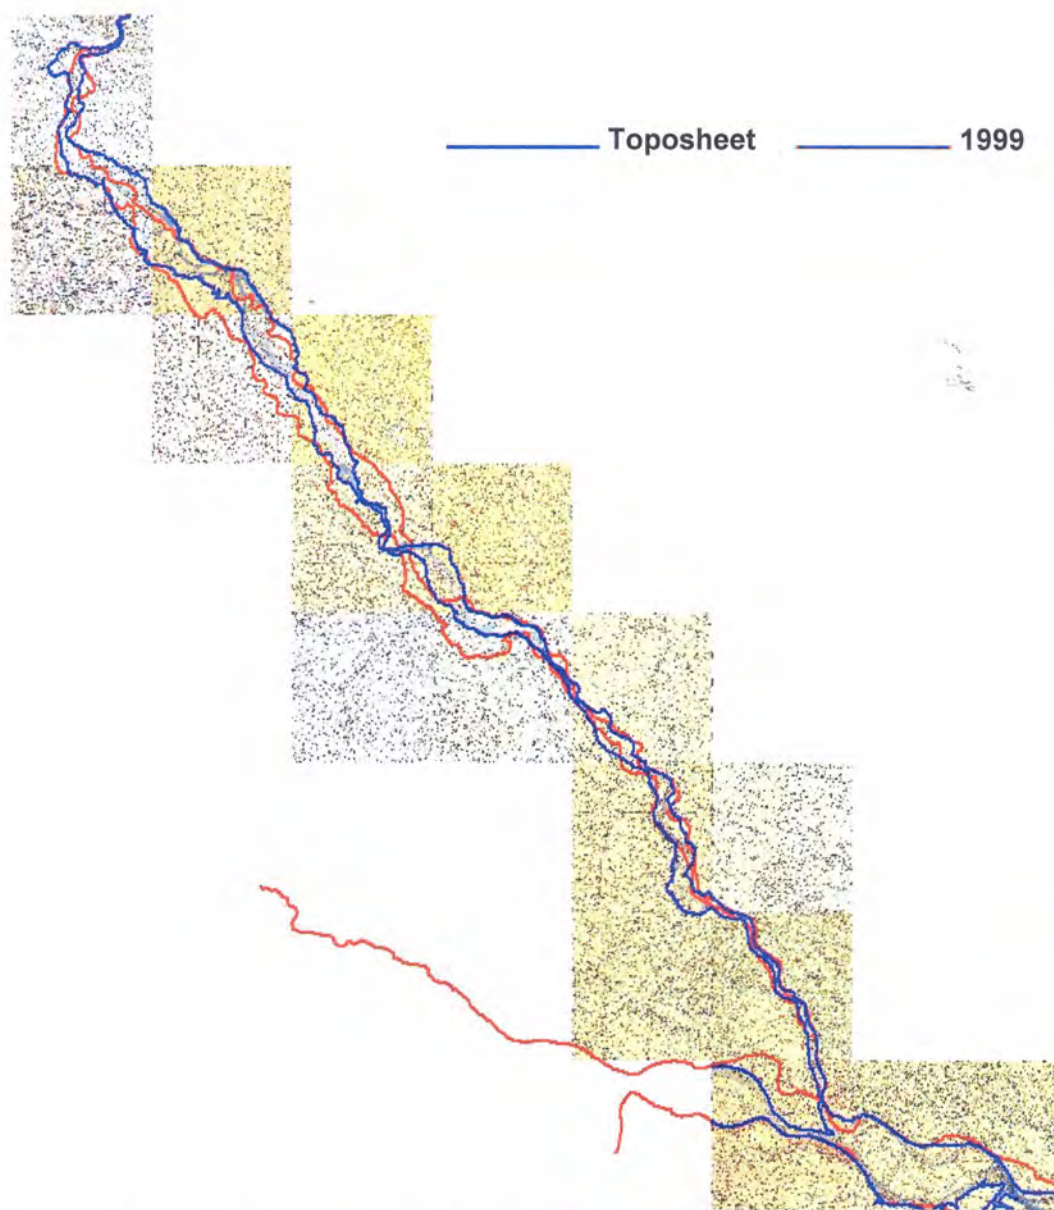
FIGURE 4.7: SUPERIMPOSED BANK LINES – TOPOSHEET & 1999

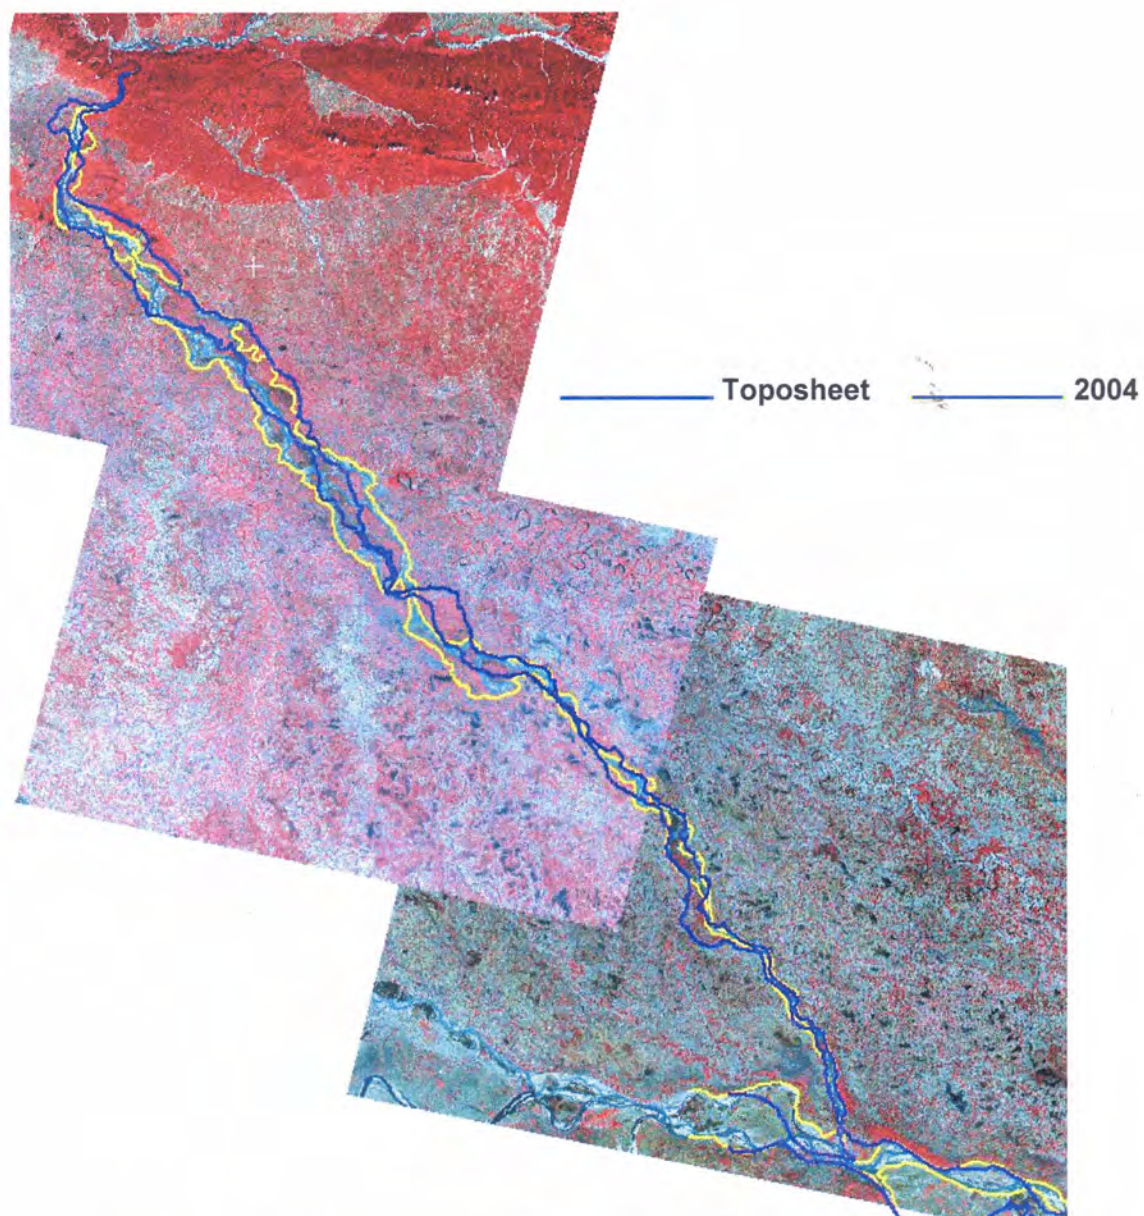
FIGURE 4.8: SUPERIMPOSED BANK LINES – TOPOSHEET & 2004

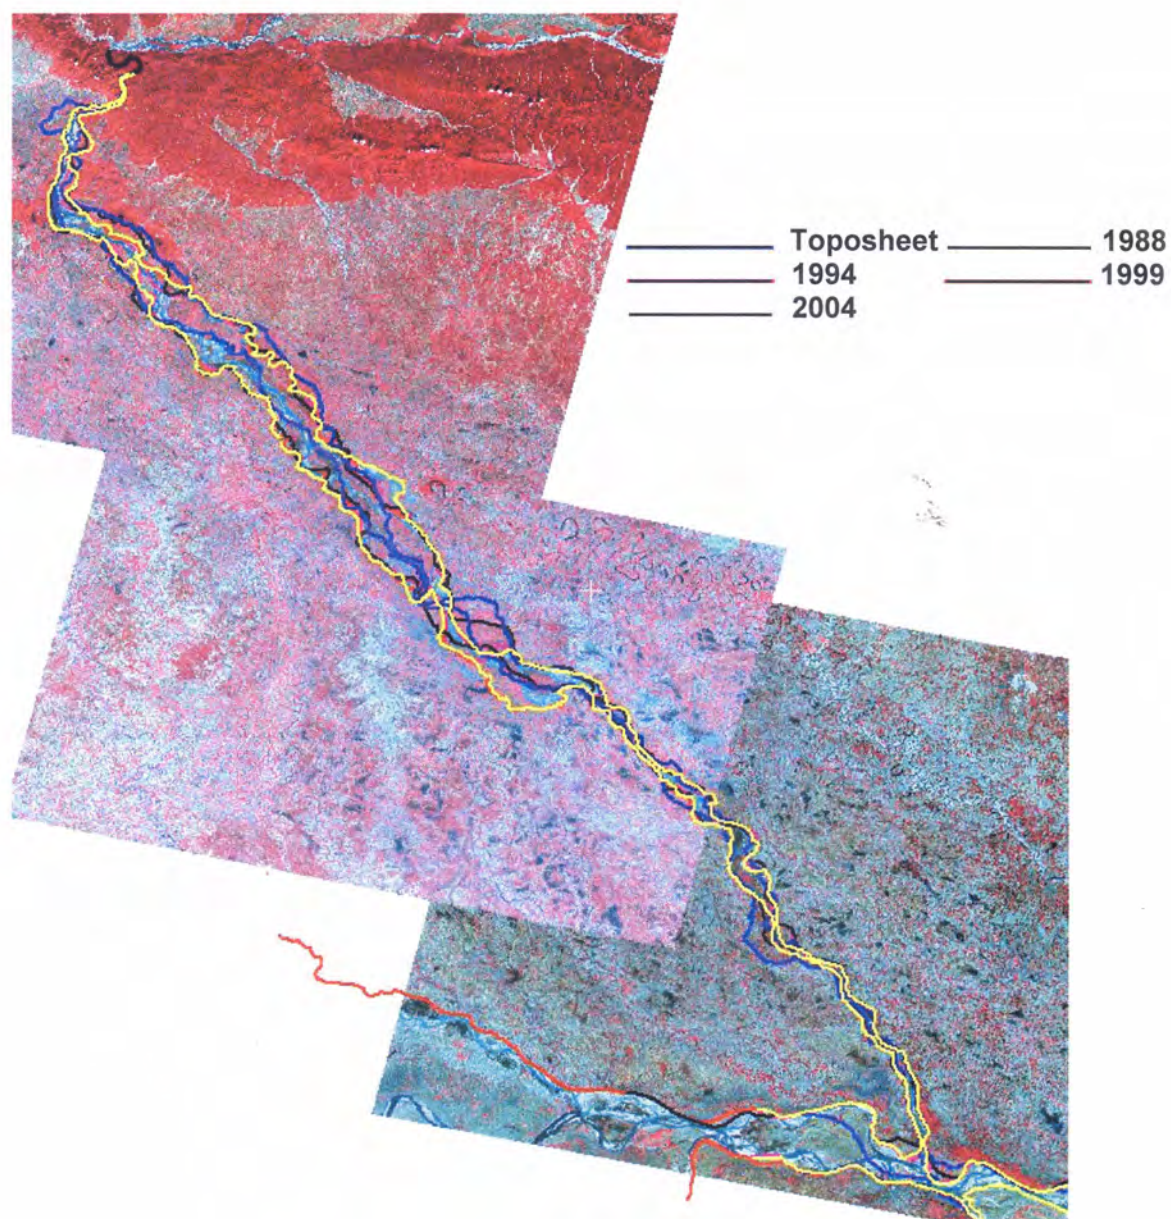
FIGURE 4.9: SUPERIMPOSED BANK LINES TOPOSHEET, 1988, 1994, 1999 & 2004

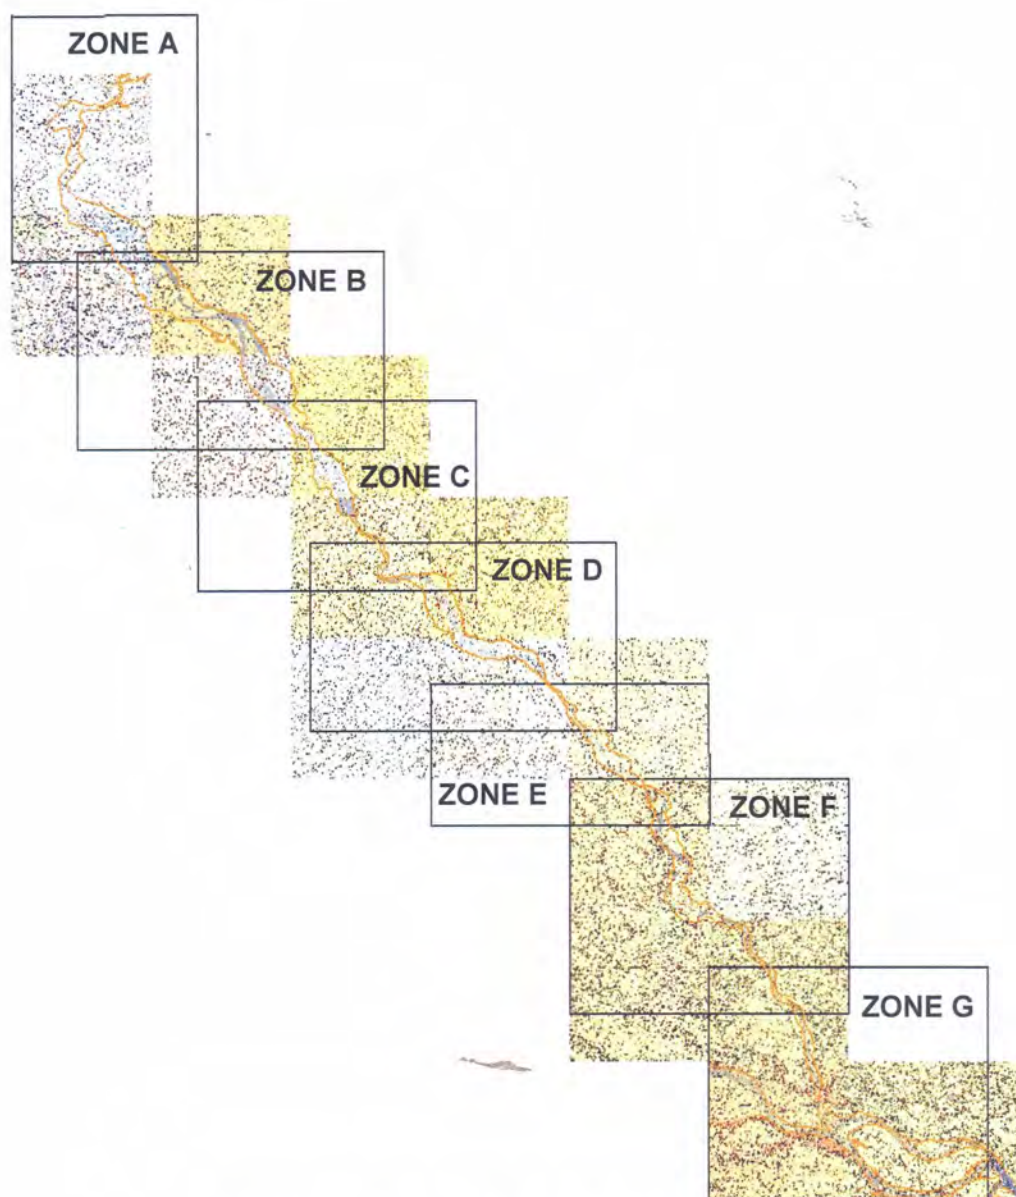
FIGURE 4.10: ZONING OF RIVER GANDAK

The total stretch of river Gandak under study has been divided in 7 different zones. The reach covers area of river Gandak downstream of origin in hilly area upto the confluence with River Ganga near Hajipur. The boundaries of these zones are shown in Figure 4.10 and coordinates of diagonal are presented in Table 4.1. The care has been taken to provide overlap of down stream zone B for the first zone on upstream side A. Similarly overlaps of interim zones from B to F have been provided for both upstream and downstream zones. The last zone G has overlap only on the upstream Zone F.

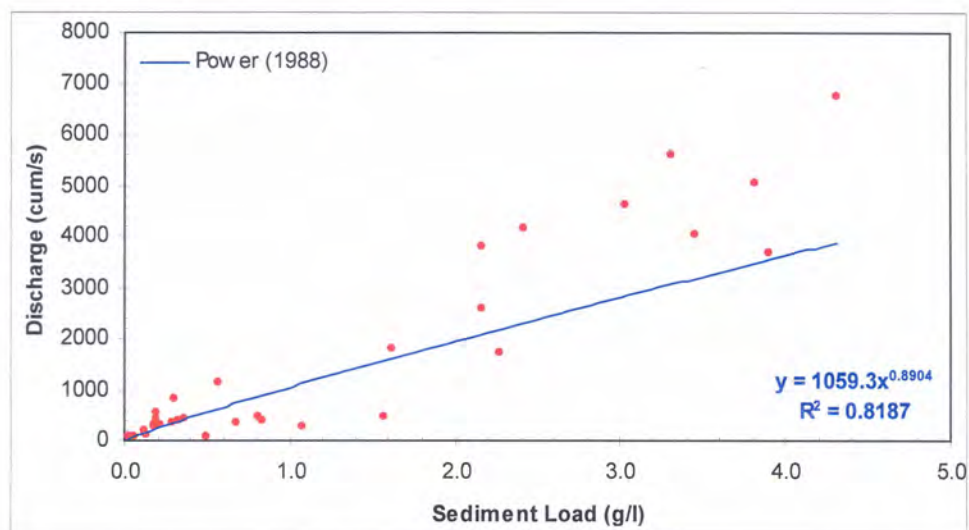
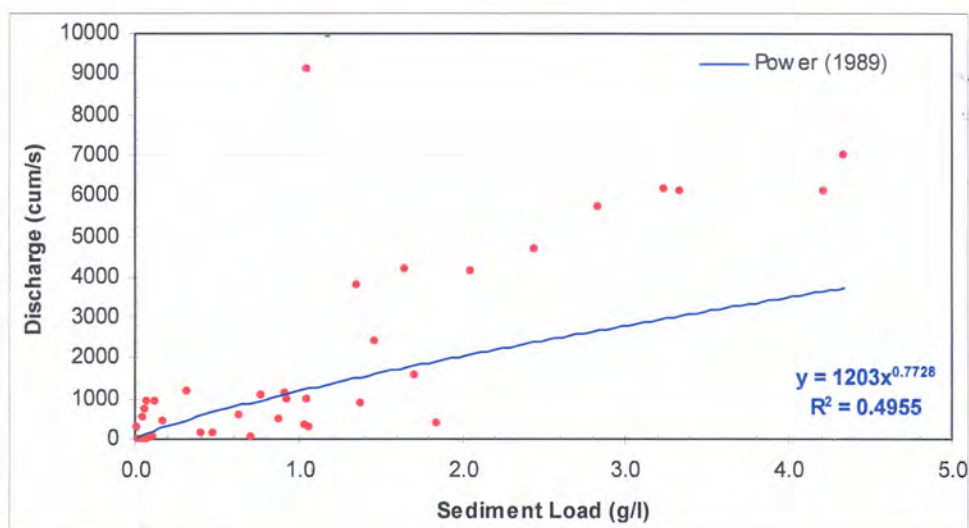
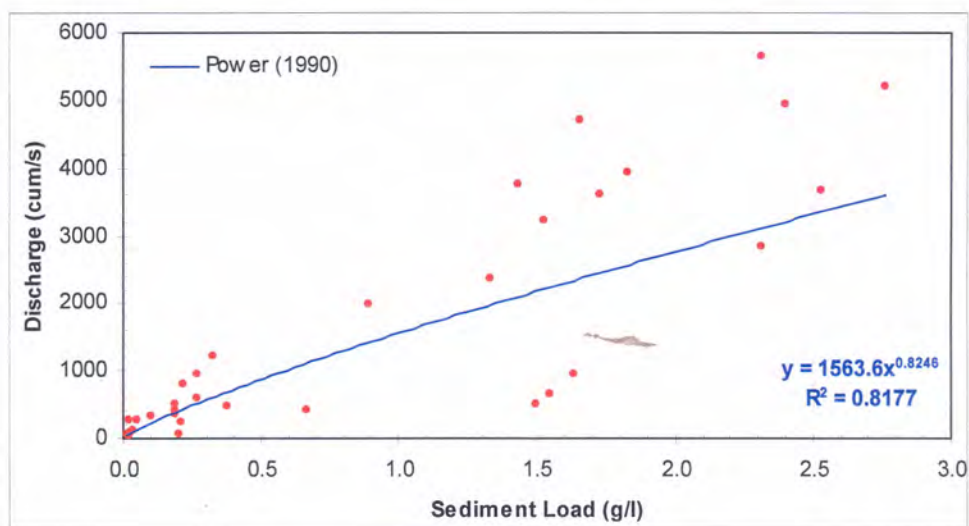
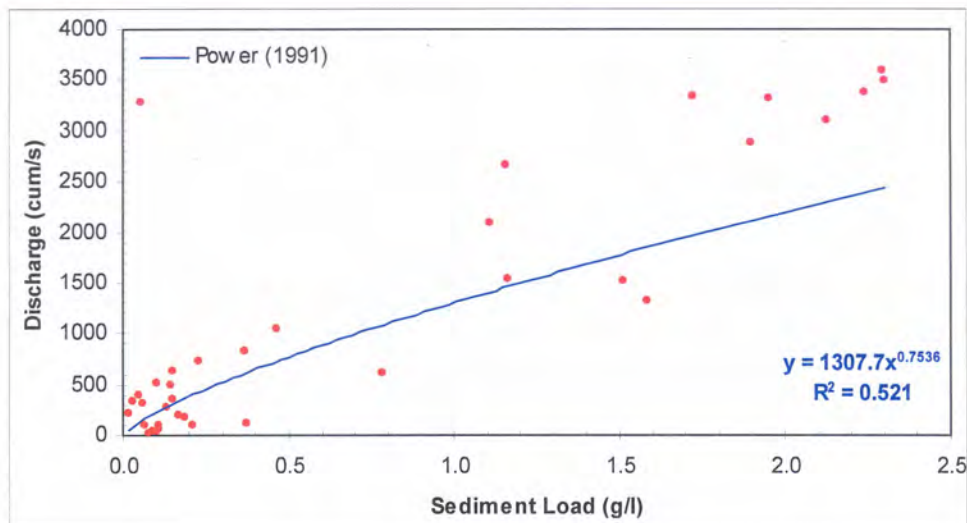
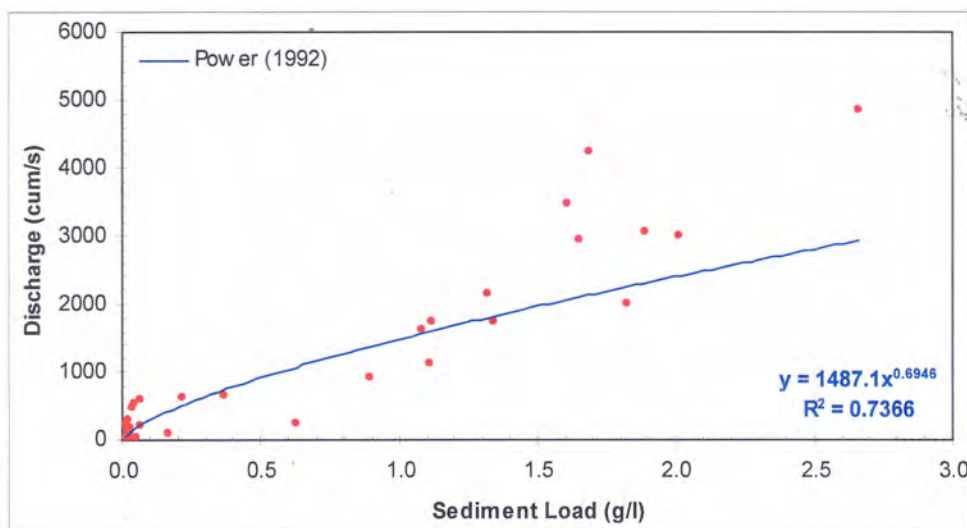
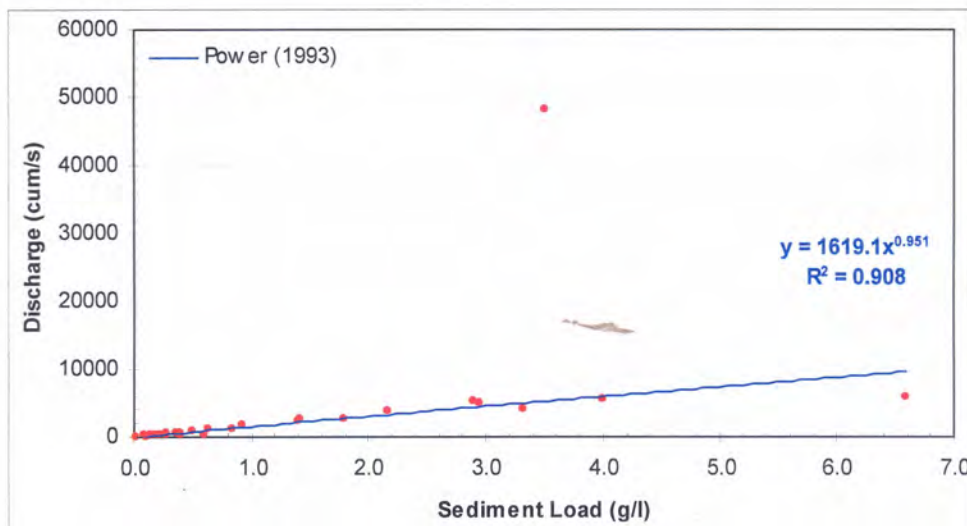
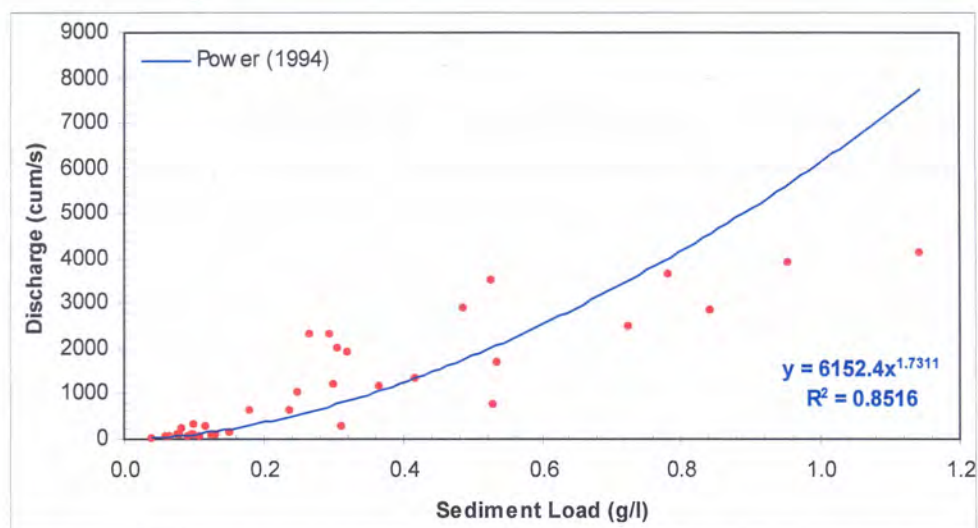
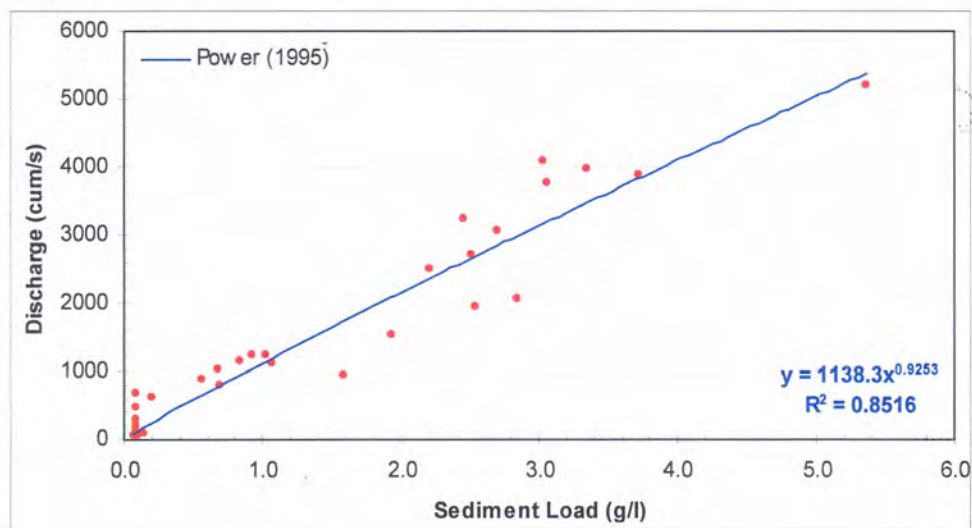
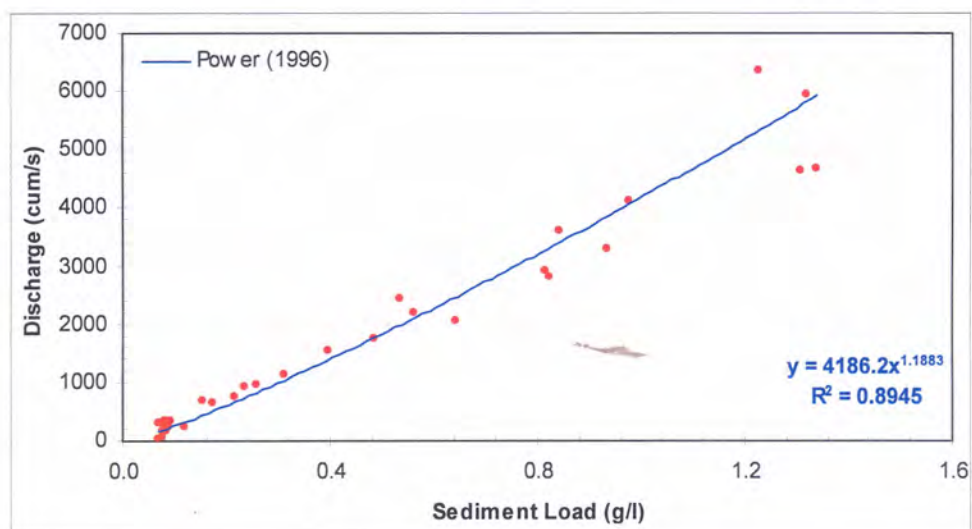
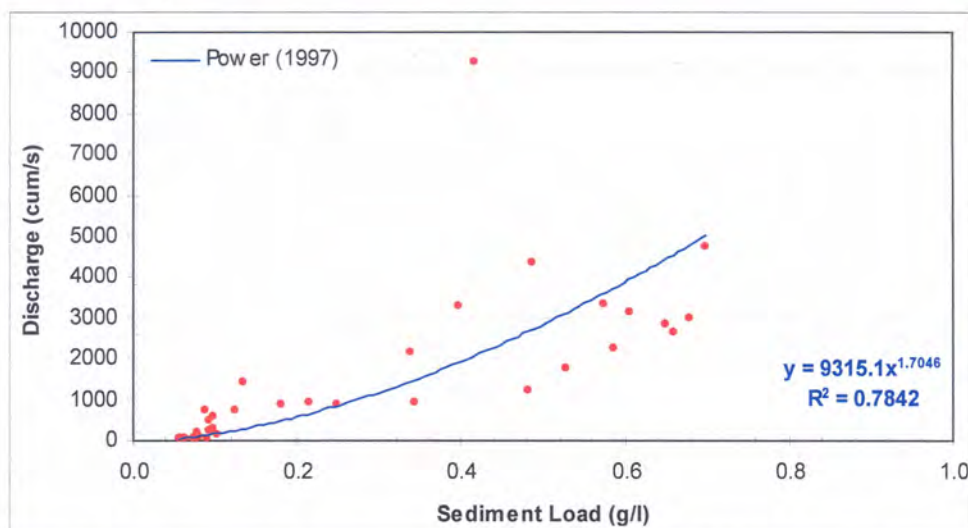
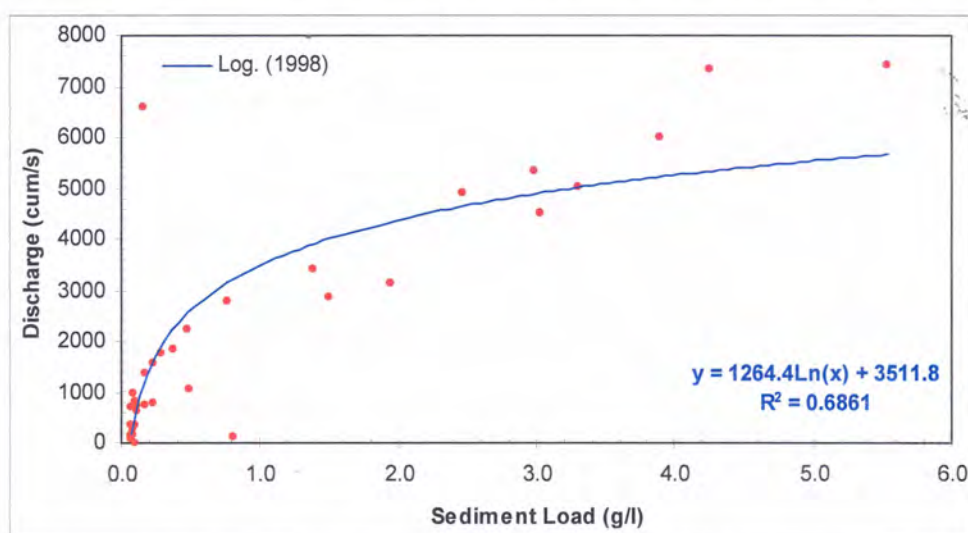
4.7.2 The 10-daily average discharge and sediment load at Triveni site on river Gandak was collected from CWC, Patna. These are reviewed for identification of outliers / exceptionally high or low value of discharge and corresponding sediment. Data for the period from 1988 to 1998 has been analyzed to derive year to year sediment rating curve in the form of discharge (cum/s) versus sediment load (g/l). These are shown in Figure 4.25 to Figure 4.35 respectively.

It can be observed that except for the year 1998 power relation can be fitted to rating curve. The rating curve equation is in the form of

Year	Regression Co-efficient		R^2
	A	b	
1988	1059.3	0.8904	0.8187
1989	1203.0	0.7728	0.4955
1990	1563.6	0.8246	0.8177
1991	1307.7	0.7536	0.5210
1992	1487.1	0.6946	0.7366
1993	1619.1	0.9510	0.9080
1994	6152.4	1.7311	0.8516
1995	1138.3	0.9253	0.8516
1996	4186.2	1.1883	0.7842
1997	9315.1	1.7046	0.7842
1998	$Q = 1264.4 \ln(x) + 3511.8$		0.6861
