केन्द्रीय जल और विद्युत अनुसंधान शाला CENTRAL WATER AND POWER RESEARCH STATION

TECHNICAL REPORT NO. 5015
NOVEMBER 2012

MORPHOLOGICAL STUDIES OF RIVER GANDAK
USING SATELLITE AND SOI DATA

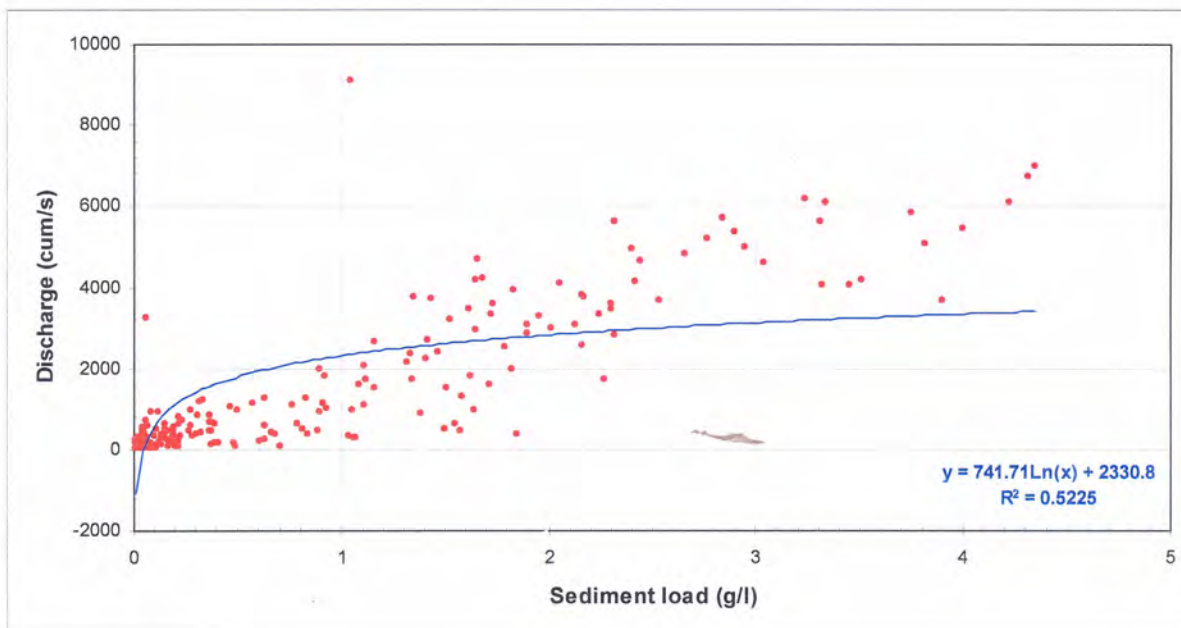
**FIGURE 4.36: SEDIMENT RATING CURVE: RIVER GANDAK AT TRIVENI - (1988-1993)**

These data were further analyzed to review the possibility of change in fluvial characteristics of river Gandak. The data were clubbed into two groups as 1988 to 1993 and 1994 to 1998. These divisions were made as per the availability of bank line from satellite data. The data were combined in above two groups and attempts were made to derive regression relations. The curves developed along with plots are presented in Figures 4.36 and 4.37.

It can be observed from Table 4.18 that except for the year 1998 power relations could be obtained for sediment rating curve. The power is changing from minimum of 0.6946 to a maximum of 1.7311. For the year 1998 logarithmic relation has been derived is as given below:

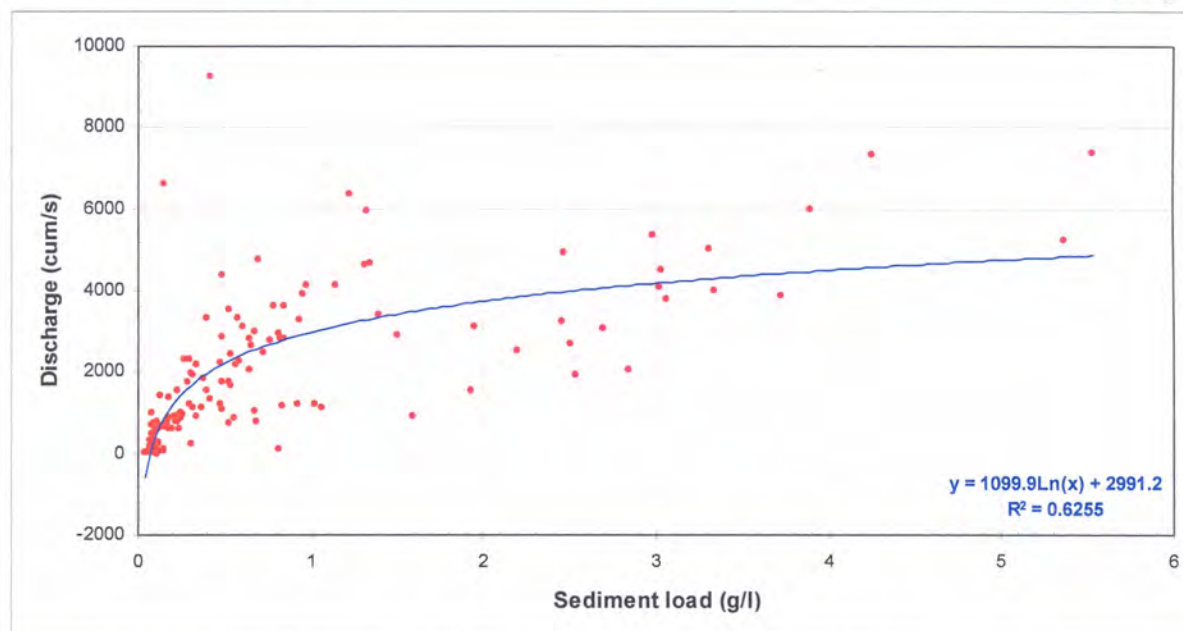
FIGURE 4.37: SEDIMENT RATING CURVE: RIVER GANDAK AT TRIVENI - (1994-1999)

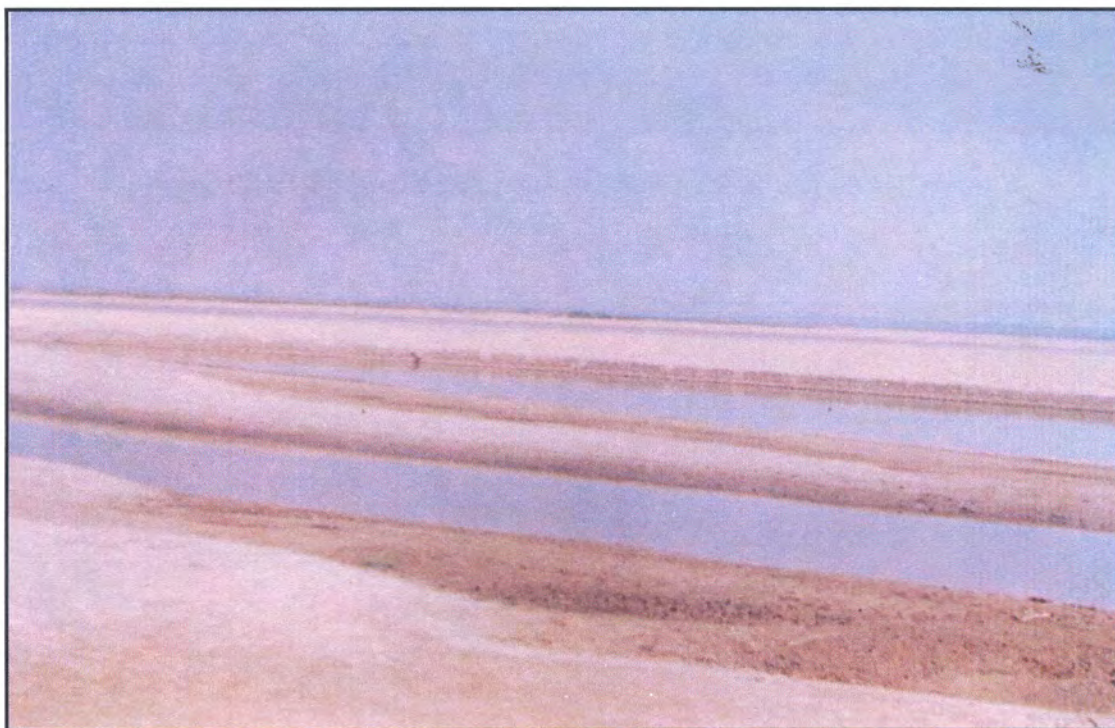
PHOTO 1: BRAIDED CHANNELS IN RIVER GANDAK

Gandak river in study reach displays braided channels in certain places (Photo 1). These are situated at different locations in the states of Uttar Pradesh and Bihar. Further, river Gandak flows at certain locations along the border of Uttar Pradesh and Bihar. Protection measures in the form of embankments and spurs are provided along the length. The embankments require careful maintenance and it is known that these are prone to failure in absence of maintenance (Photo 2). Spurs are provided at number of locations in study reach. Protection with crates from brick/stone is provided. These also need maintenance and state of some spurs is shown in Photos 3 and 4.

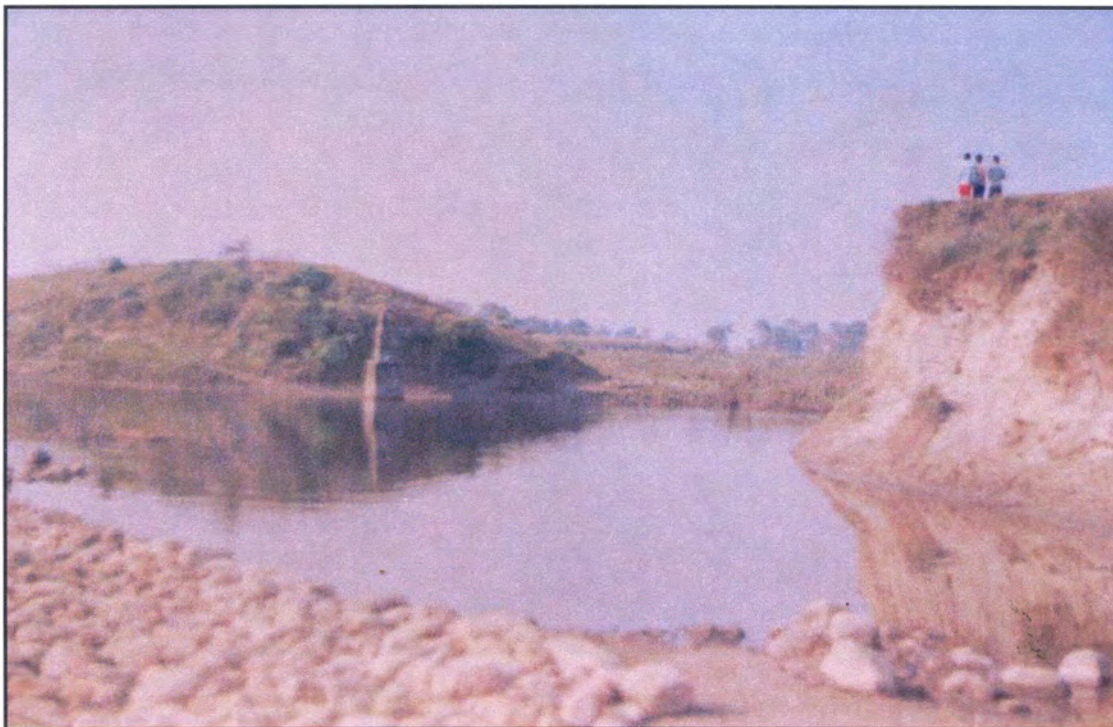
PHOTO 2: BREACH IN EMBANKMENT OF RIVER GANDAK

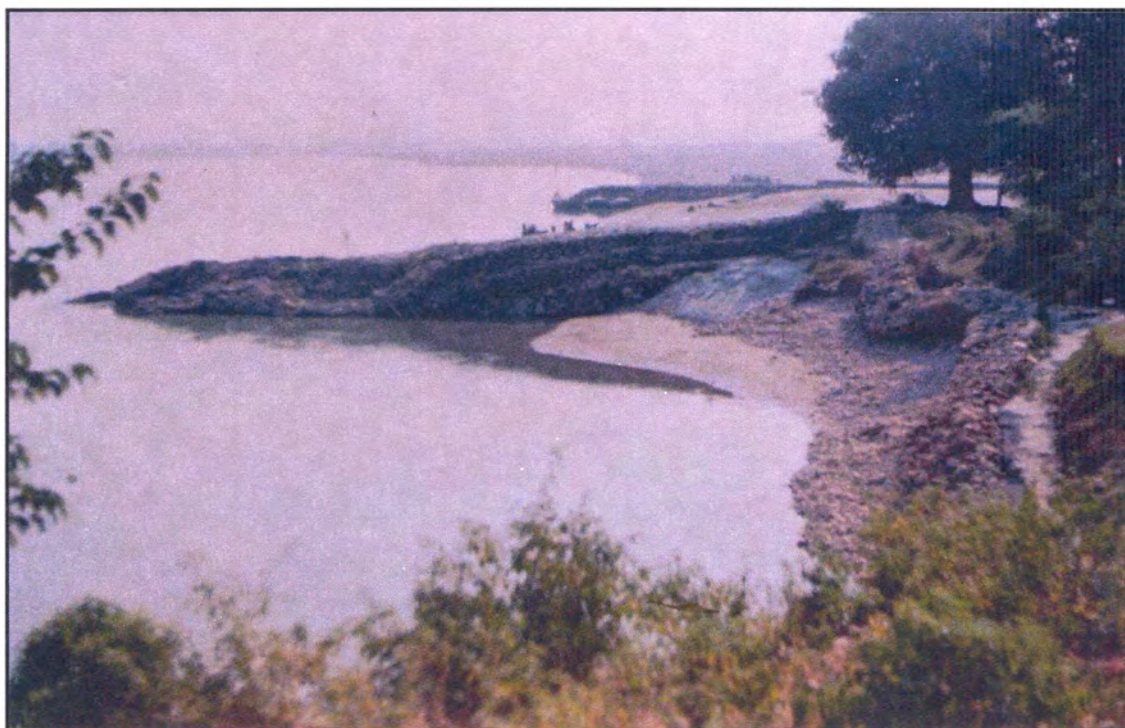
PHOTO 3: SERIES OF DAMAGED SPURS ON RIVER GANDAK

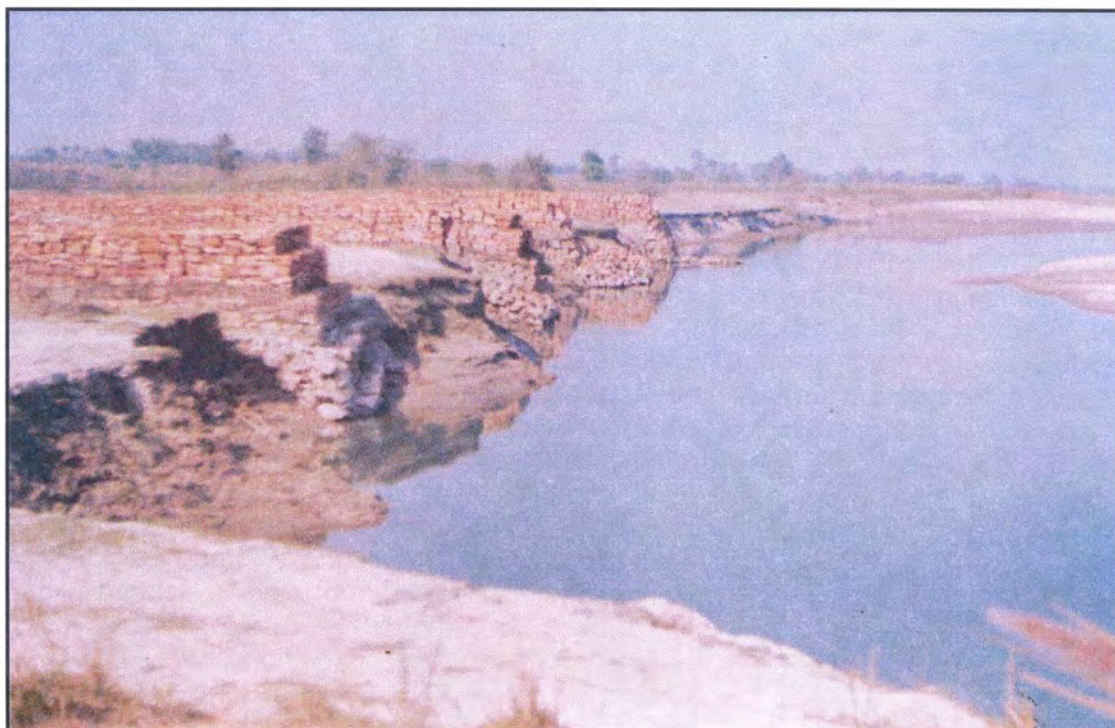
PHOTO 4: DAMAGED SPURS WITH STONE PITCHING

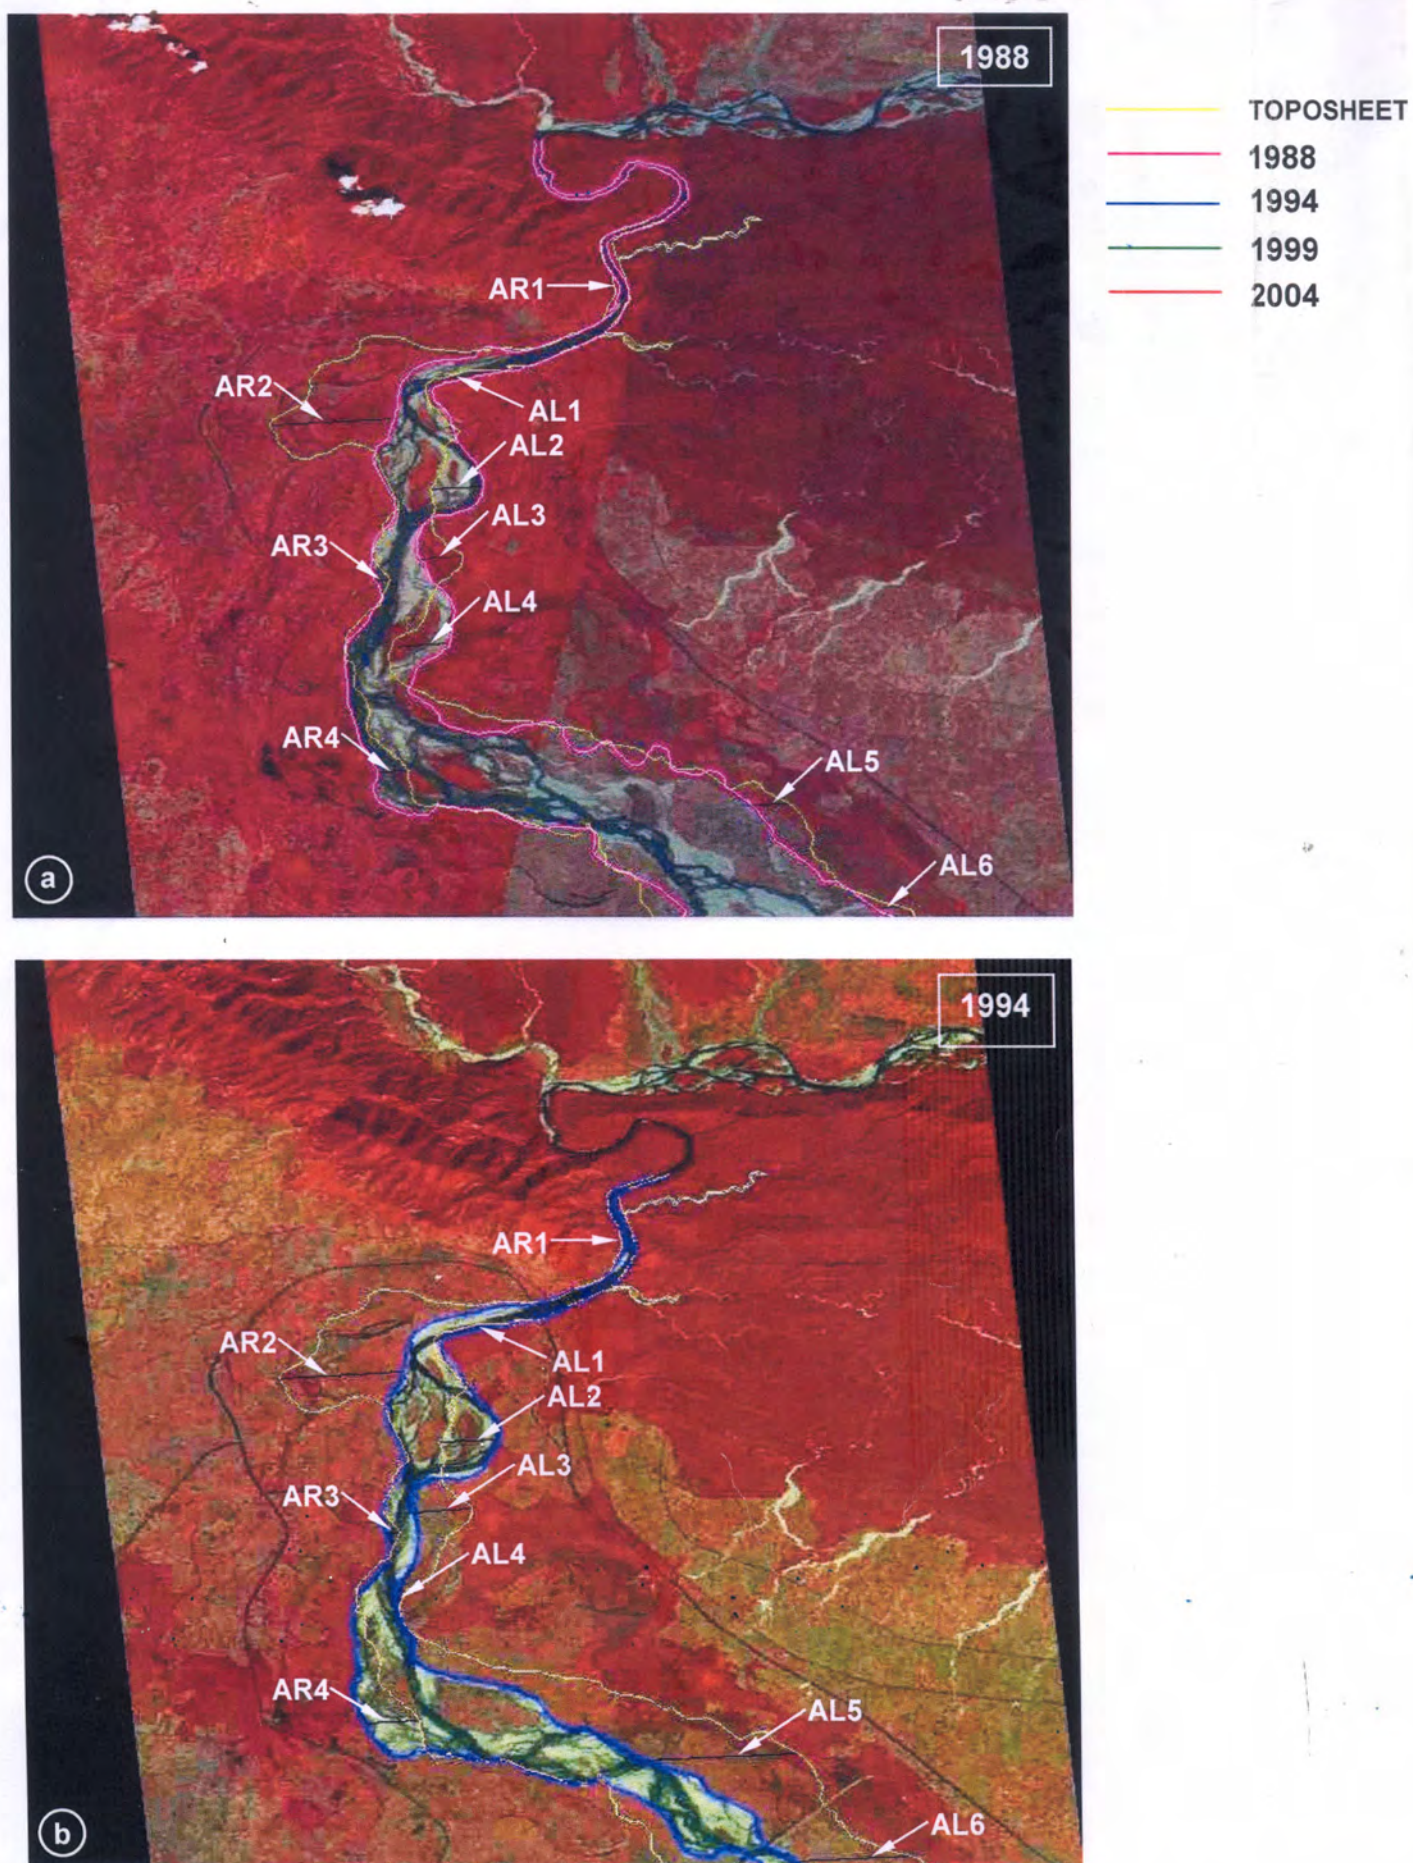
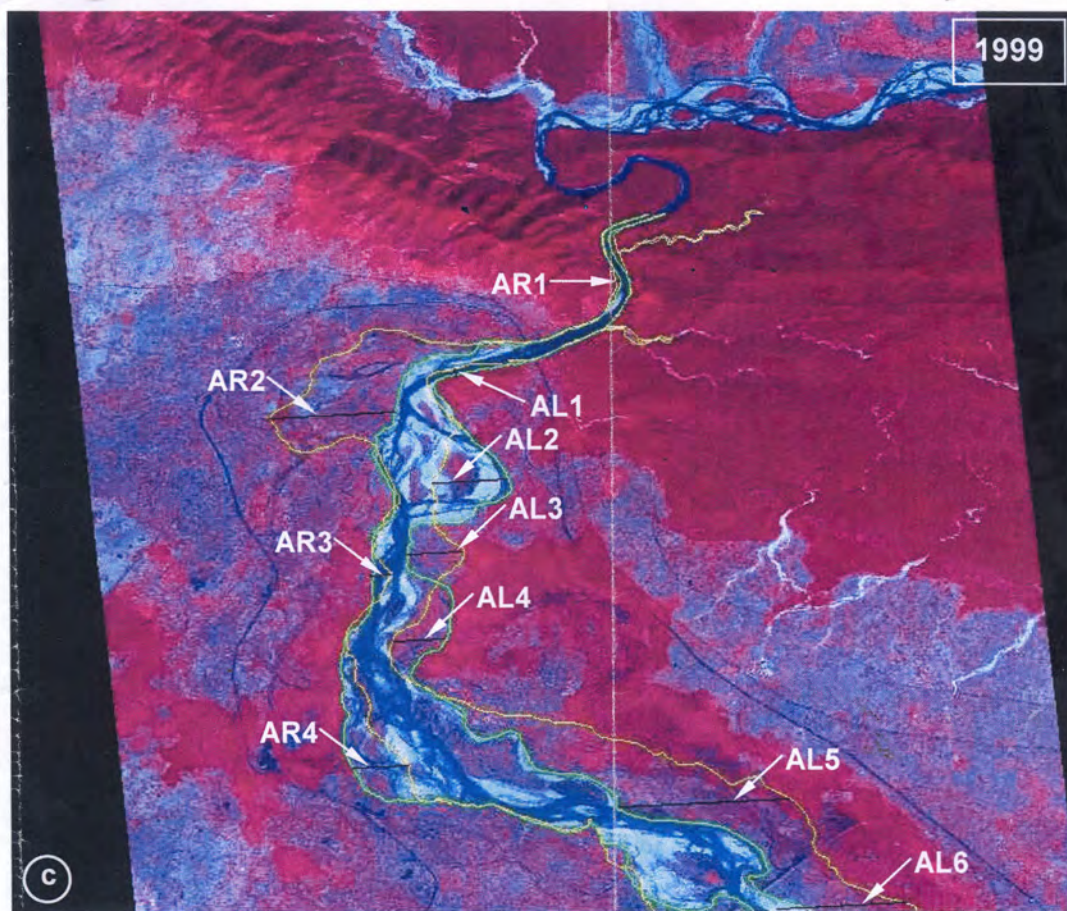
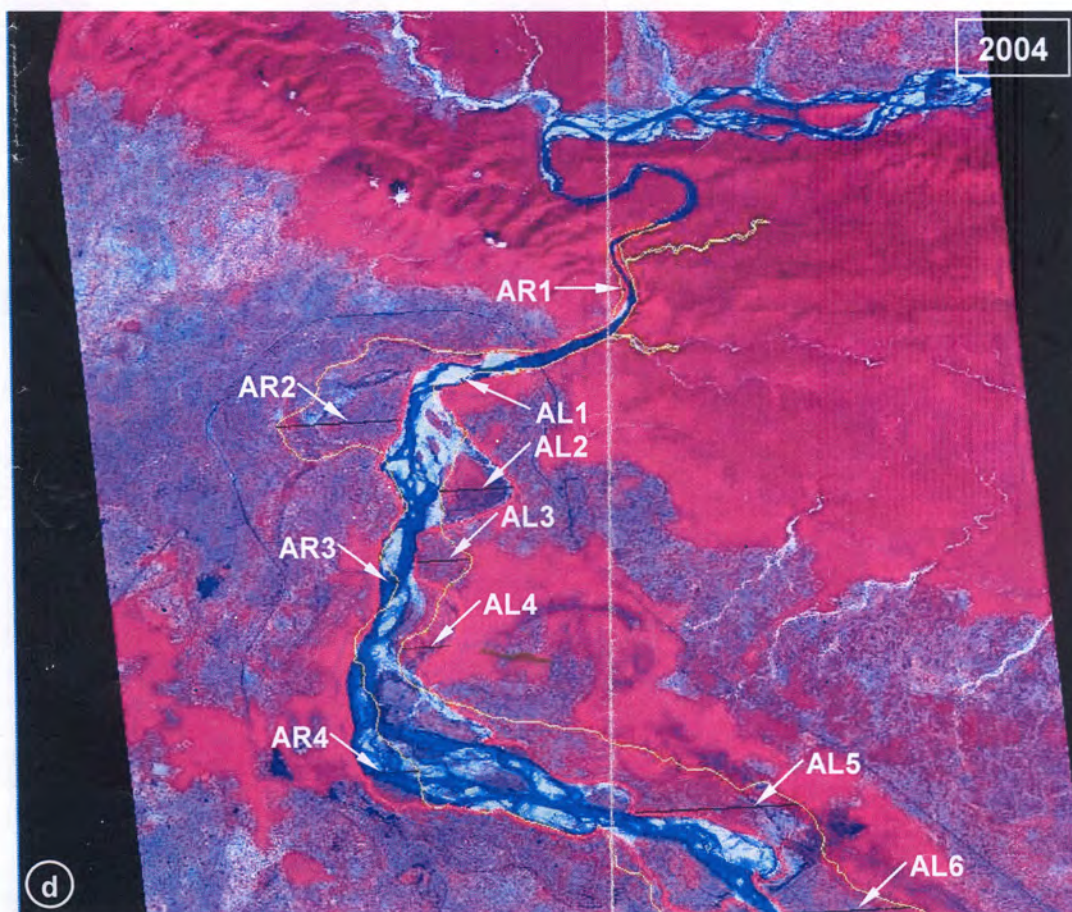
FIGURE 4.11: CHANGES IN BANK LINES OF RIVER

BANK LINES OF RIVER GANDAK FOR ZONE A

At location AR2 near Nansahi Jangal the trend is similar to the trend observed for AR1. The bank is nearing stable state.

The trend of change in bank line at AR4 is similar to the trend observed at AR3. However, the rate of change is tending to be zero between 1999 and 2004.

The change in bank line at AL6 below the Bagaha has similar trend to the change in bank line observed at AL5. The magnitude of change in bank line is fluctuating from 1988 to 2004. The overall trend of cumulative rate of bank line follows the trend of change in bank line.

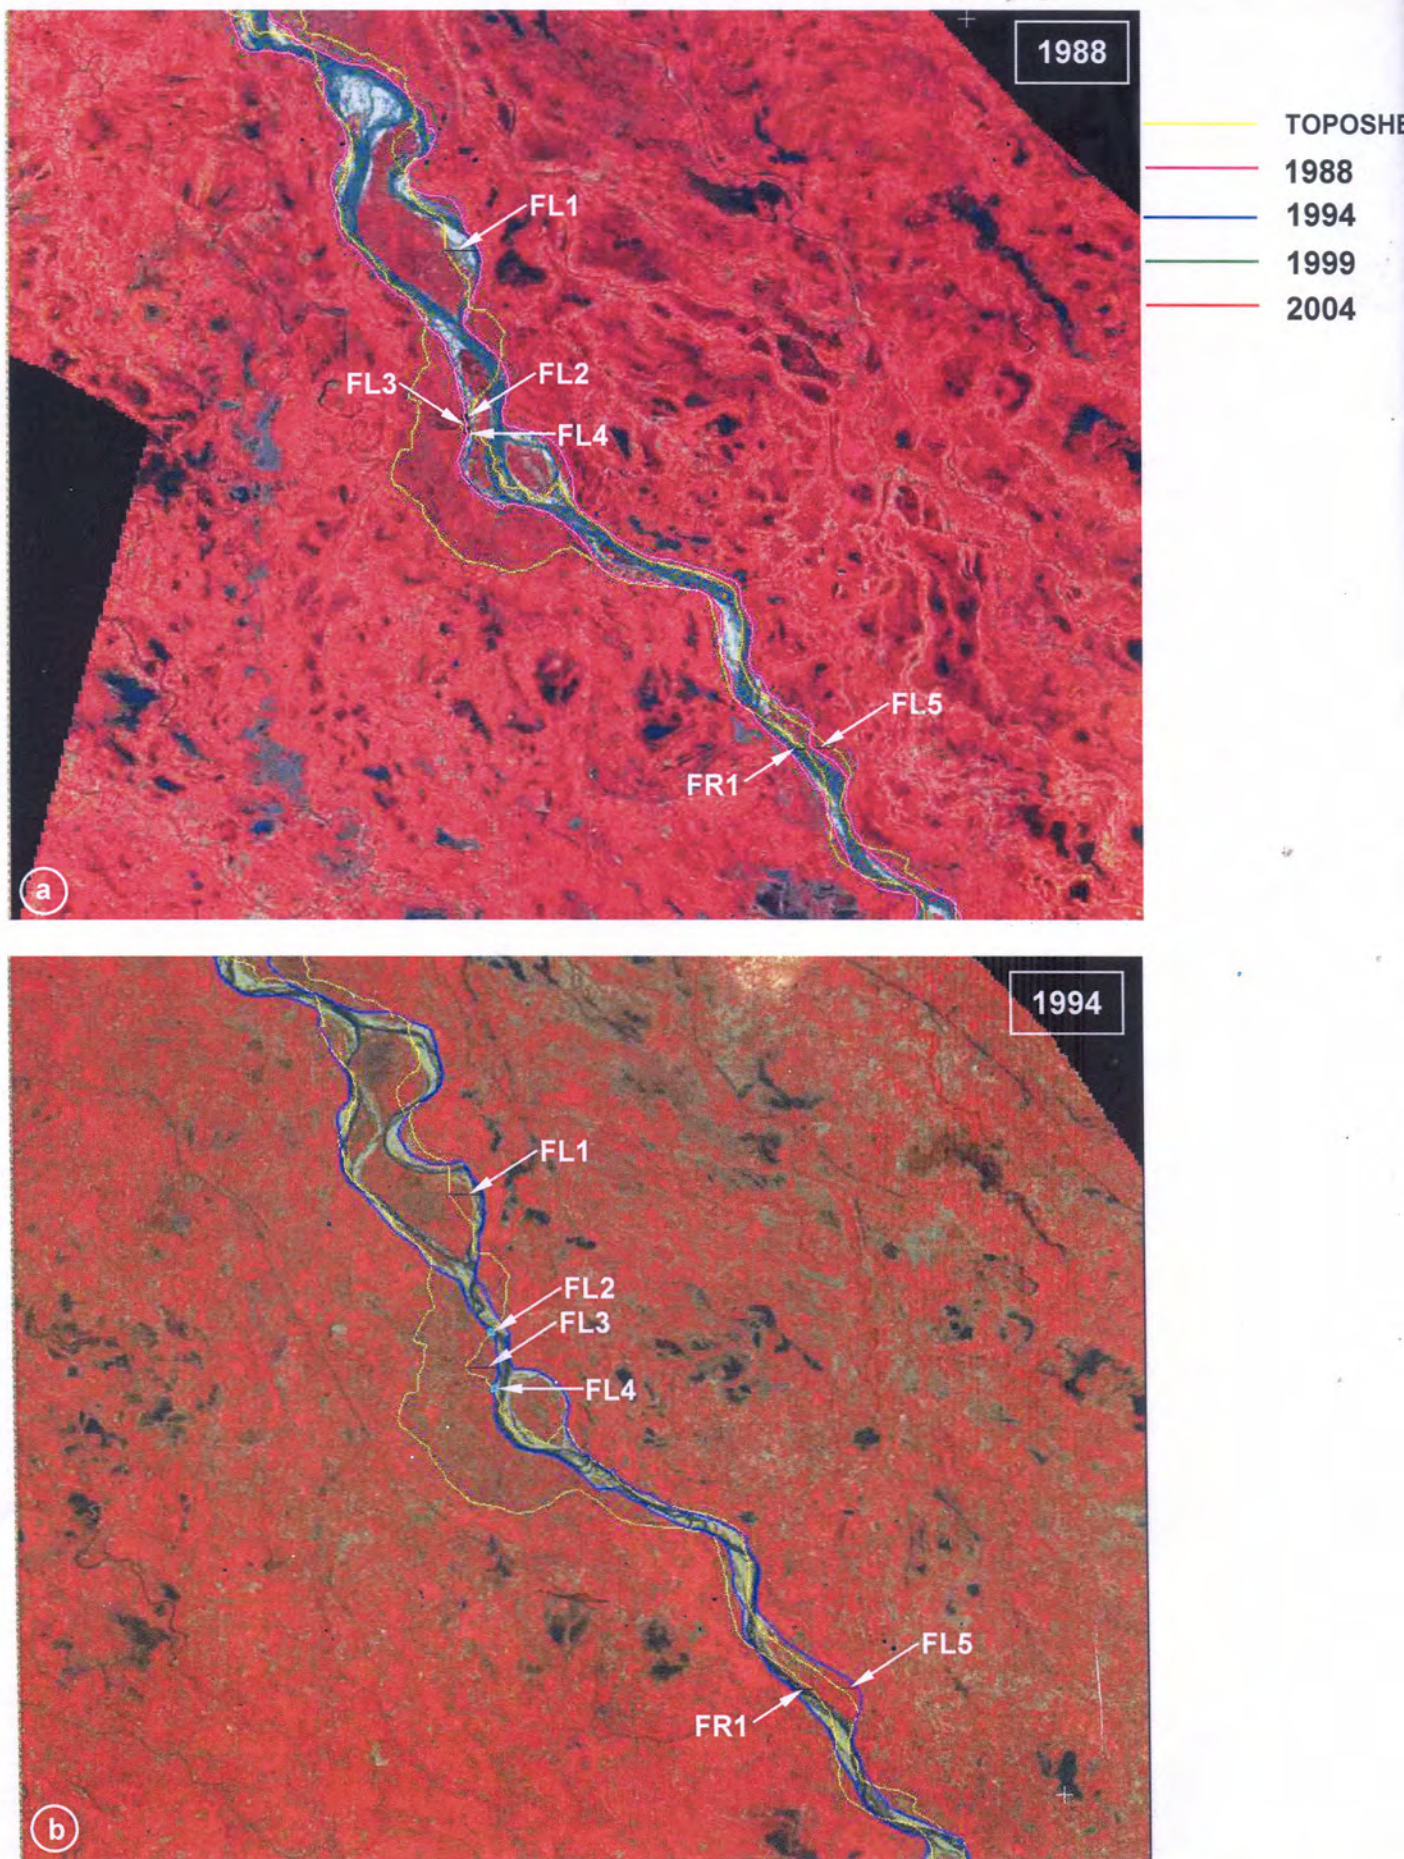
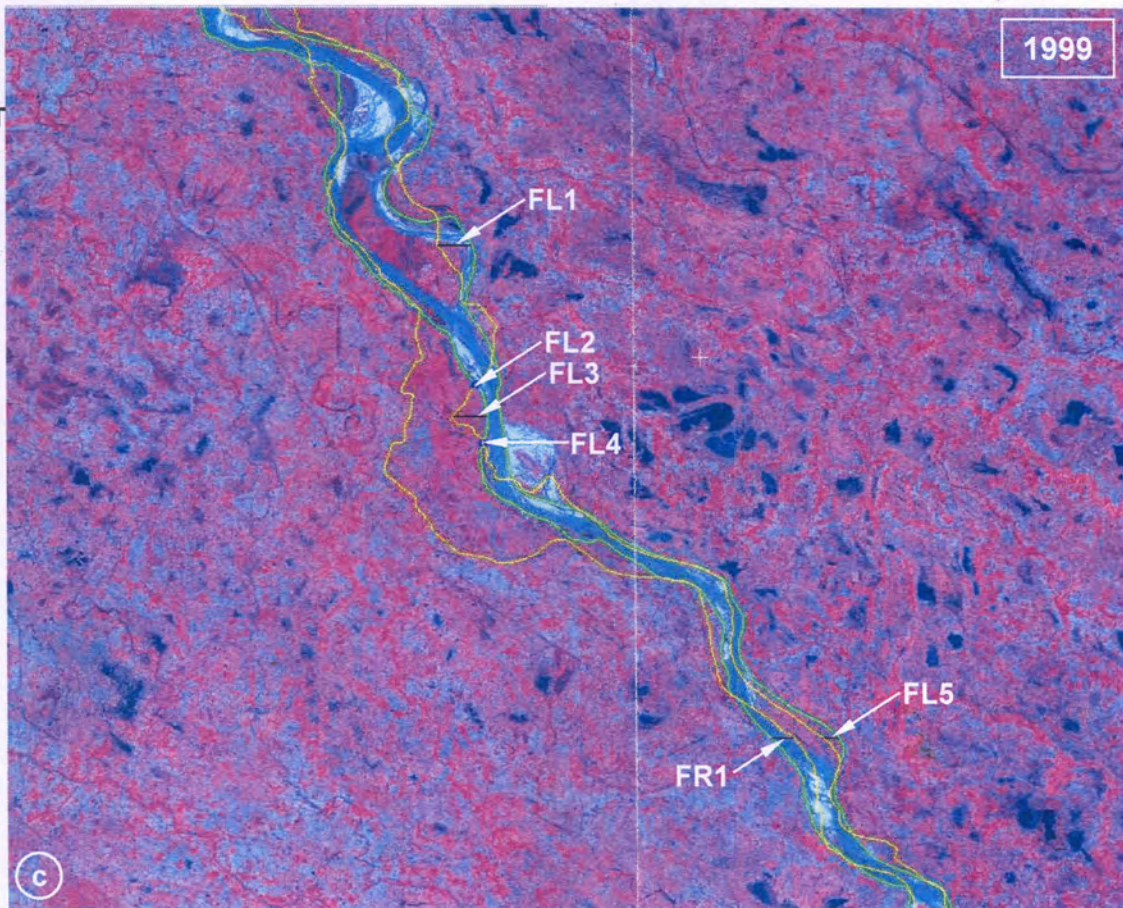
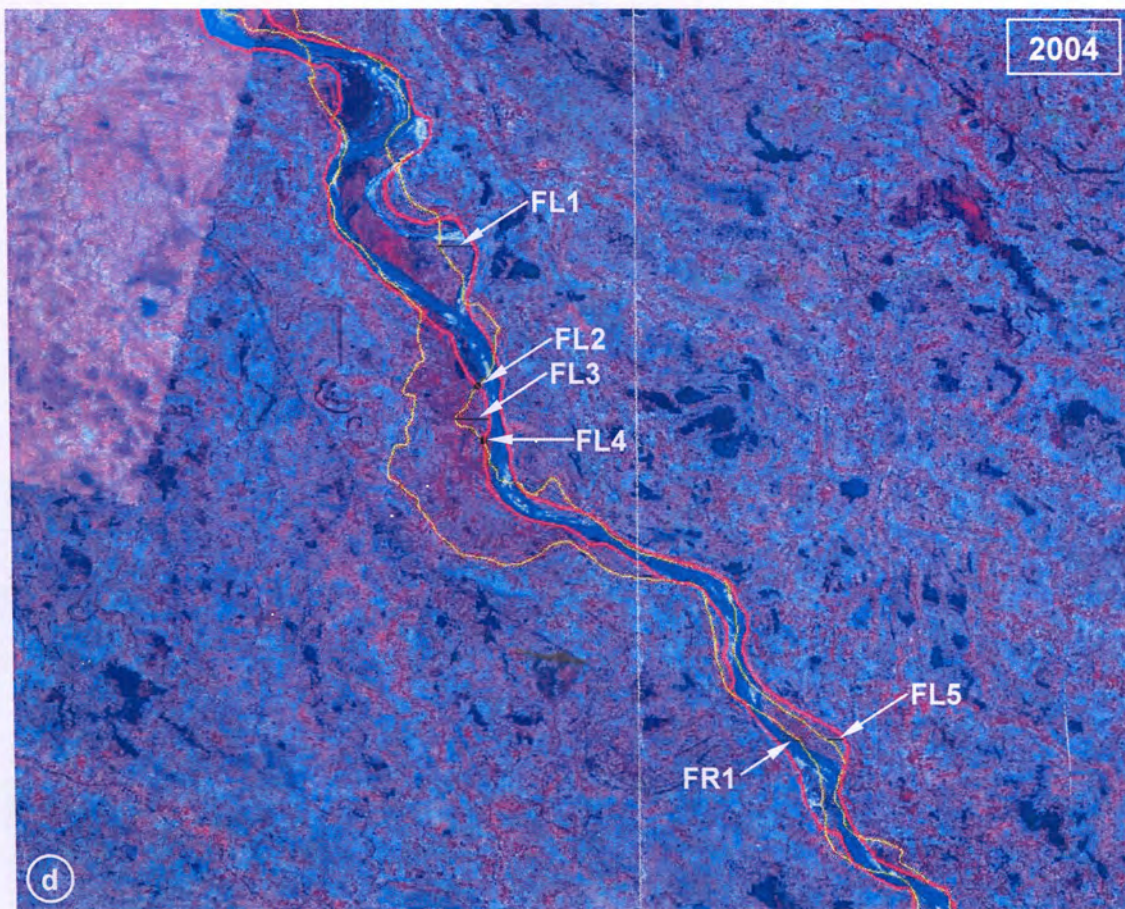
FIGURE 4.16: CHANGES IN BANK LINES OF

BANK LINES OF RIVER GANDAK FOR ZONE F

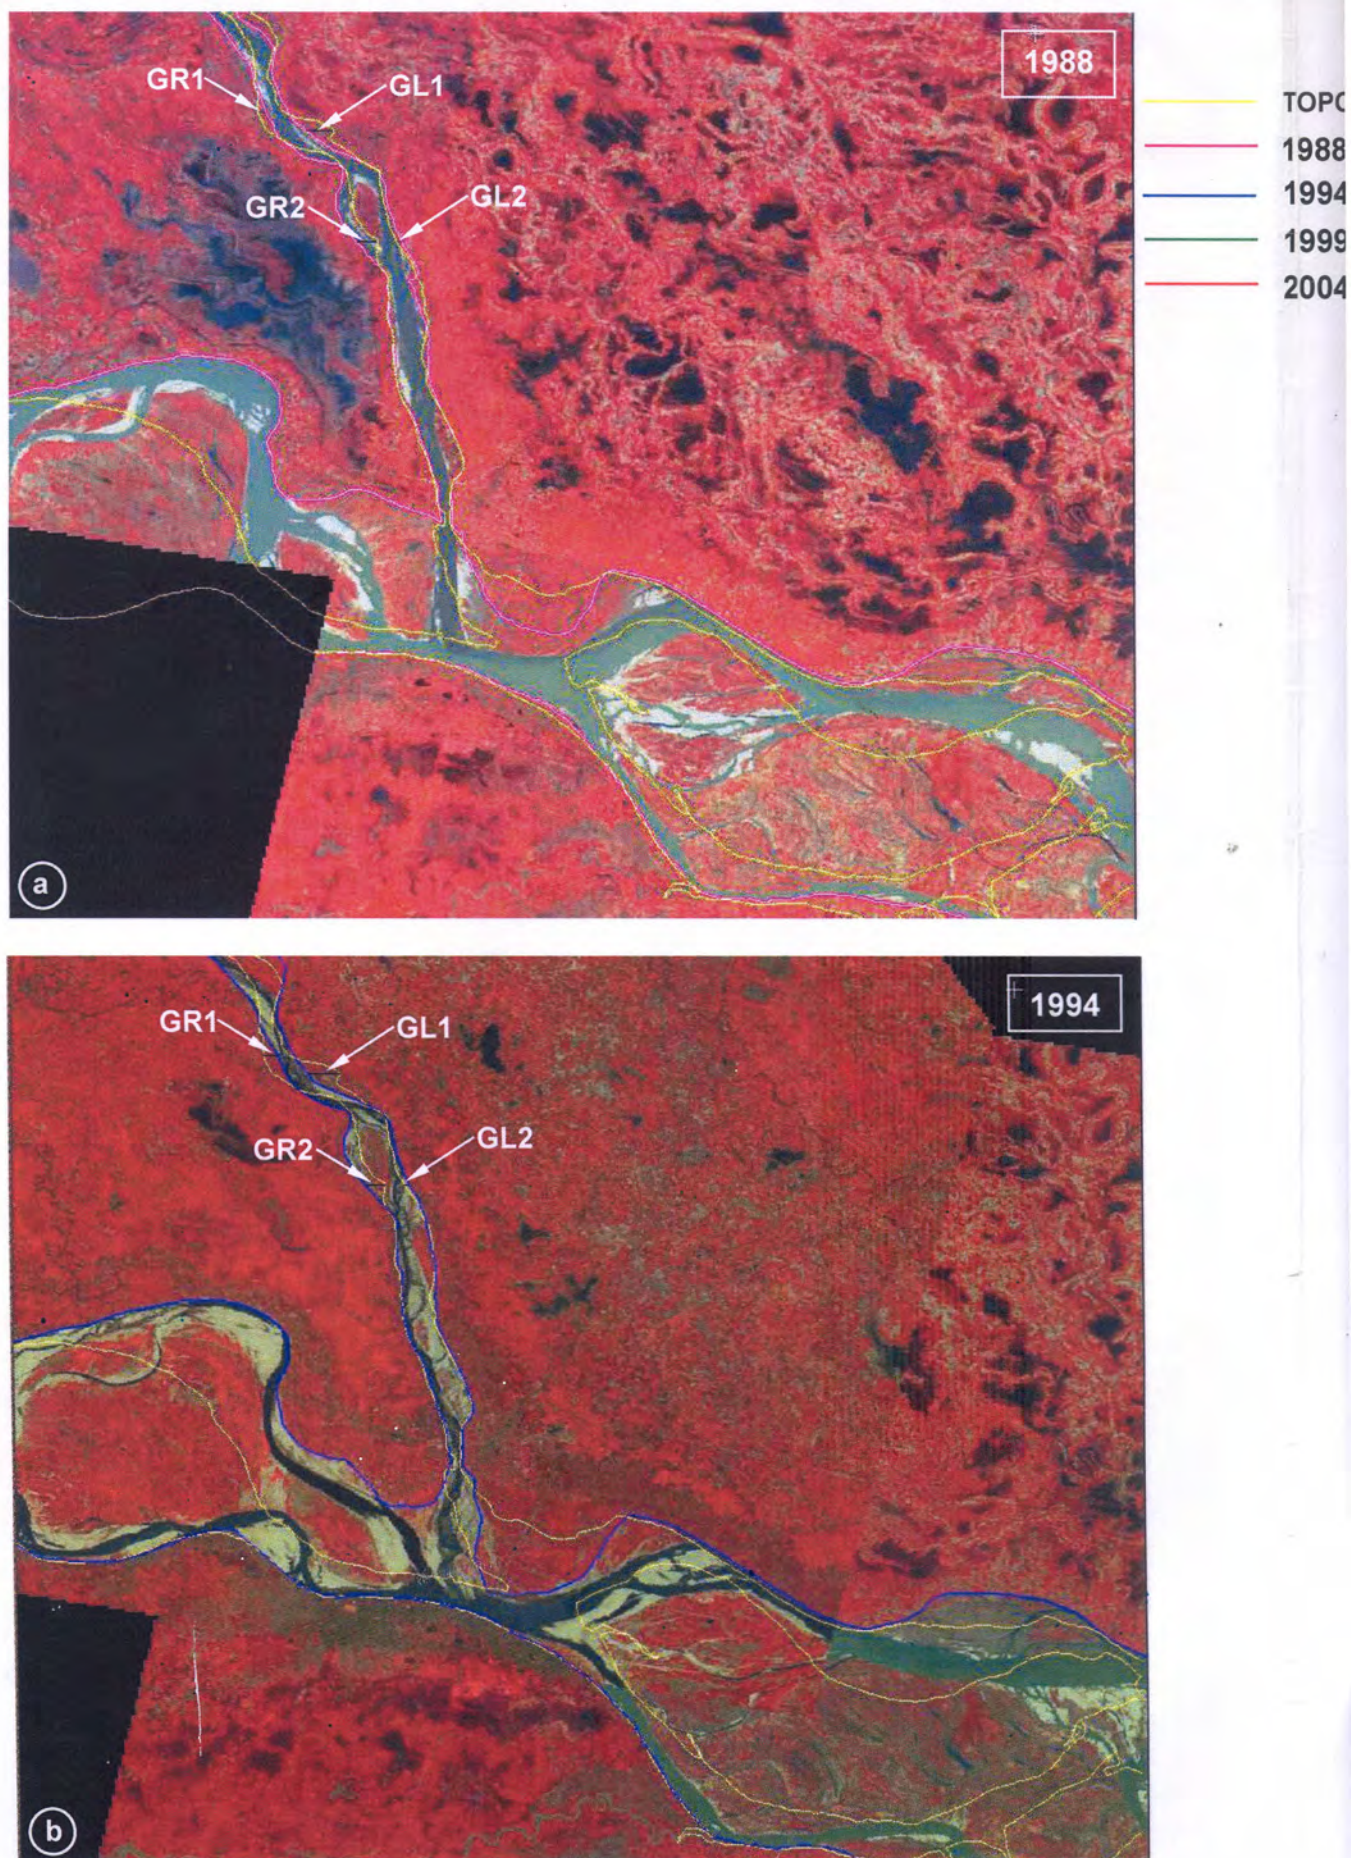
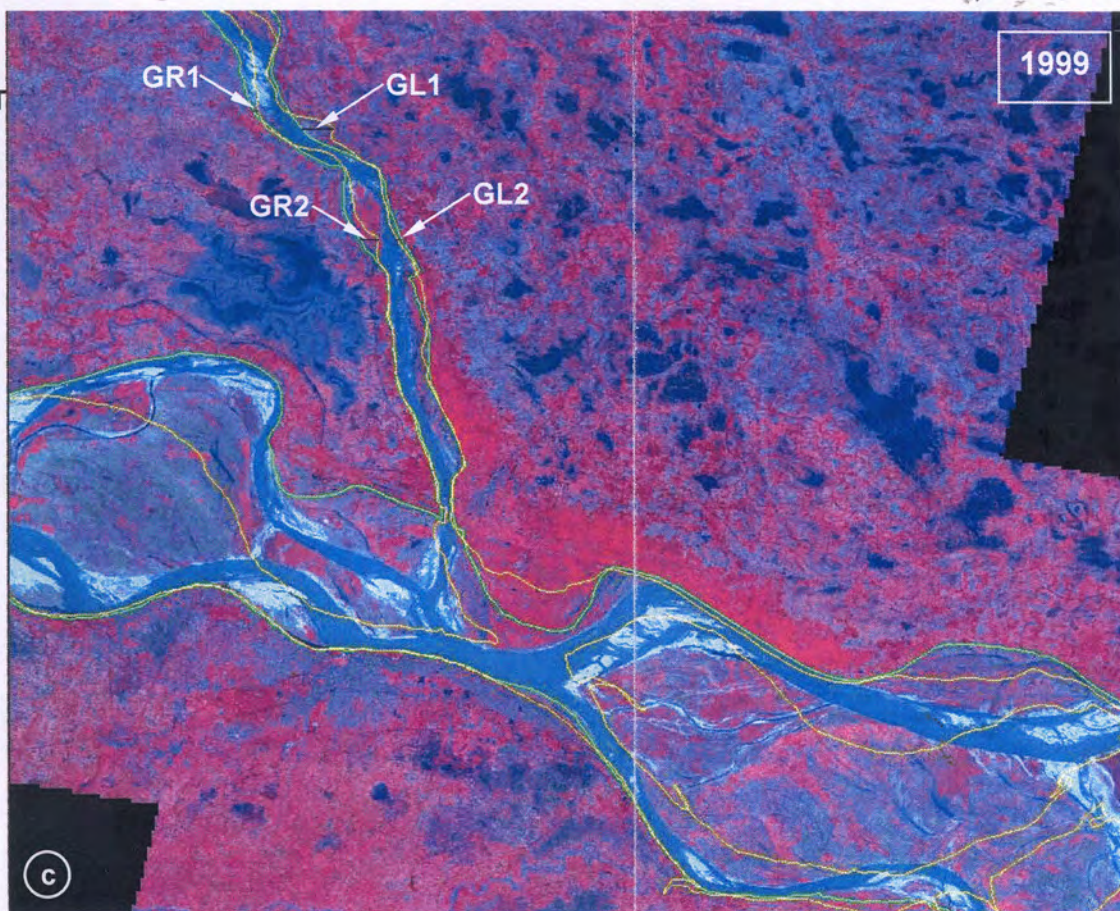
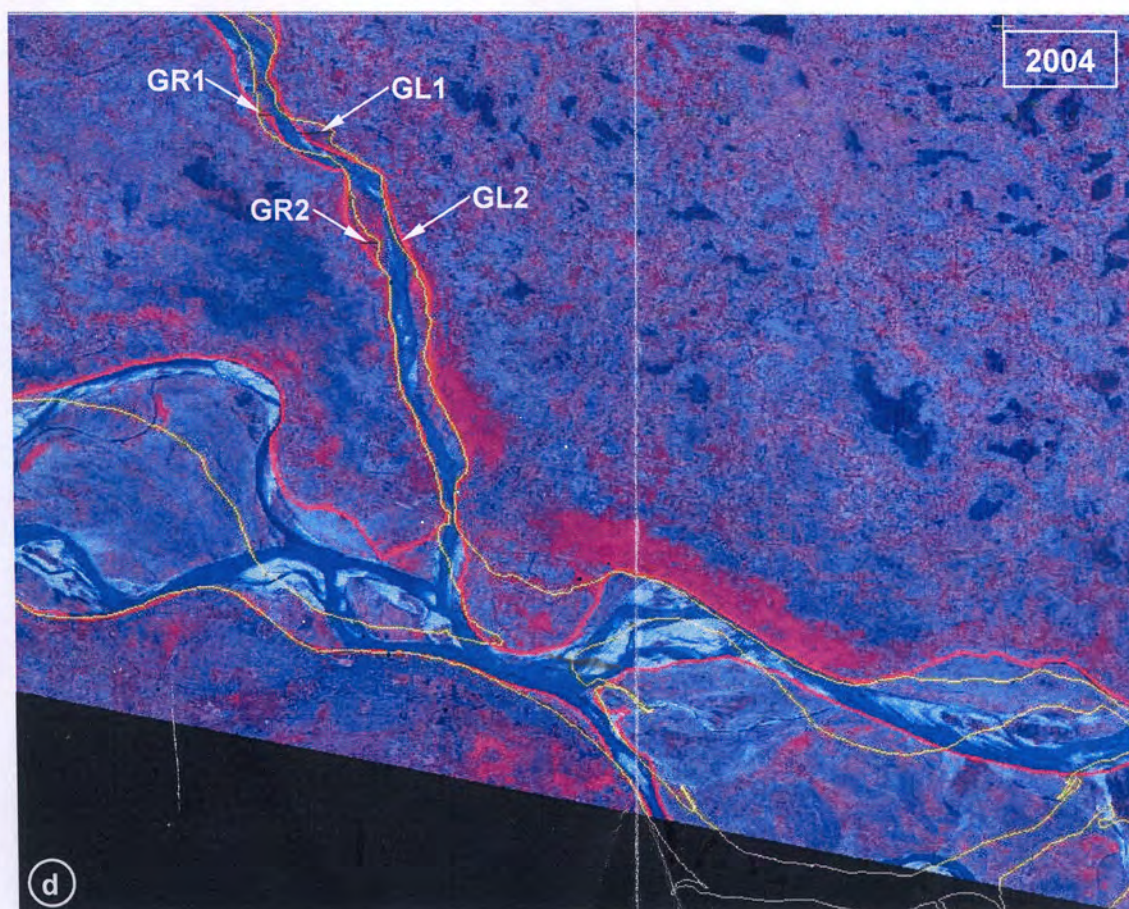
FIGURE 4.17: CHANGES IN BANK LINES

BANK LINES OF RIVER GANDAK FOR ZONE G

Zone G – Right Bank: This is the last zone of the study area, which is near the confluence of river Gandak with wholly river Ganga. The confluence is near Hajipur town. The changes in bank lines are likely to be affected by hydraulic and morphological conditions as well as sequence of water and sediment flow experienced in both the rivers. It is, therefore, considered appropriate to review the changes in bank lines of river Gandak at location sufficiently upstream of the confluence where the above factors are not influencing the flow conditions in river Gandak. Accordingly, the study reach was restricted upstream of confluence of river Ganga. In this reach two locations each on right bank and left bank could be identified. The deposition trend is shown at location GR1 upto 1994 followed by reduction in deposition in 1999 and continuation of deposition further upto 2004. A location GR2 erosive trend could be noticed during comparison of bank line of 1935 to 2004. The change in bank line indicates reducing trend upto 2004.
