केन्द्रीय जल और विद्युत अनुसंधान शाला CENTRAL WATER AND POWER RESEARCH STATION

TECHNICAL REPORT NO. 5015
NOVEMBER 2012

MORPHOLOGICAL STUDIES OF RIVER GANDAK
USING SATELLITE AND SOI DATA

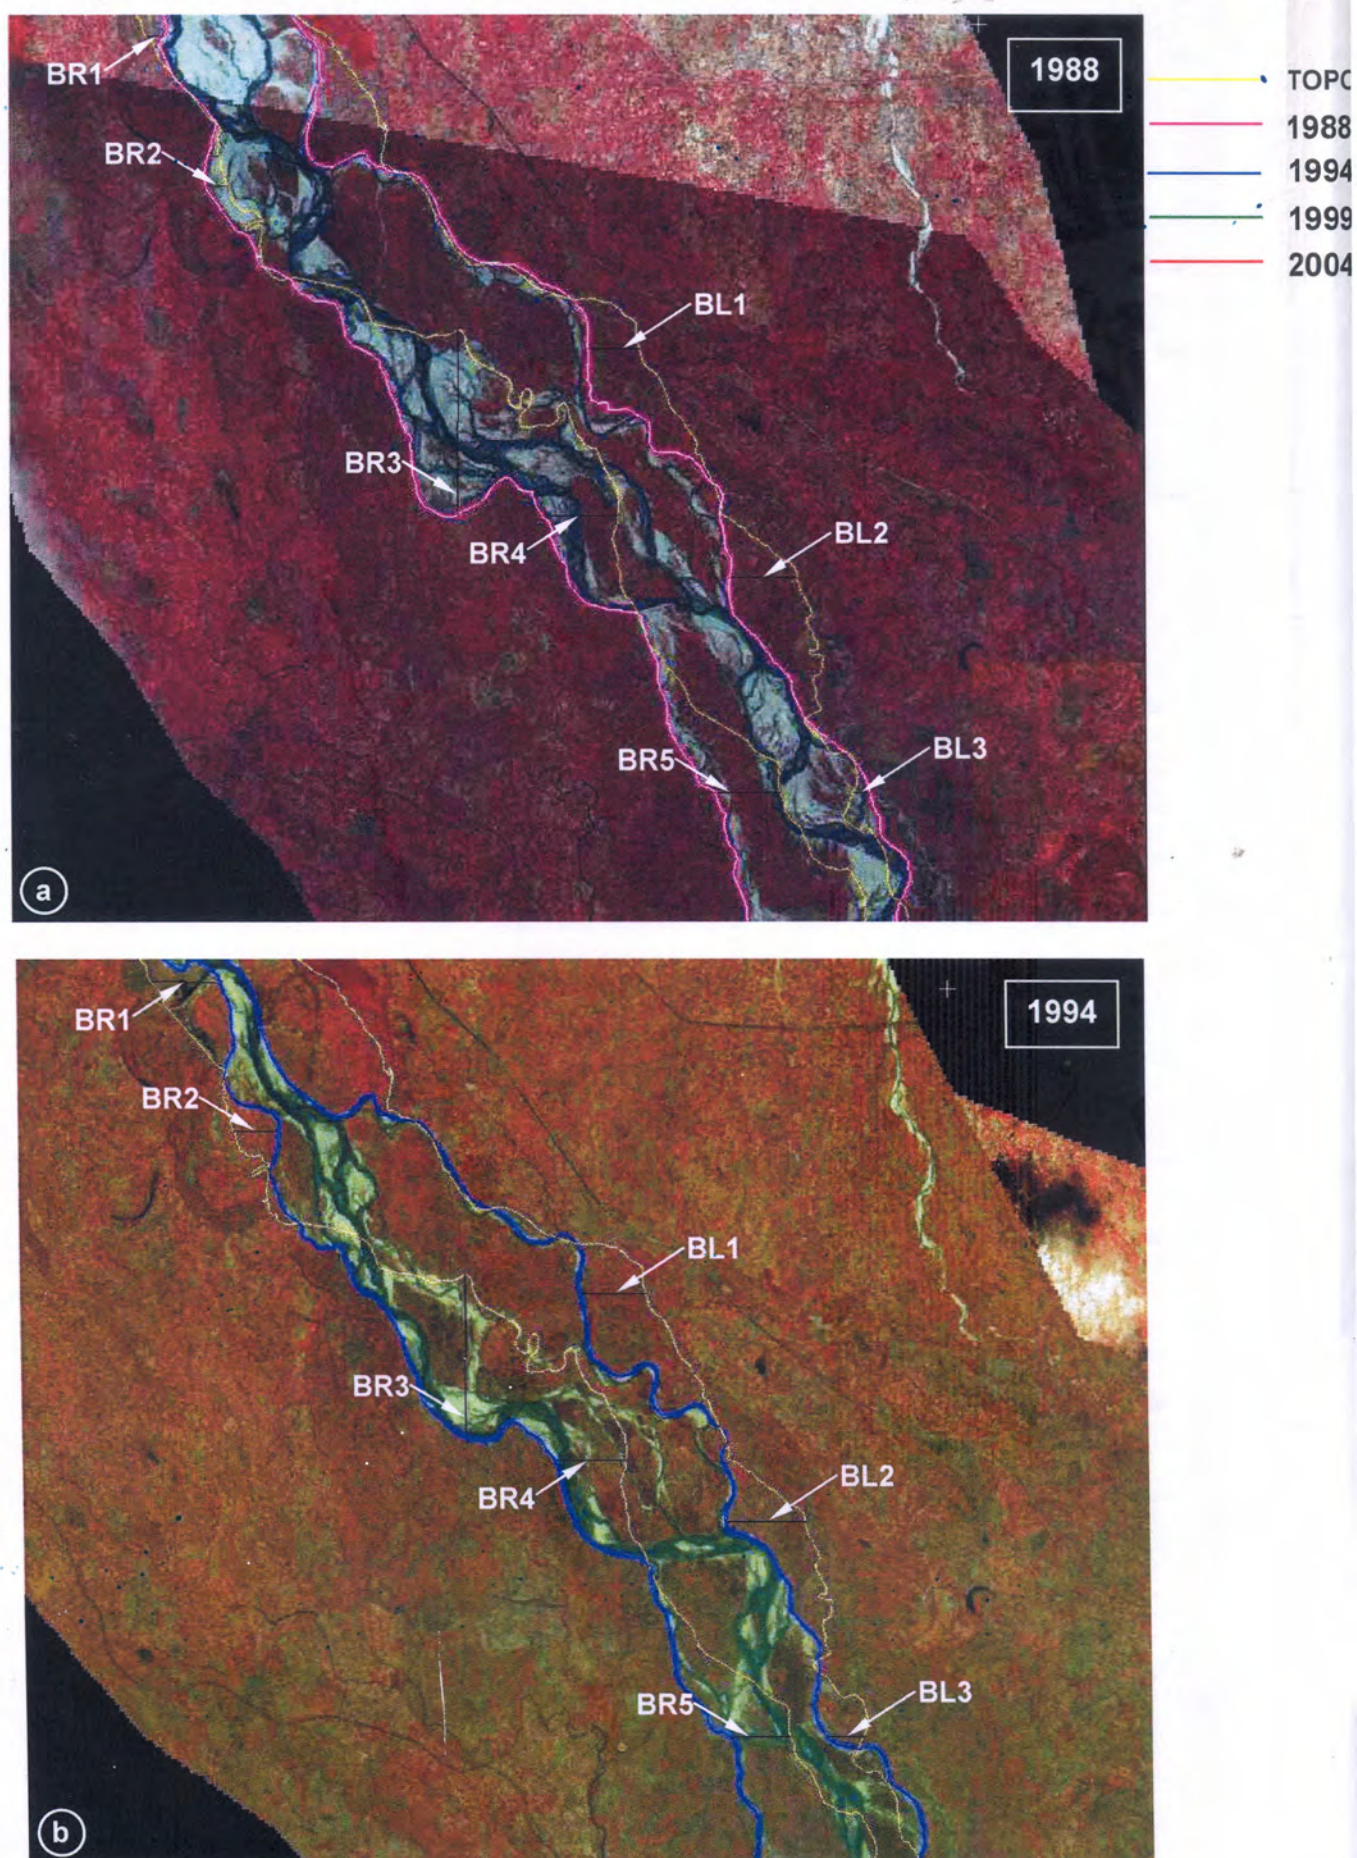
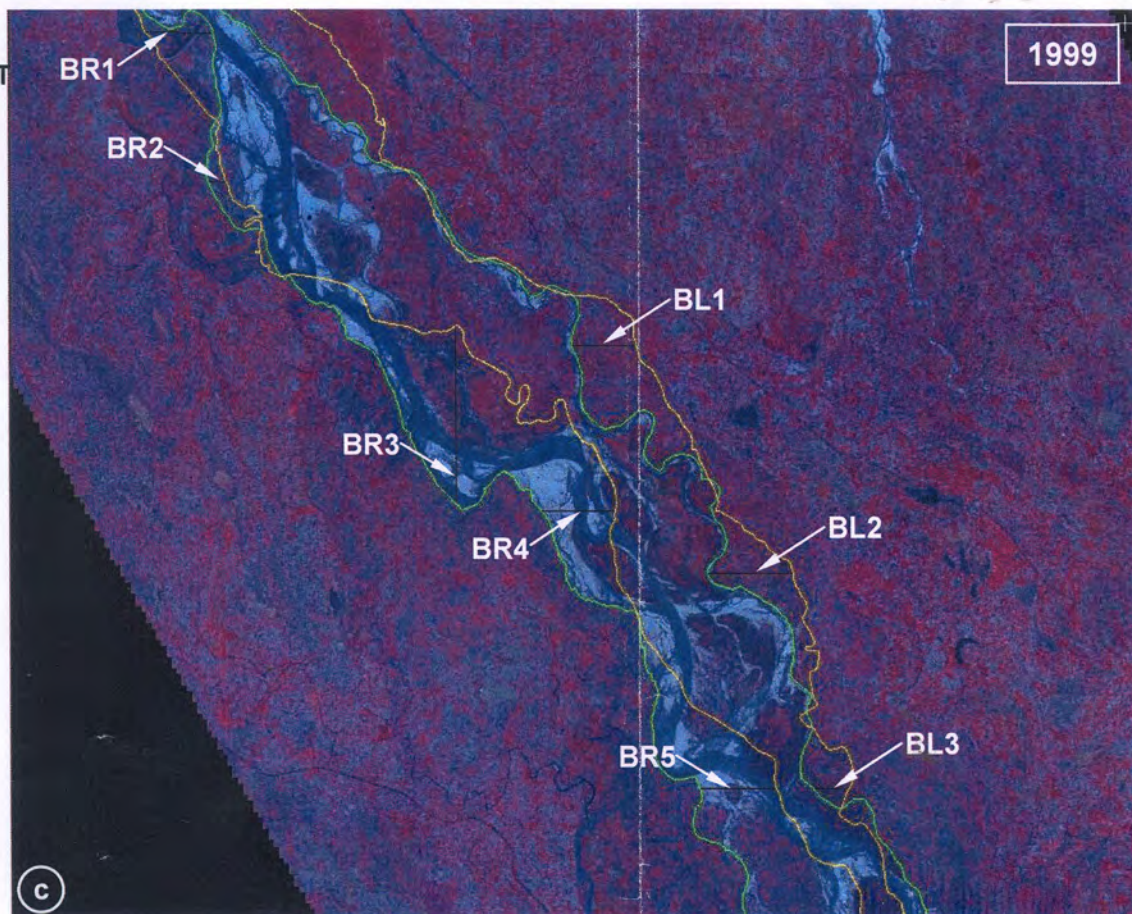
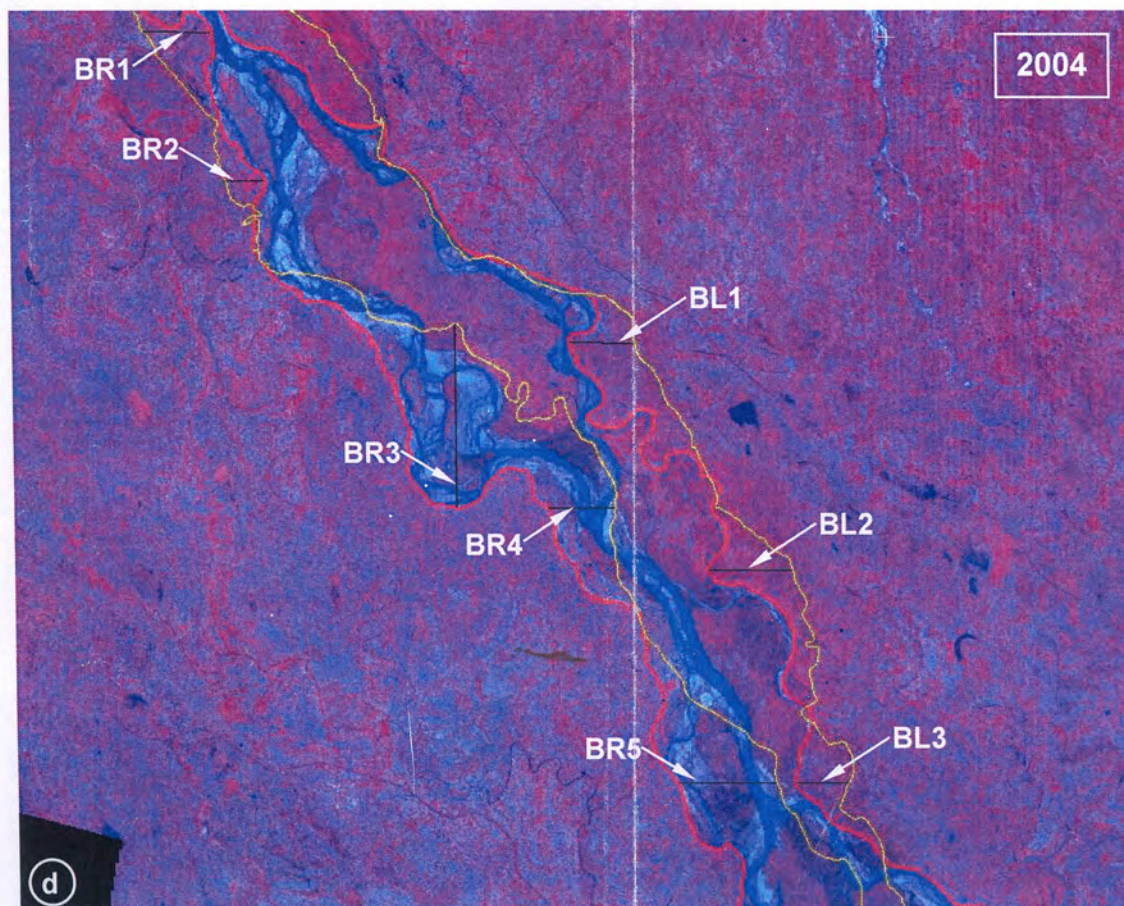
FIGURE 4.12: CHANGES IN BANK LINES

BANK LINES OF RIVER GANDAK FOR ZONE B

Zone B – Right Bank: In Zone B there are five locations on right bank and three locations on left bank that show change in bank line. Out of the five locations, on right bank deposition is observed at first location and trend of erosion is shown at the last three locations. The second location shows the fluctuating trend of erosion and deposition.

At other three locations viz. BR3, BR4 and BR5 the trend of erosion is observed. The magnitude of change is maximum in BR3 near Madhubani PO with a value of about 8000 m between 1928 and 2004. The overall change in bank line is reducing from BR3 to BR5. The reach between BR3 to BR5 needs to be kept under observations for possible erosion/deposition.

Zone B – Left Bank: In Zone B along left bank the trend of deposition is observed. The maximum change in bank line has occurred at BL1 near Ratwal of about 4500 m from 1928 to 2004. Similar order of magnitude of change in bank line is observed at location BL2 near Nawalpur. However, the change in bank line between 1958 and 2004 is of the order of 4100 m at location BL3 near Jogapatti. It can be observed that overall there has been deposition along the left bank of Zone B.

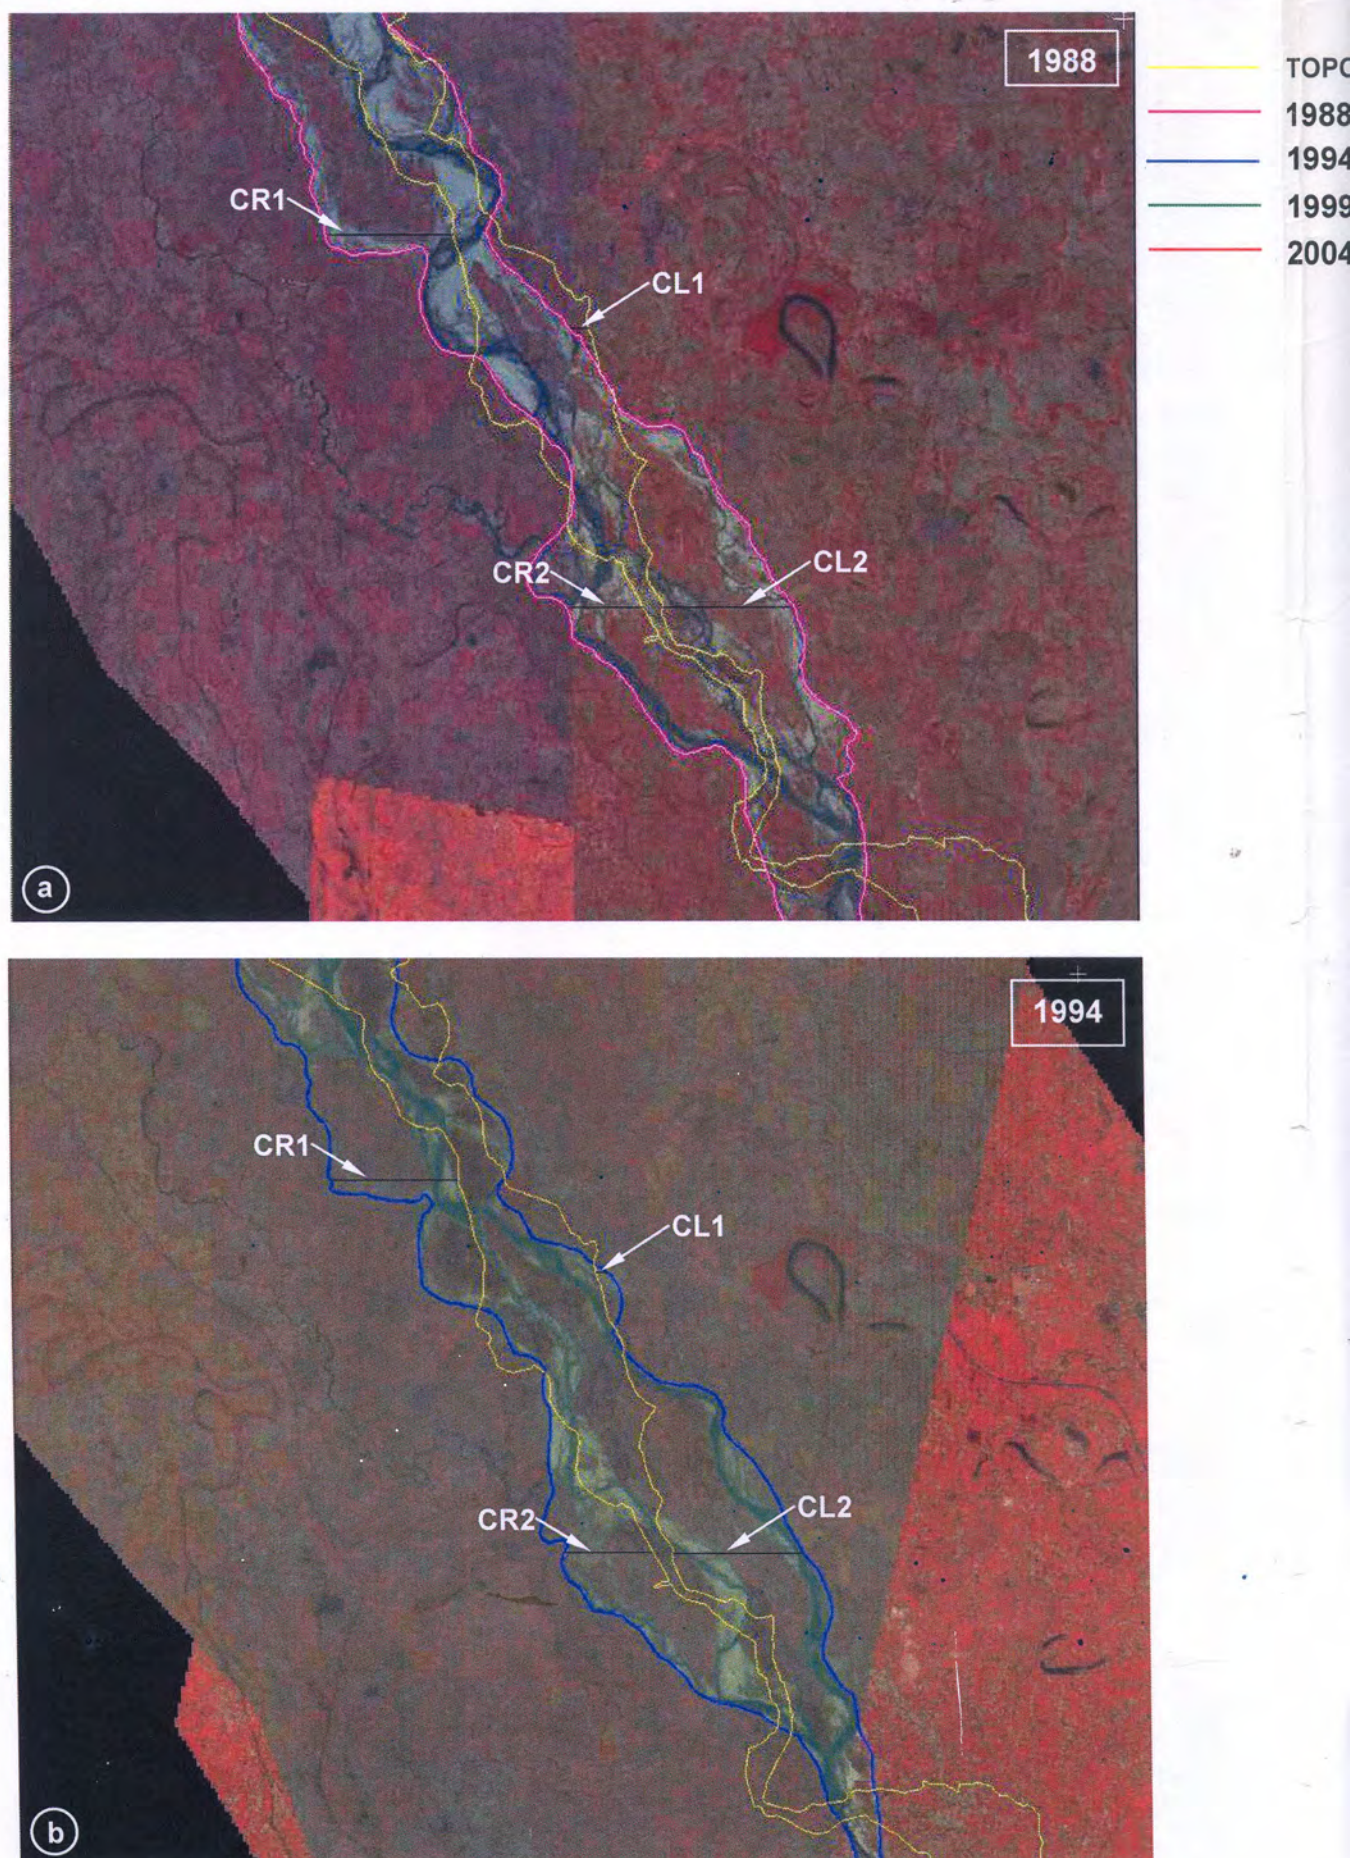
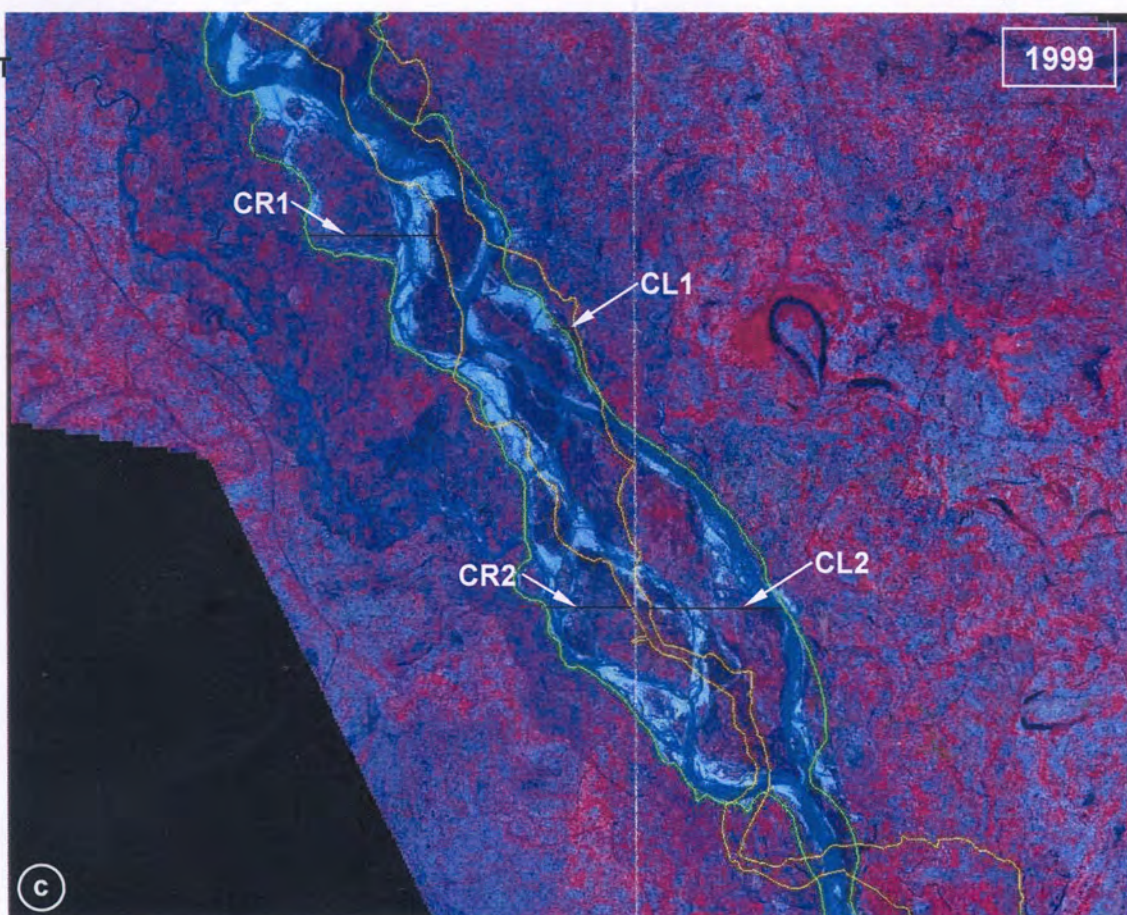
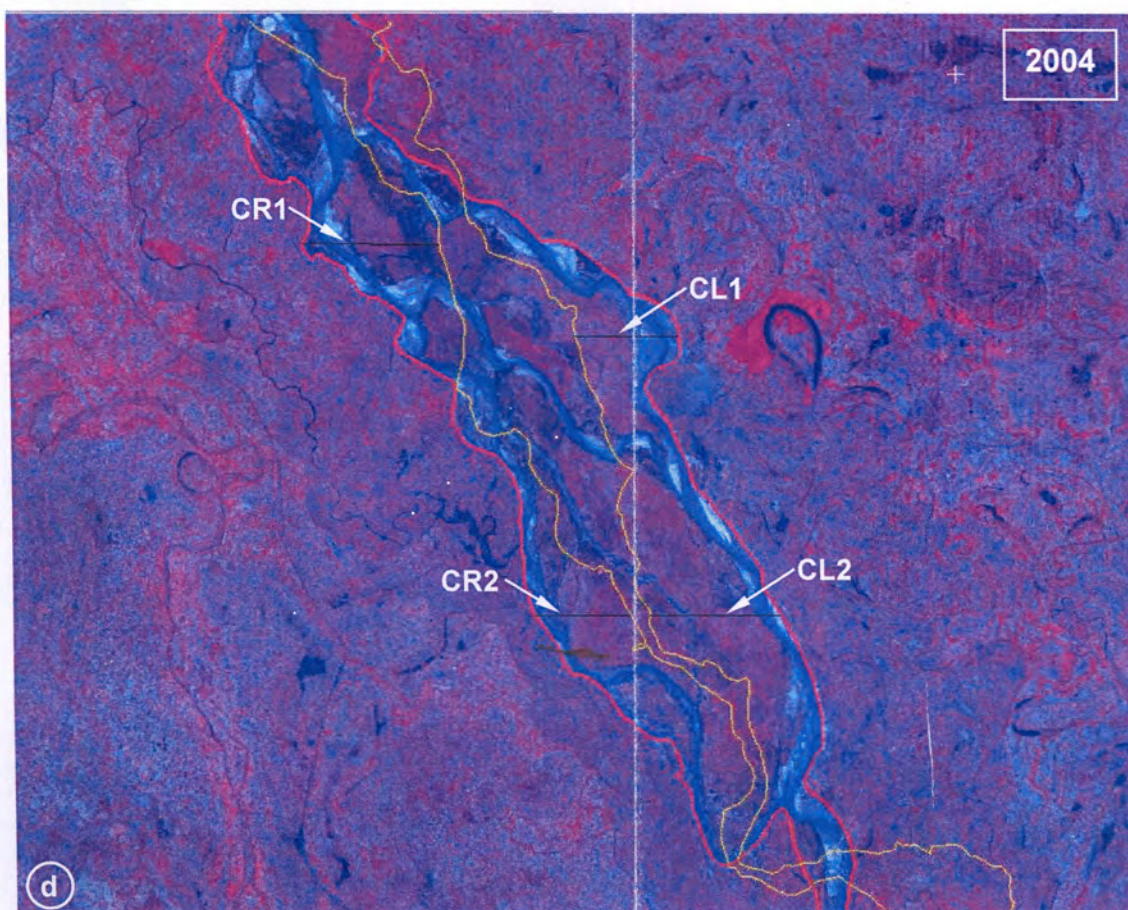
FIGURE 4.13: CHANGES IN BANK LINES OF

LINES OF RIVER GANDAK FOR ZONE C

Zone C – Right Bank and Left Bank: There are two locations each along right bank and left bank where changes in bank line were noticed. There is tendency of erosion along right bank. Along left bank the change is alternative in nature at location CL1 near Malahi and trend of erosion is displayed at location CL2 near Nutan Dube. The maximum change in bank line of 6000 m is observed at CR1 and minimum change of bank line of about 530 m is observed near location CL1. The changes in bank line at CR1 appear to reach stability upto

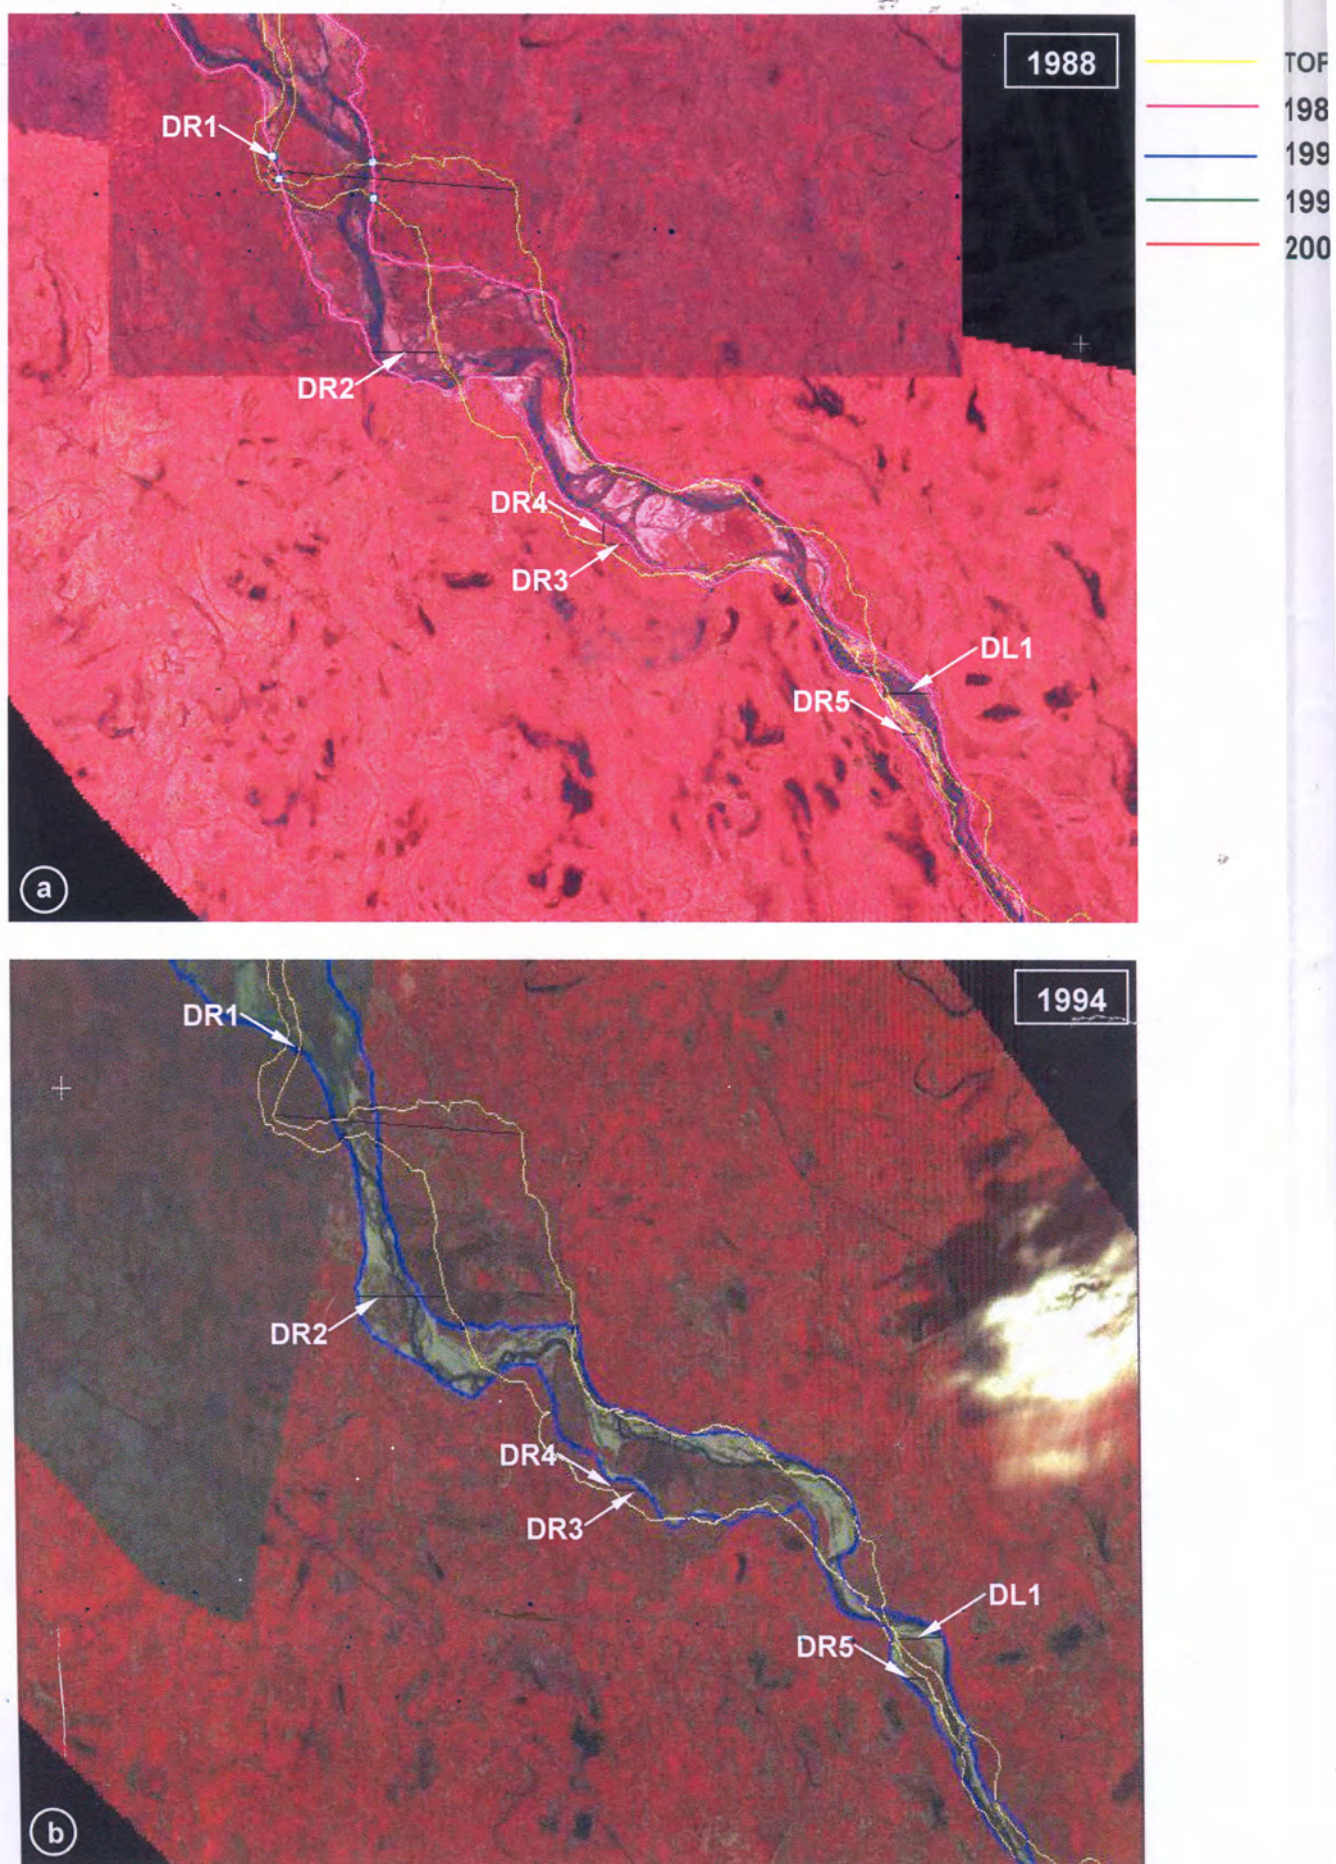
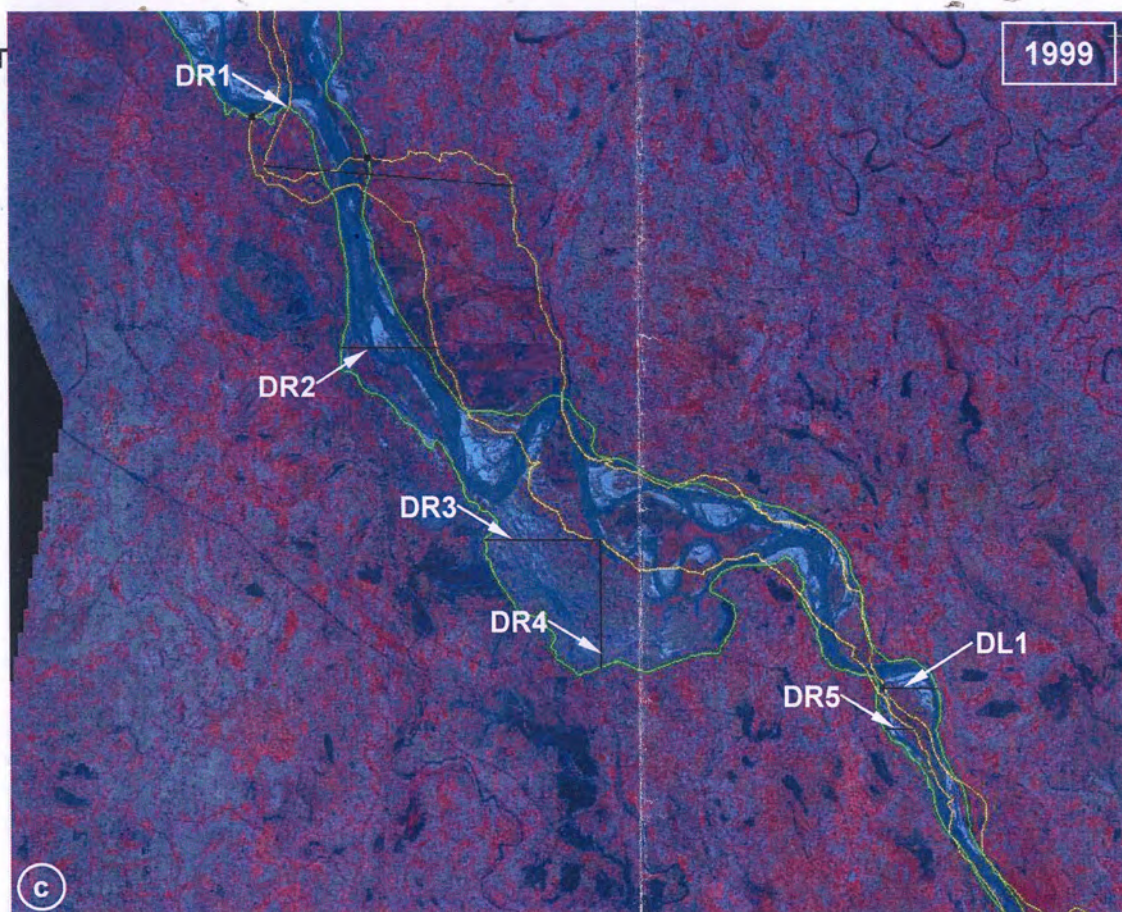
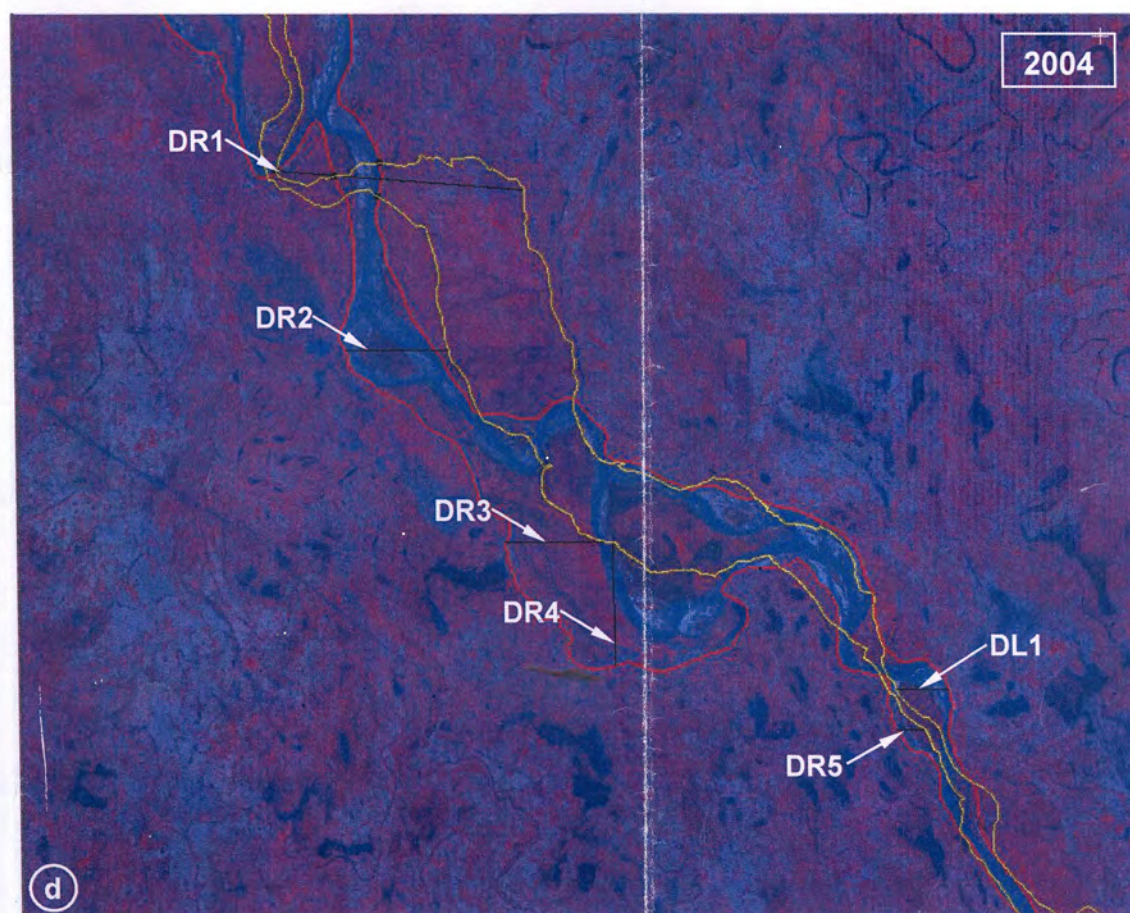
FIGURE 4.14: CHANGES IN BANK LINES

BANK LINES OF RIVER GANDAK FOR ZONE D

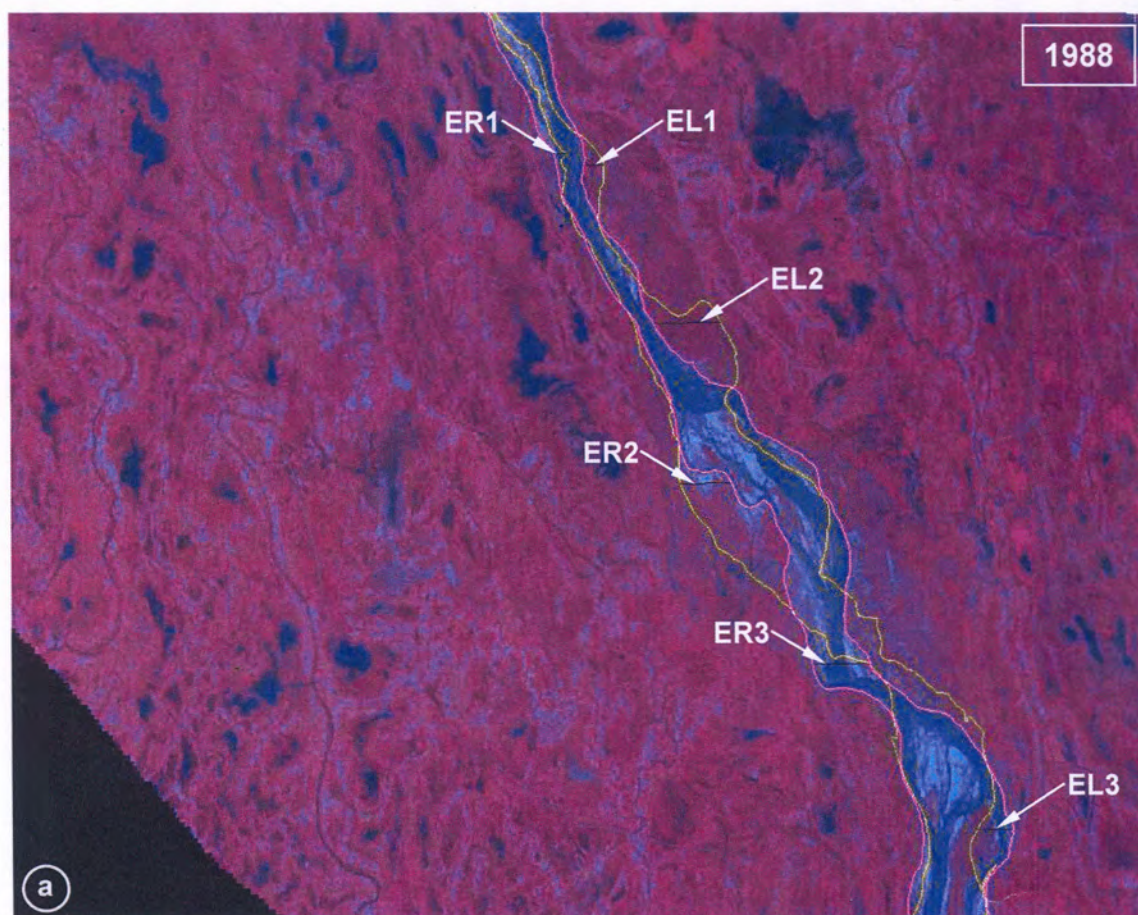
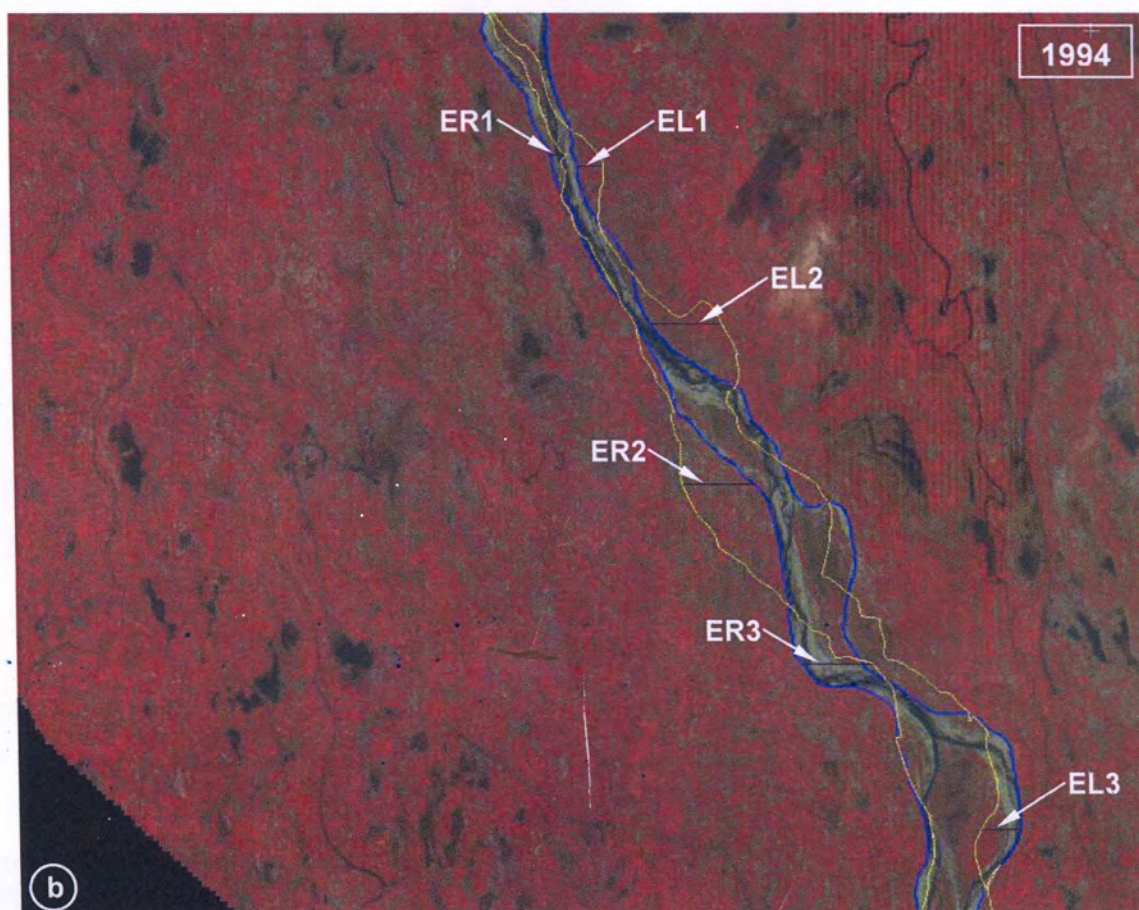
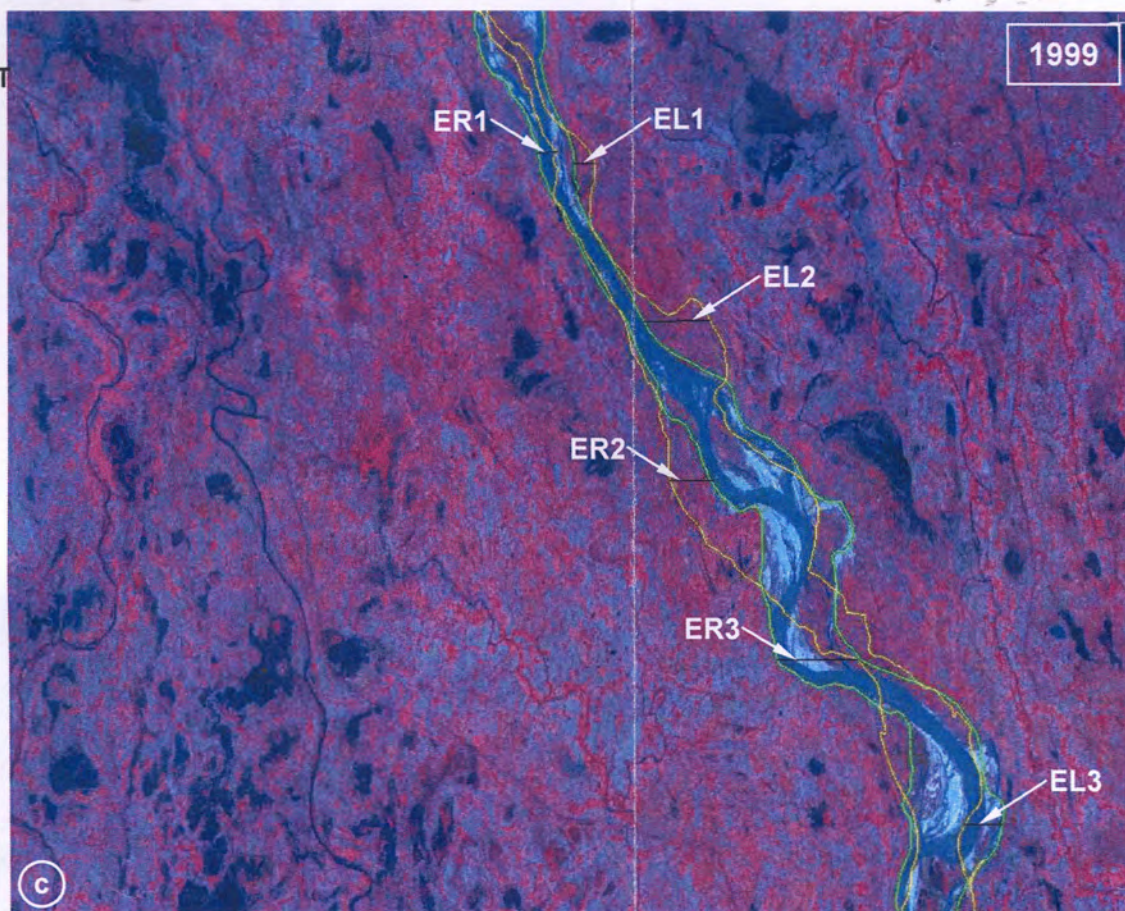
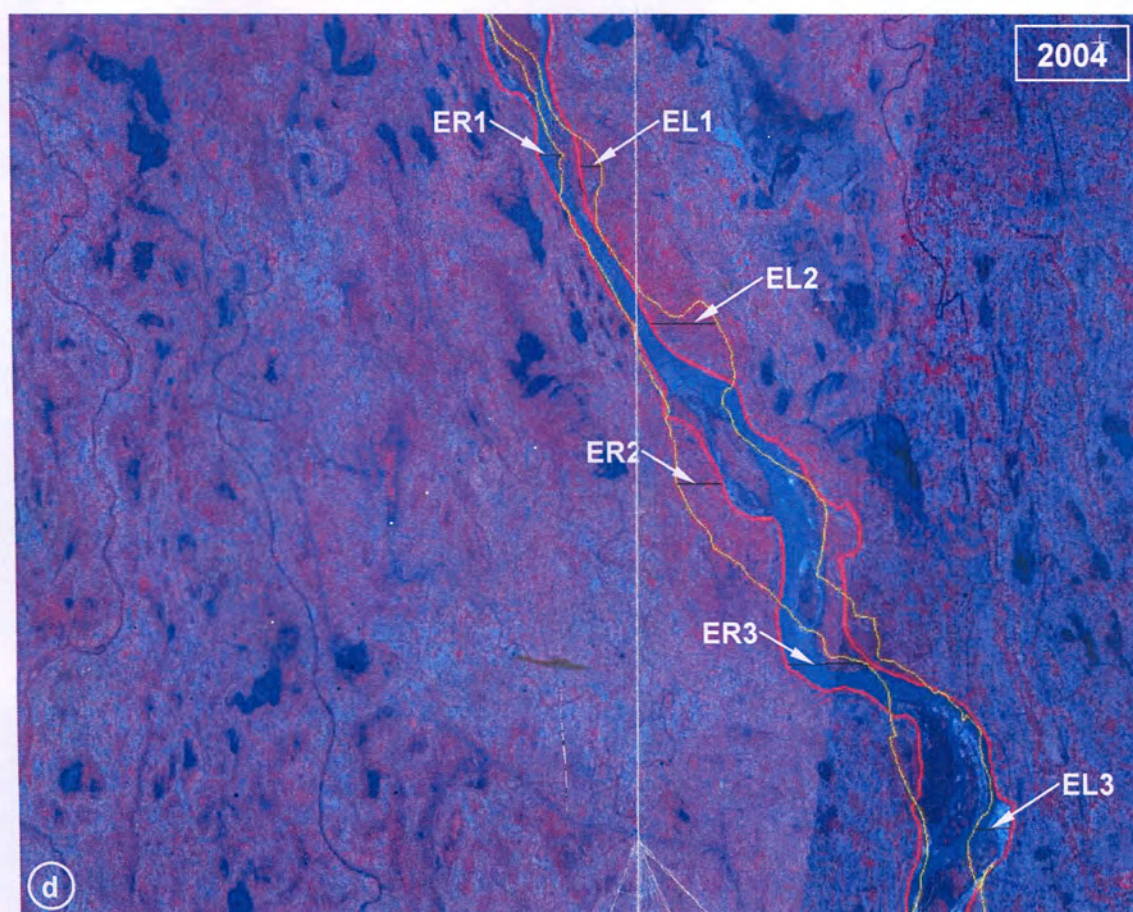
FIGURE 4.15: CHANGES IN BANK LINES

BANK LINES OF RIVER GANDAK FOR ZONE E

The deposition pattern is likely to be observed at ER2. The change in bank line shows rise from 1930 to 1988 and continued upto 1994. Thereafter, the change is remaining between 1800 m and 1900 m for 1999 and 2004 respectively.
