PLANNING OF COASTAL PROTECTION MEASURES ALONG KERALA COAST

Final Report

GOVERNMENT OF KERALA

DEPARTMENT OF OCEAN ENGINEERING
INDIAN INSTITUTE OF TECHNOLOGY MADRAS
CHENNAI - 600 036
AUGUST 2007

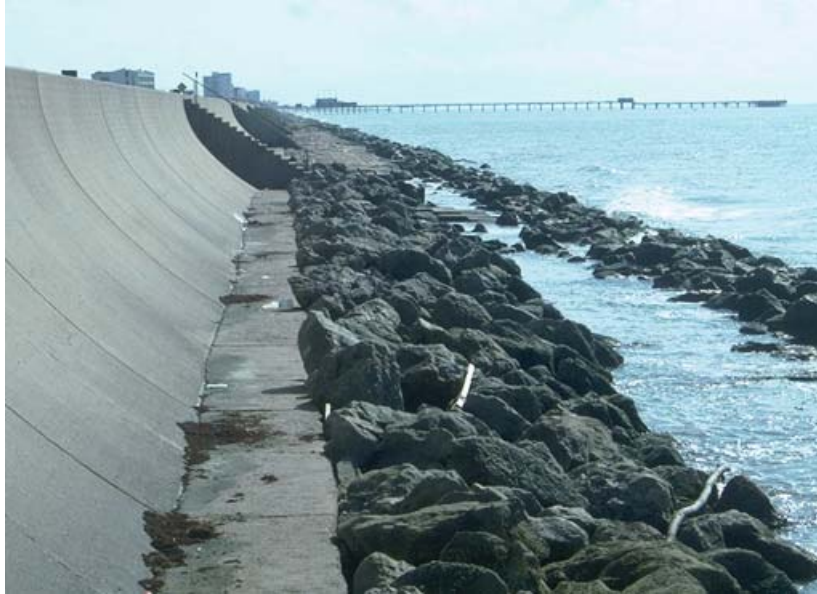
Photo. 1.1 View of a typical concrete seawall

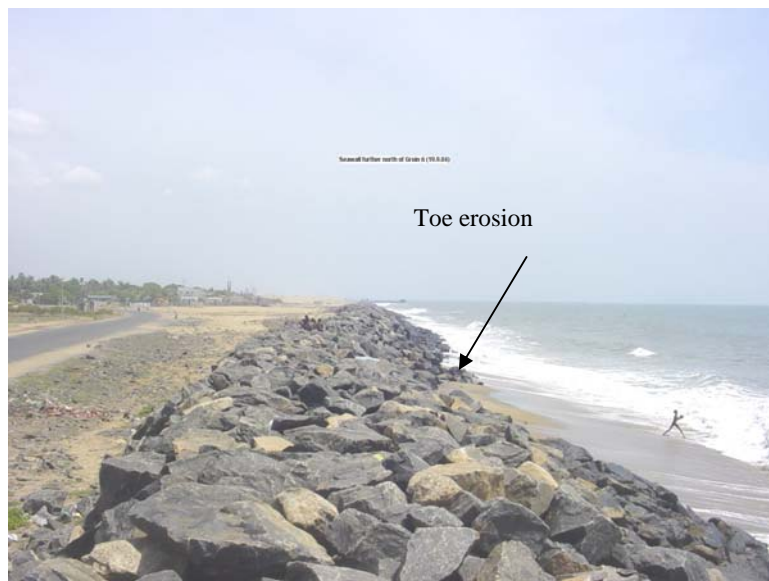
Photo. 1.2. Seawall beyond Ernavur experiencing toe erosion

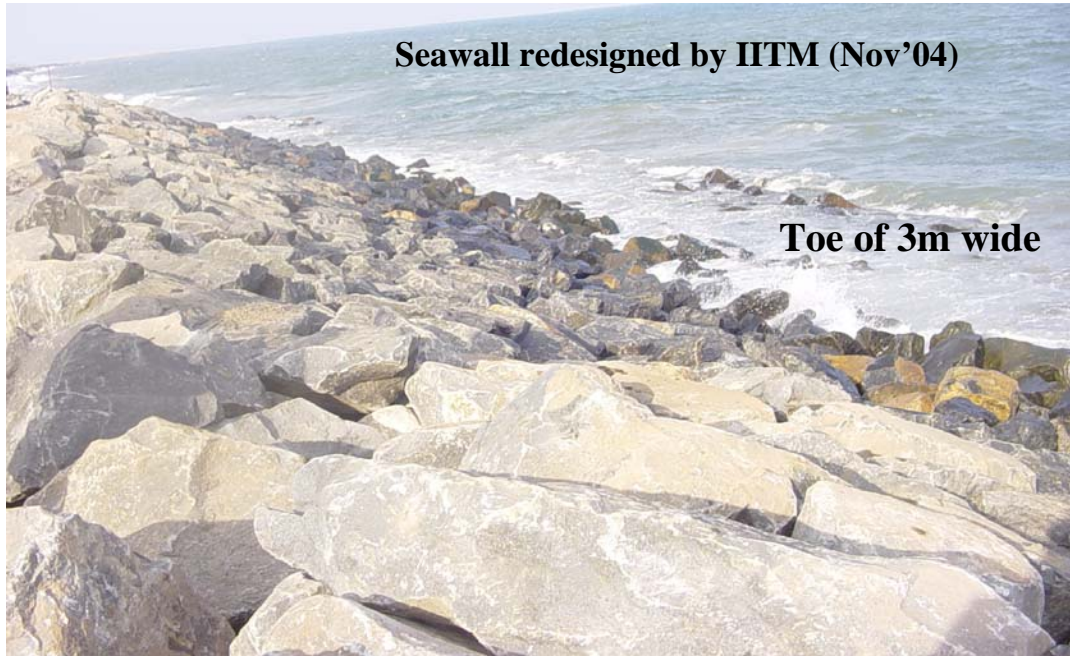
Photo. 1.3 Seawall with toe protection north of Ernavur

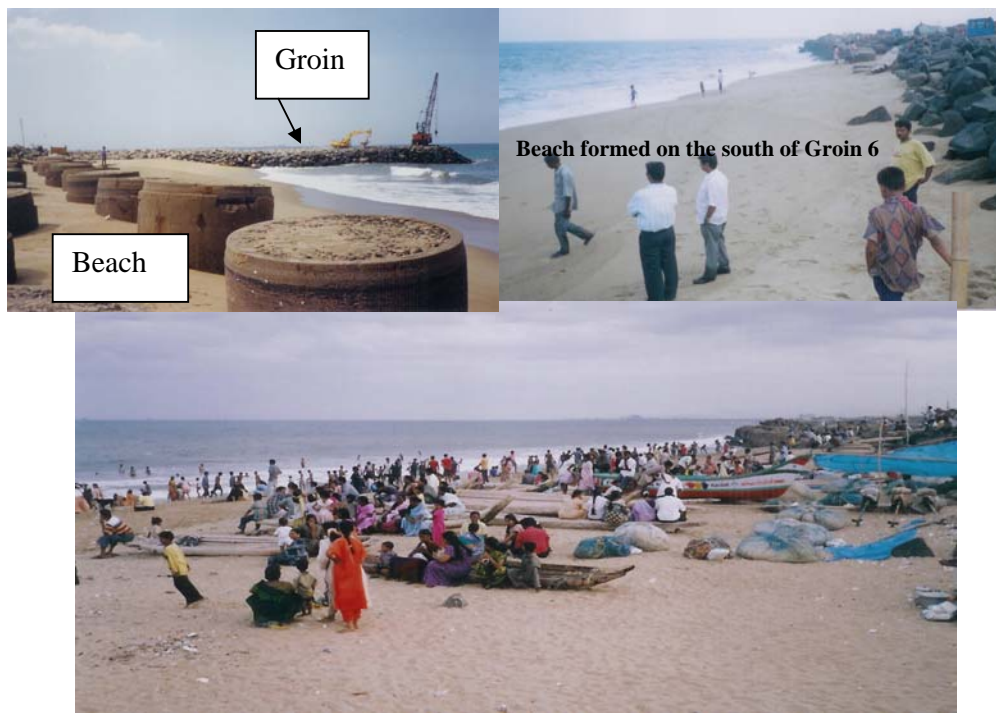
Photo. 1.10. Effect of Groin field in winning the beach (Royapuram, Chennai)

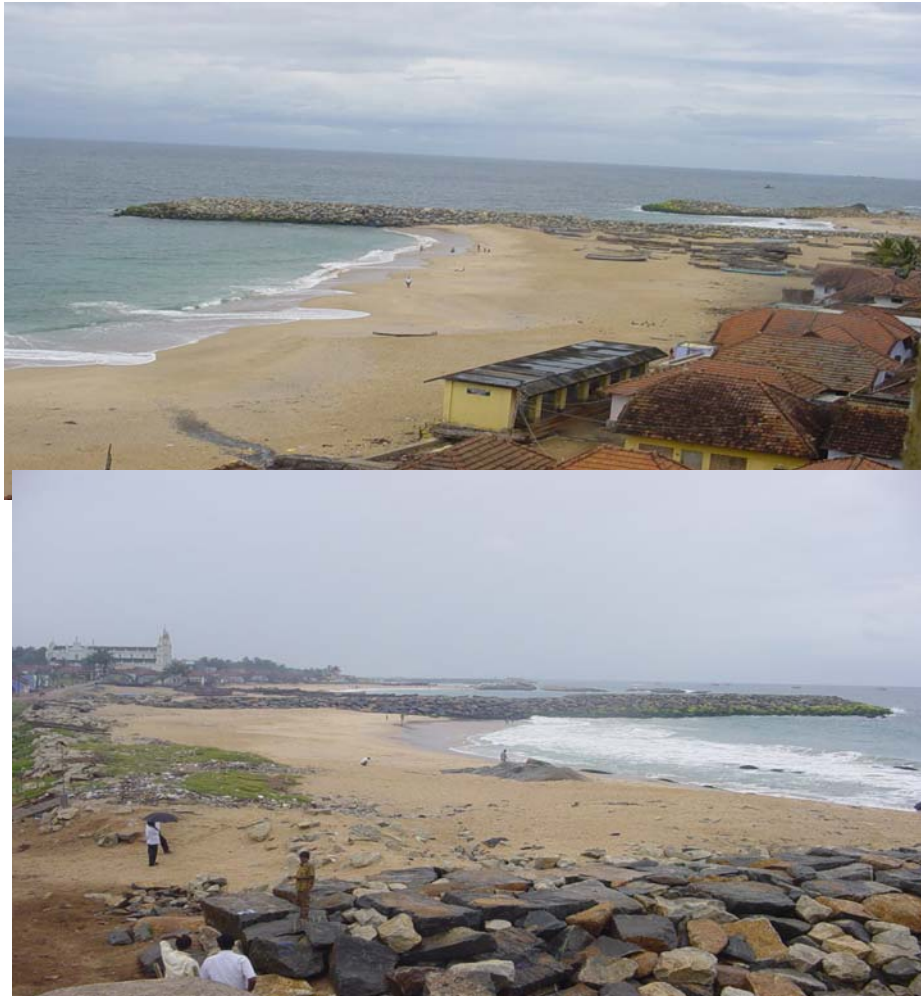
Photo.1.11. Effect of groins as an effective coastal protection measure (Kanyakumari District)

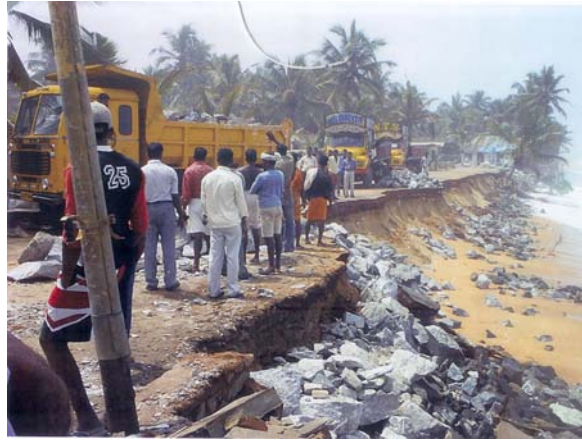
Photo 2.4 Erosion during monsoon seasons at Shankumukam

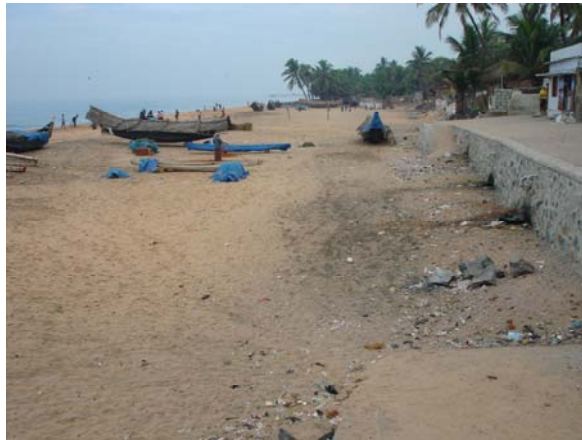
Photo 2.5. North of Beemapally

This site is south of Shankumukam beach and is densely populated. The views towards north and south from the beach are given in Photos 2.5 and 2.6. It has been reported that there is perennial erosion with maximum erosion occurring during the monsoon season of June – September. A stretch of the coast of about 200m along the coast abuts fishing

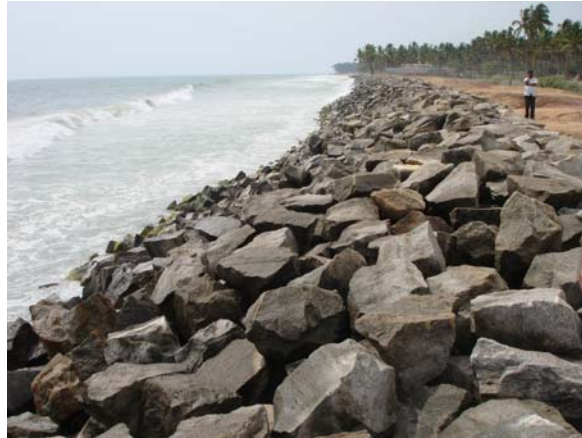
Photo 3.1. North of Kappil

The views showing the north and south of this stretch of the coast are given in Photos 3.1 and 3.2. This stretch has been already protected by a seawall and the present status of which along with the originally proposed cross-section is presented in Fig. 3.2. It is proposed that the existing seawall needs to be rehabilitated for a length of about 1.2km with a cross section as presented in Fig. A3 of Annexure A.

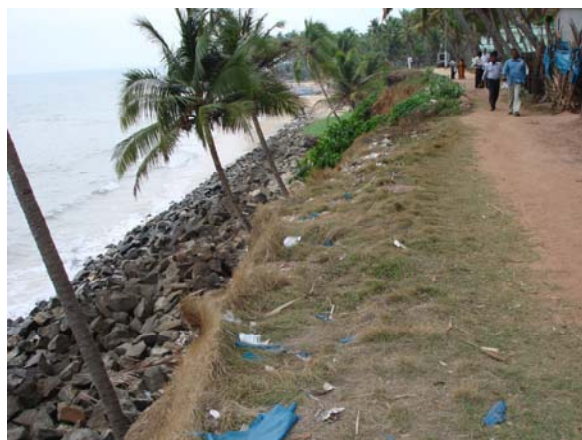
Photo 3.3. North of Chillackal

This stretch of the coast is characterized by laterite cliffs that are under continuous threat from waves similar to that near Varkala beach. The views towards north and south from top of the cliff are provided in Photos. 3.3 and 3.4. As a temporary protection measure, the KID has been dumping natural rocks from the top of the cliff. This dumping of stones does not withstand the aggravating wave conditions. Hence, it is recommended that for a stretch of about 740m, a seawall with gabion boxes be provided as depicted in Fig. 3.3. The gabion boxes may be placed from top of the cliff by means of cranes. An alternate option for this site could be provision of submerged geo-tubes filled with sand and laid parallel to the coastline in a water depth of about 5m as shown in Fig. 3.4. The details of

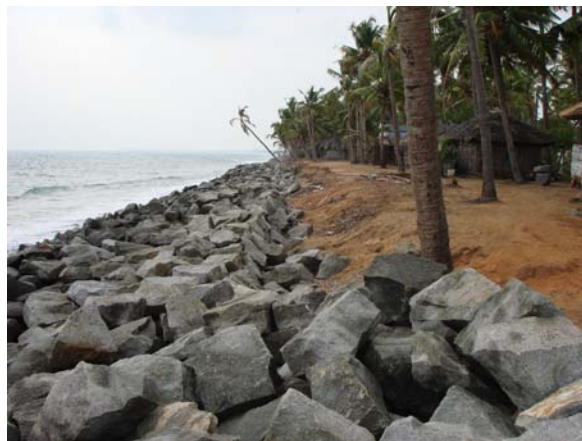
Photo 3.5. North of Thanni

This stretch of the coast spans between Thangasseri harbour on the north and Paravoor / Pozhikkari on the south. The view from the above location looking towards the harbour is shown in Photo 3.5 and looking towards Paravoor is given in Photo 3.6. A coastal road from Quilon to Paravoor has been proposed to be laid by the state government. Hence, the stretch needs appropriate protection from coastal erosion. The existing cross section of the seawall is shown in Fig. 3.5 which is quite unstable due to the toe erosion. As a short-term measure, the existing seawall needs to be rehabilitated with the cross section shown in Fig. A3 of Annexure A. As a long term measure, in order to also serve as a protection for the proposed road, is the construction of a groin field. The groin field is expected to encourage formation of a beach. Hence, the threat posed by the sea to the road and the shoreline could be nullified. A similar solution to a similar problem north of Chennai port has been proposed by IITM has yielded fruitful results. This information in the form of a technical paper is provided in Annexure-B. In addition, IITM has already proposed a groin field for this stretch of coast Paravoor/Pozhikkari based on a request from HED. The details of the proposed groin field are provided in Fig.3.6, which need to be taken up.

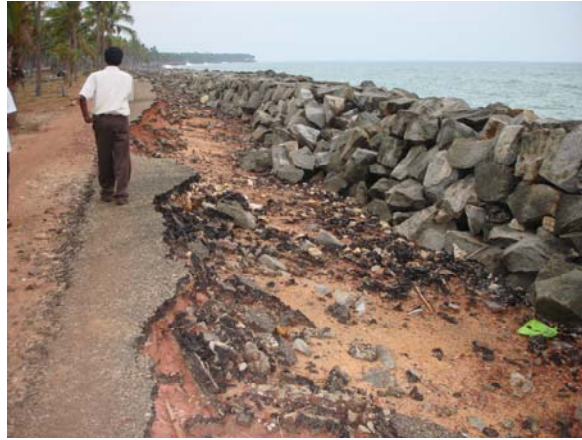
Photo 3.7. North of Mukham (North of Paravoor)

Extensive damages to the existing coastal road have been observed and the same is shown in Photo 3.7. It is also observed that the seawall has a vertical heel and the beach behind the seawall has being undermined. This is possibly due to percolation of water through the seawall from its leeside caused due to wave overtopping and rain water run off. This process will be dominant during monsoon seasons. This aspect is discussed in detail in Annexure-A. The vertical heel has to be modified as discussed in the above annexure.

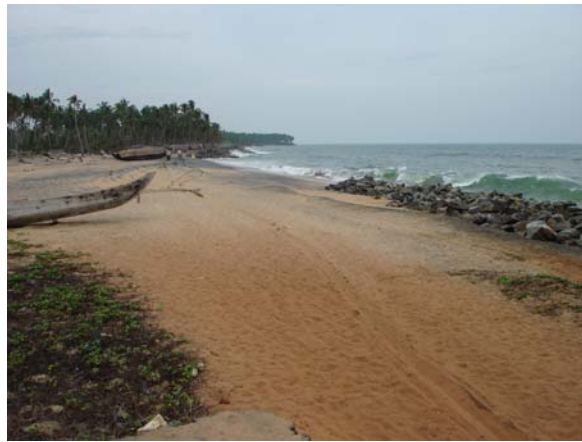
Photo 3.8. South of Mukham (North of Paravoor)

Further, south of this stretch is a virgin beach of about 150m in between the existing seawalls which is basically a fishing gap. Photo 3.8 depicts the current situation prevailing at this station. Basically two options exist. Option-1: Construction of a seawall designed by IITM as shown in Fig. A2 of Annexure A. Option-2: Develop this

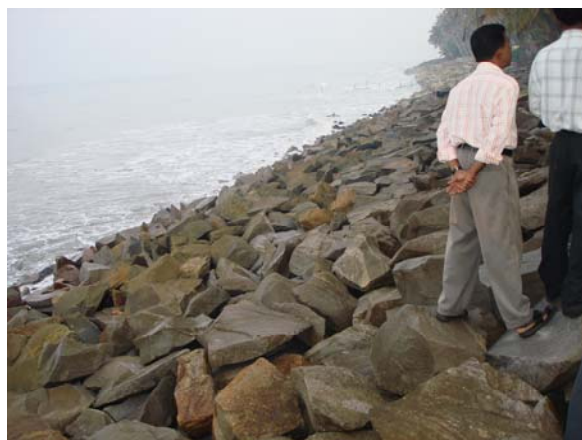
Photo 3.9. North of Maruthadi

The location of this site is north of Kollam and is thickly populated. This is almost a straight and stable stretch of coastline protected by a seawall for about 3.1 km. The seawall is in good condition as indicated in Photos 3.9 and 3.10. The originally adopted and the existing cross sections are given in Fig. 3.7. The major problem, as reported by KID, is the continuous wave overtopping during monsoon seasons. This area has also been flooded by tsunami. No replenishment of the exiting seawall is recommended. However, in order to reduce the overtopping, gabion boxes of size 1m x 1m x 1m should be provided as crown wall.

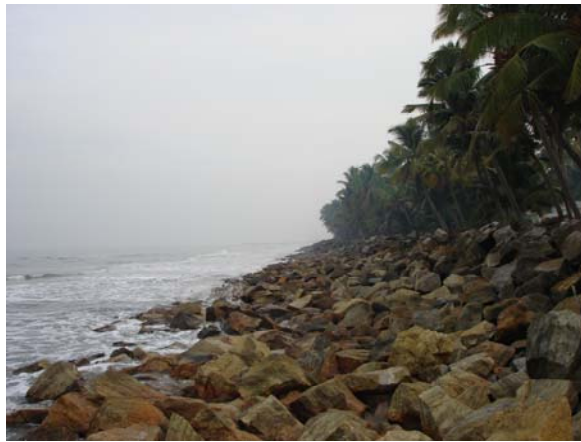
Photo 3.11. North of Valavilthoppu

Presently, a stable beach with a flat slope exists in this location. This stretch could be developed as a fish landing centre by providing appropriate protection from direct wave attack. The length of the beach stretch is 150m. Photos 3.11 and 3.12 provide an idea of the gap, abutted by the seawalls on the north and south. It is proposed that this virgin beach (Photo 3.12) be protected by a pair of groins as indicated in Fig. 3.8. The length of the groins should be such that the water depth at the head is about 3.0m.

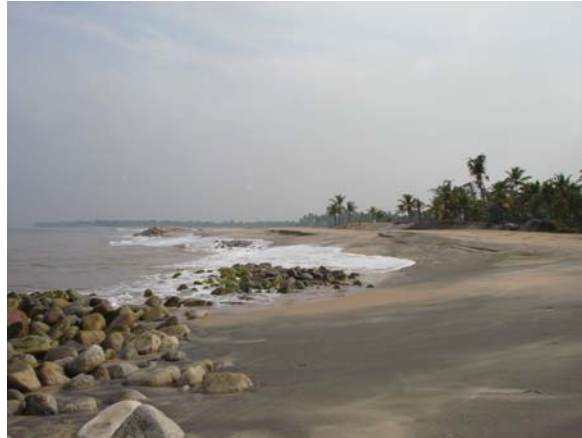
Photo 3.13. North of Panmana

The stretches of the coast north and south of the location are shown in Photos 3.13 and 3.14 respectively. This is an area in which sand is being mined at present by IREL & KMML. The mining is of the order of 1500m³/day as per KID. The best option for this stretch is to prevent excessive mining and there is no requirement for protection as of now. However, continuous mining carried out in this stretch of coast may lead to over exploitation resulting in the breach of the adjoining TS canal. As of now, no protection measure is suggested as IRE and KMML continue their mining activity in this area. Any suitable measure for this stretch of coastline could only be worked out after knowing proposed mining extent in this area.

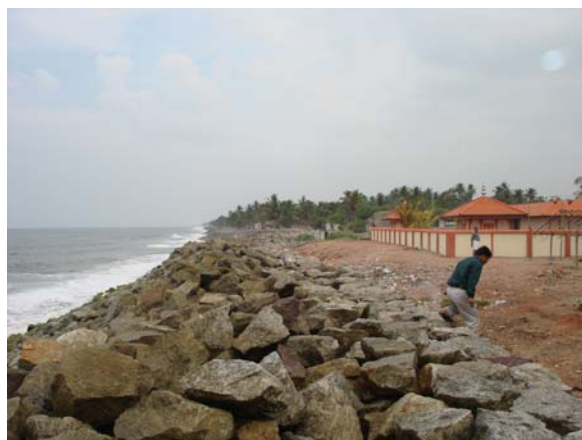
Photo 3.15. North of Cheriyaazheekal

The status of the existing seawall on the north and south of this location are shown in Photos 3.15 and 3.16. The size of the stones adopted during the execution of the seawall work is found to be small (<200kg). KID has informed the IITM team about the proposal of dredging the sand offshore and building a beach in front of the seawall which is pending since a long time. It is opinion of IITM team that this scheme would not serve as a long term solution, even though; it may be a temporary solution for the fair weather season. It is most likely that the sand deposited could be washed away along and offshore during high seasons. The cross section of the existing seawall is shown in Fig. 3.9. The top level adopted for the present seawall is +3.0m resulting in frequent over topping added to which the flow water on its rear side during monsoon is expected to undermine the structure leading to the instability from its leeside too. The suggested rehabilitation for this stretch of the coast for a length of about 500m is given in Fig. A5 of Annexure A

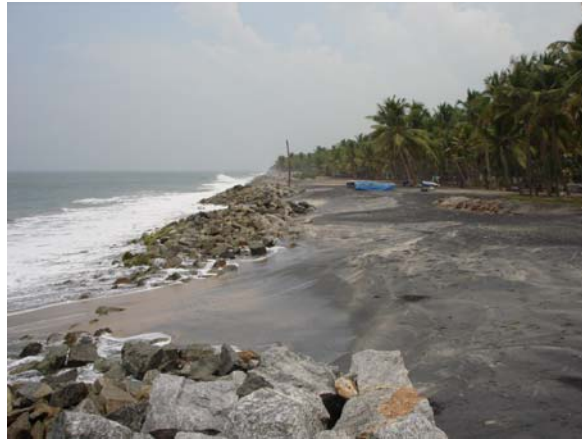
This stretch of coast is protected by a seawall and the views of which are shown in Photos 3.17 and 3.18. Portion of the seawall on the northern side of this stretch of coast has been breached as can be seen in Photo 3.19. On the southern side of this stretch of coast, the toe of the seawall is being eroded leading to its instability. Moreover, the entire landside of the seawall is vertical with frequent overtopping resulting in undermining of the structure. The present cross-section of the seawall is shown in Fig. 3.10. It is proposed that this stretch of the coast needs to be protected with flexible gabions for a distance of about 700 m. The details of the cross-section proposed are shown in Fig. A5 of Annexure A

Photo 3.17. Status of the seawall north of Srayikadu

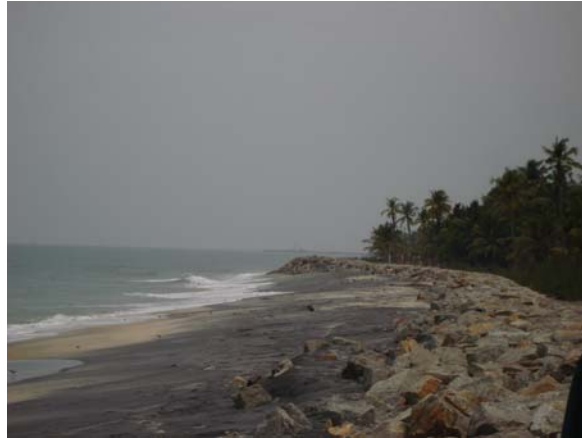
Photo 3.22. Status of the existing seawall at Jayanthi Colony

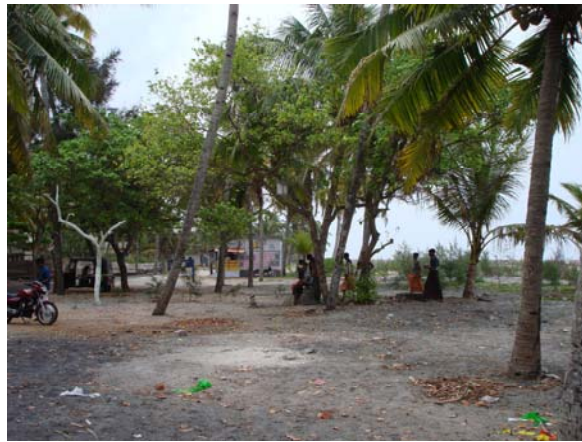
Photo 3.23. Stretch of the coast suitable for plantations

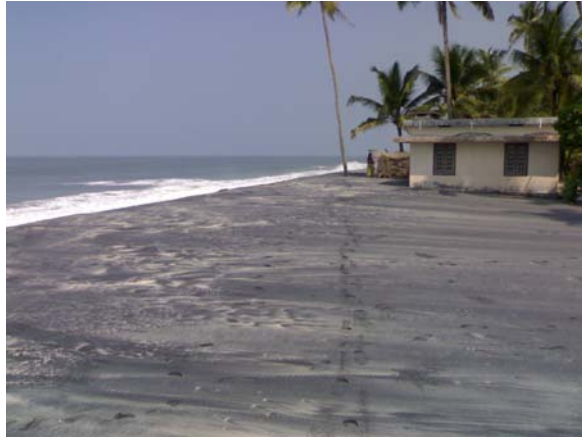
Photo.3.25 Flooding of the beach by sea water ingress near Kayamkulam

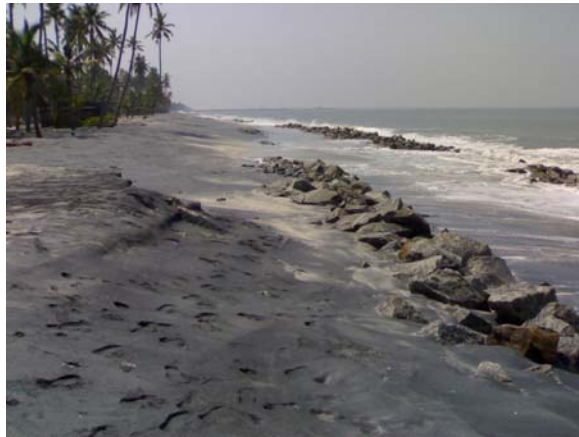
Photo.3.26 Remains of the seawall near Kayamkulam

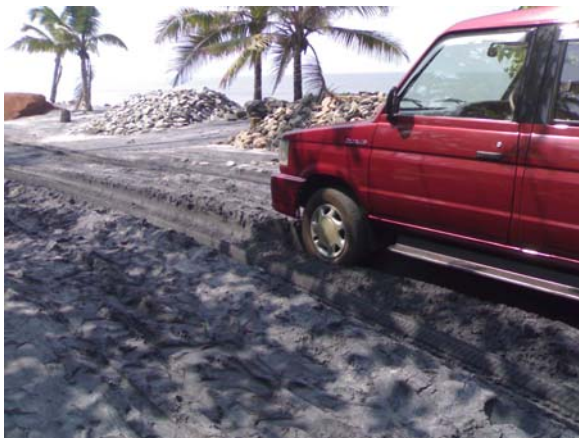
Photo.3.27 Overtopping of sand over the existing seawall near Kayamkulam

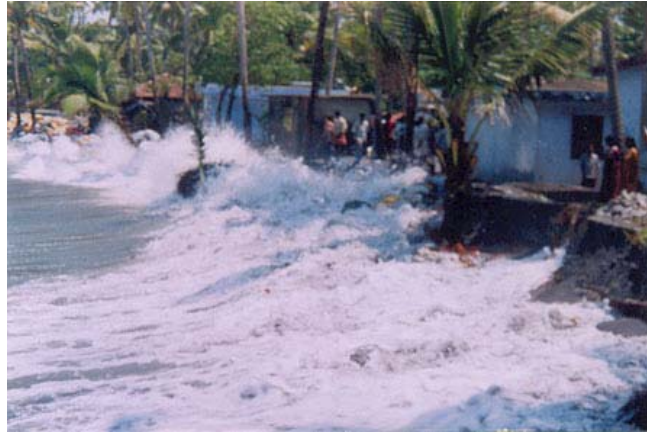
Photo.3.28 Ingress of sea water responsible of the coastal erosion near Kayamkulam

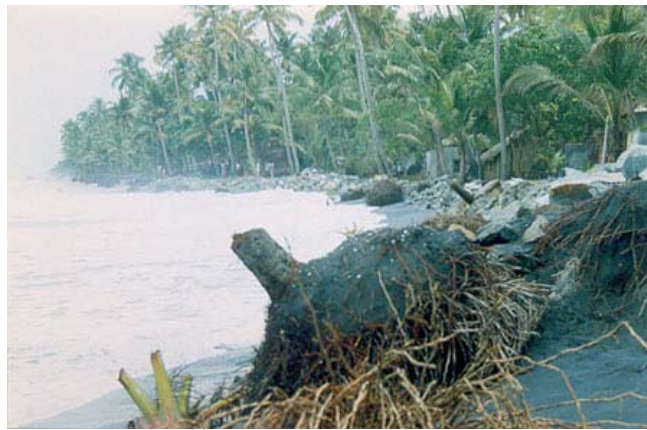
Photo.3.29 Coastal erosion near Kayamkulam during storm

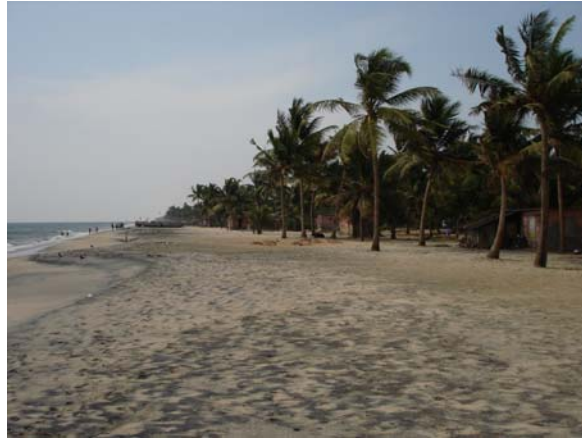
Photo 4.1. North of Kakkazham

This stretch of coast has been experiencing perennial erosion and a temporary measure of a seawall has not provided sufficient protection against the erosion. The condition of the site is depicted in the views towards north and south of this stretch of coast as shown in Photo. 4.1 and 4.2. The total stretch of coast that is experiencing perennial erosion along this coast is of length about 1.9 km out of which only 60 m will be covered under this plan as the protection measure for the remaining stretch of coast has already been finalized in 12th finance commission plan for which the design has been finalized and work contract is awarded. IITM proposes a new seawall with improved cross-section as shown in Fig. A7 of Annexure A.

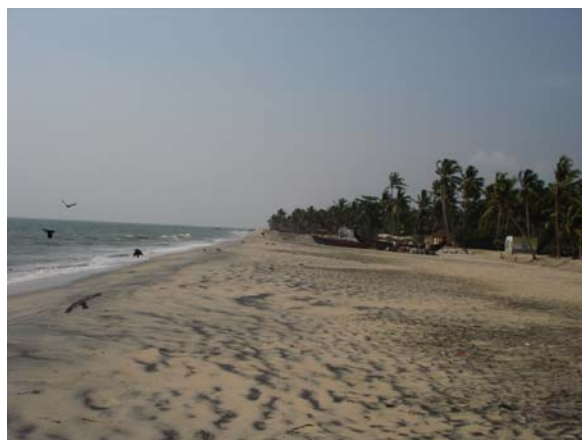
Photo 4.3 North of Neerkunnam

This stretch of the coast is being protected by a fairly stable seawall of cross-section shown in Fig. 4.2. Typical views towards north and south of this stretch of coast are shown in Photos. 4.3 and 4.4. A beach of width of about 20 m was found during the site visit as can be seen in above photos, which as per the KID, will be lost during the monsoon seasons. Hence, the existing seawall, for a length of about 350 m has to be rehabilitated with the cross-section designed by IITM and of increased crest level of seawall (+4.3 m) as shown in Fig. A5 of Annexure A.

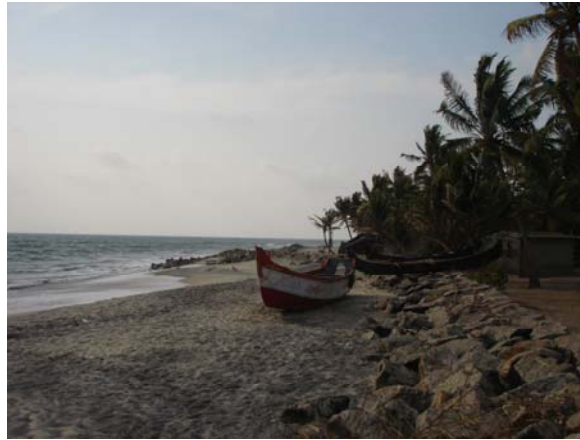
This stretch of the coast is presently protected by a seawall for a length of about 735 m. However, currently the seawall is completely damaged. The extents of the damages of the seawall are shown in Photos. 4.8 and 4.9. The original cross-section and the present status of the seawall are presented in Fig.4.3. In order to improve the situation, it is proposed that the existing seawall be rehabilitated with the cross-section proposed by IITM as shown in Fig. A4 of Annexure A.

Photo 4.8. Existing seawall north of Punnapra

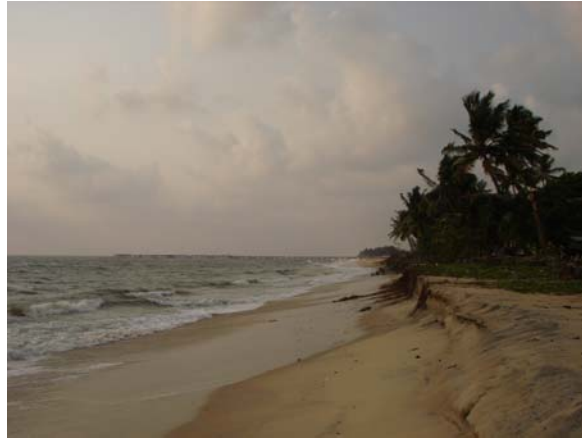
This is a stretch of unprotected sandy coast of length of about 200m (Photo 4.10 and 4.11). The new cross section of seawall for this 200m stretch has to be selected from Annexure-A based on available beach width at the time of construction.

Photo 4.10. Status of the beach at Vadackal North

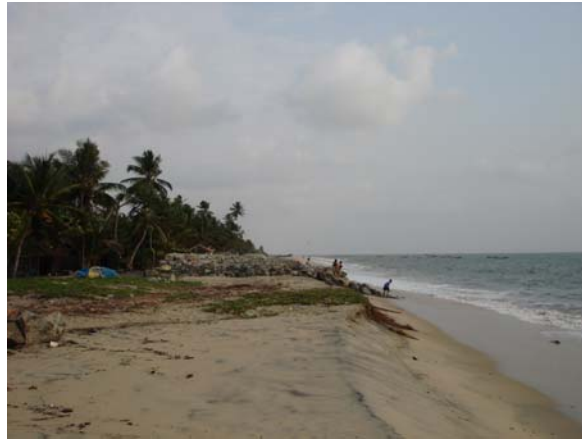
Photo 4.11. Existing seawall at Vadackal North

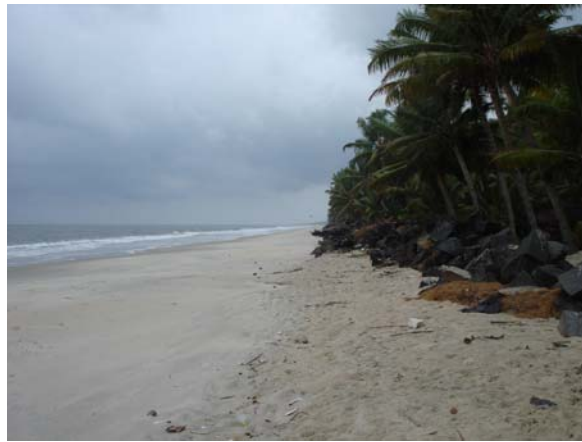
Photo 4.17. North of Kadakkarapally

This stretch of coast is densely populated and is protected by a seawall. Typical views towards north and south of the above site are shown in Photos 4.17 and 4.18.. Reformation of the damaged seawall is not necessary as of now. A beach of width of about 20 m is available at this site. T-groins are suggested for this stretch of coast of length of about 1.0 Km. The details of the suggested protection measure is as shown in Fig. 4.5.

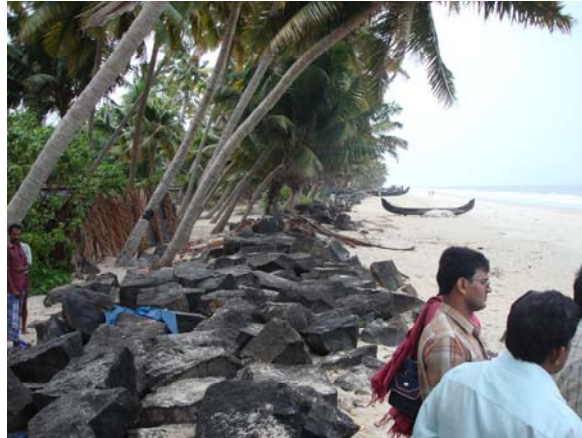
This stretch of coast was affected to a moderate extent during tsunami. The existing seawall is in a damaged condition (Photo. 4.19). It is proposed that the existing seawall be rehabilitated for a length of 122 m with a modified top level of +4.0 m. The details of the cross-section of the proposed seawall is shown in Fig. A5 of Annexure A.

Photo. 4.19. Breached seawall at Andhakkaranazhy south

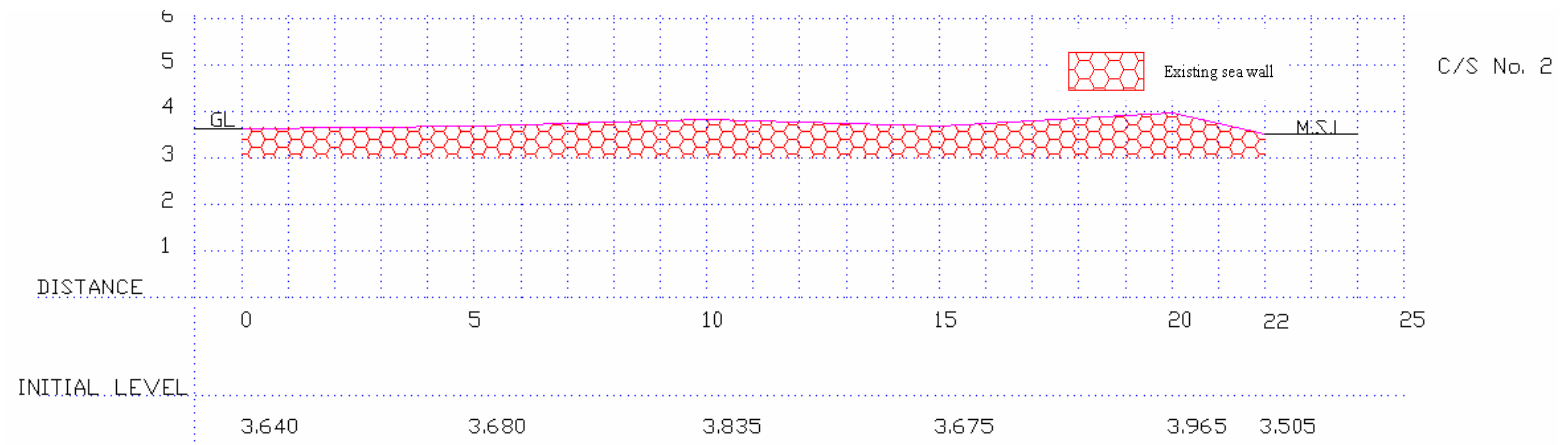
Fig. 4.2. Cross-section of the existing seawall (as per KID) at Neerkunnam

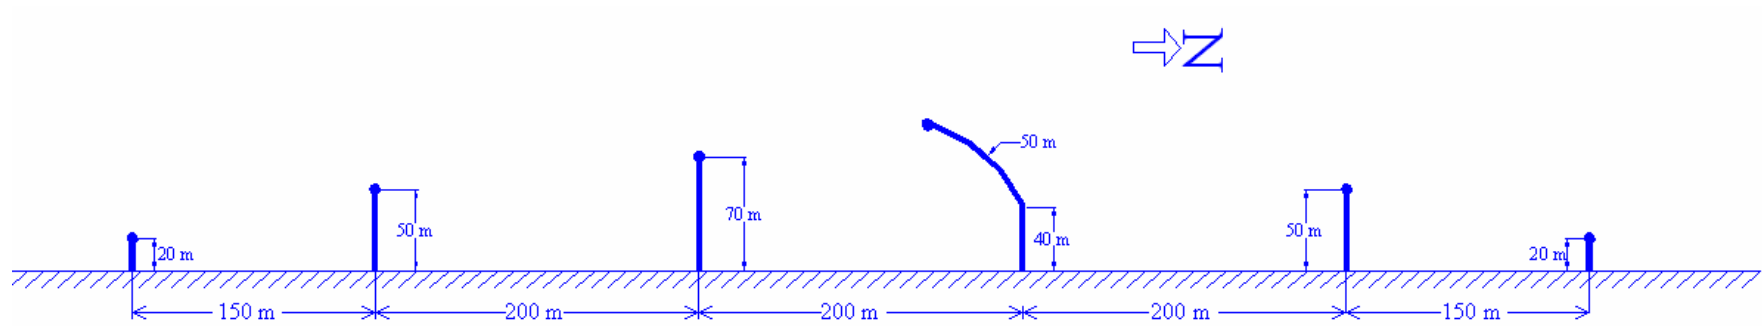
Fig. 4.4. Proposed Transition Groin field for the coast of Kattoor

Transition groins either with natural stones or gabions are recommended for this stretch of coast. There is an existing fishing gap and hence the protected space in between groins can be effectively used for fishing activities. The details of the suggested protection measure are shown in Fig. 4.4.

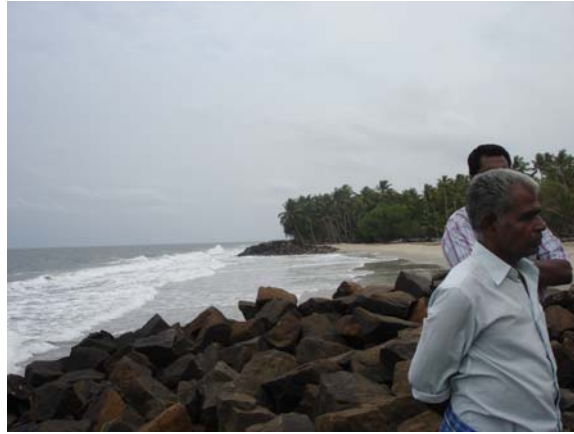
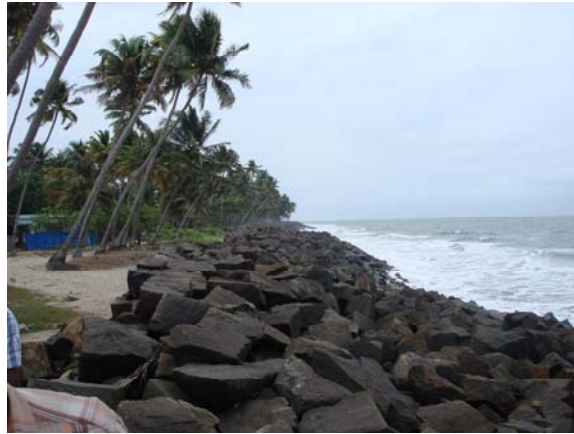
Photo 5.1. View towards North of Gunduparambu

This stretch of the coast is thickly populated. The views of this stretch of the coast towards north and south are shown in Photos.5.1 and 5.2. The original cross-section adopted and the cross-section in existence as of now at this stretch are superposed in Fig.5.2. The top level of the existing seawall is +2.8m. This is inadequate protection against the normal waves and in particular against extreme events. It is proposed that the existing seawall be reformed with a new cross-section designed by IITM and shown in Fig. A4 of Annexure A. The top level of the reformed seawall is to be maintained at +4.2m keeping in view the wave attack at this particular stretch of coast.

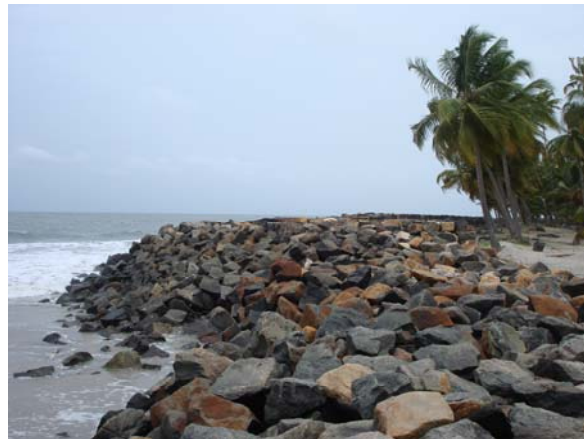
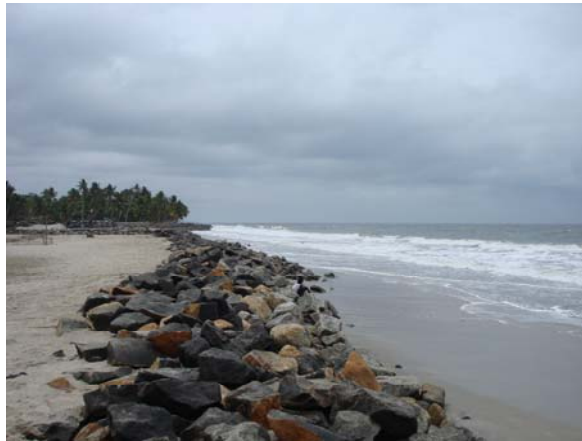
Photo 5.3. View towards North of Kandekadu

The views towards north and south of this stretch are shown in Photos. 5.3 and 5.4. The fishing gap between the existing seawall, is under erosion particularly, during monsoon seasons. The waves surge onto the beach in this gap, resulting in unfavorable conditions

for the fishing vessels. Hence, it is proposed to protect this stretch with two numbers of groins at a distance of 350 m apart as shown in Fig. 5.3.

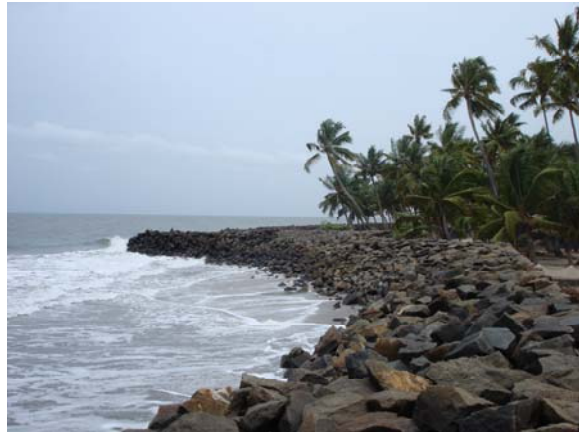
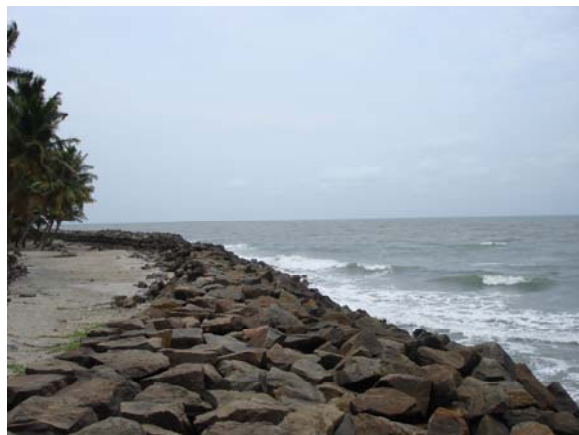
Photo 5.5. View towards North of Maravukadu

This stretch of coast is about 300m in length and is already protected by a seawall. The typical views of the existing seawall are shown in Photos 5.5 and 5.6. The original cross-section adopted and the cross-section in existence as of now at this stretch are superposed in Fig.5.4. It is proposed to replenish the existing seawall with a cross-section as shown in Fig. A4 of Annexure A. The top level of the replenished seawall is kept at +4.0 m.

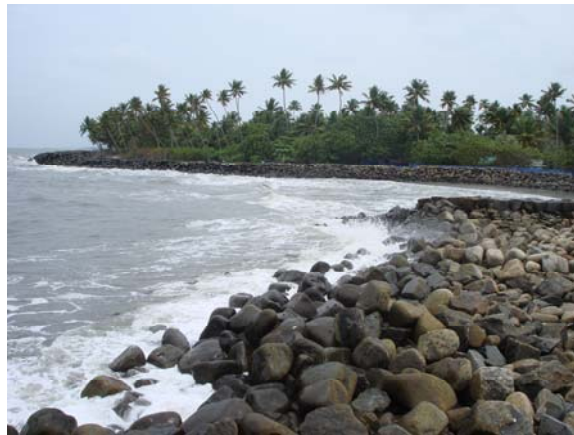
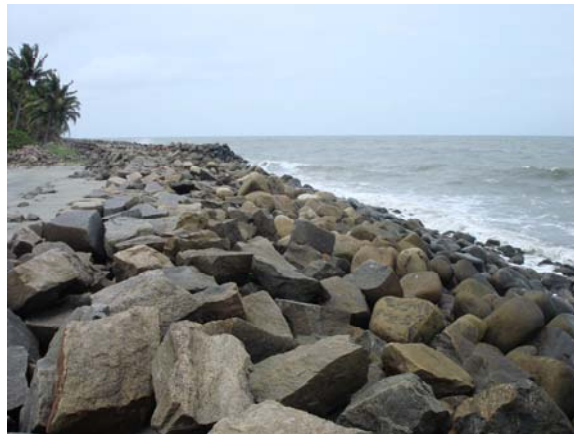
Photo 5.7. View towards North of Kannamazhy

The views of the existing seawall protecting this stretch of coast are shown in Photos 5.7 and 5.8. The seawall has breached for a length of about 30 m. The original cross section of the seawall and the cross-section in existence as of now are superposed in Fig.5.5. It is proposed to replenish the existing seawall Fig. A4 of Annexure A. Further south of this stretch, a length of the coast of about 120 m protected by a seawall is in damaged condition. It is proposed to replenish this seawall with a modified cross-section of top level +4.0m as shown in Fig.5.6. Photo 5.9 shows the damages to the seawall protecting the coast north of the above location. This seawall needs to be replenished with a cross-section as shown in Fig. A4 of Annexure A. Further, it is proposed that a groin for a length of about 220 m is to be constructed to protect the fishing gap from sand accumulation.

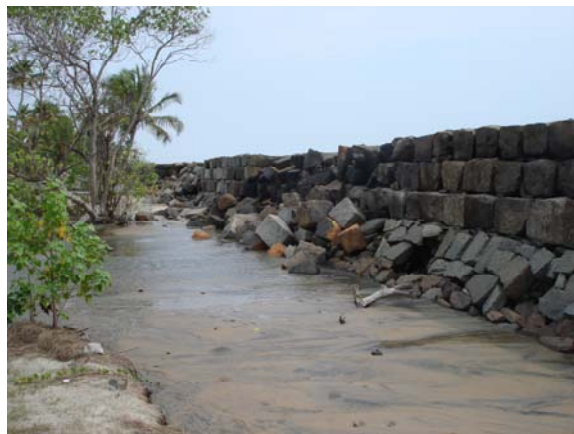
Photo 5.12. shows continuous seeping of sea water through Seawall

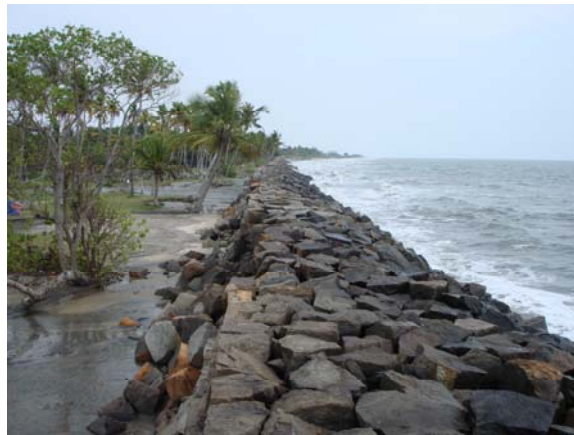
Photo 5.13. shows continious seeping of sea water through Seawall

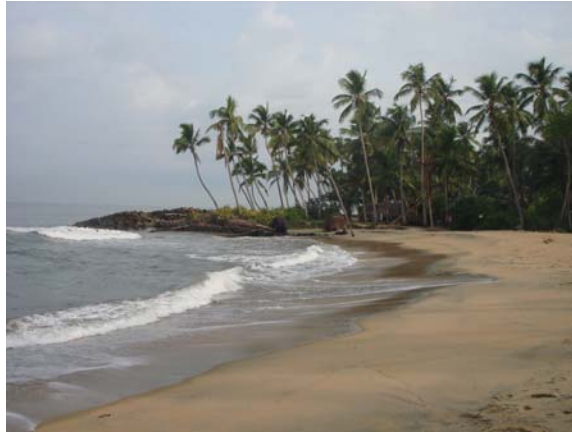
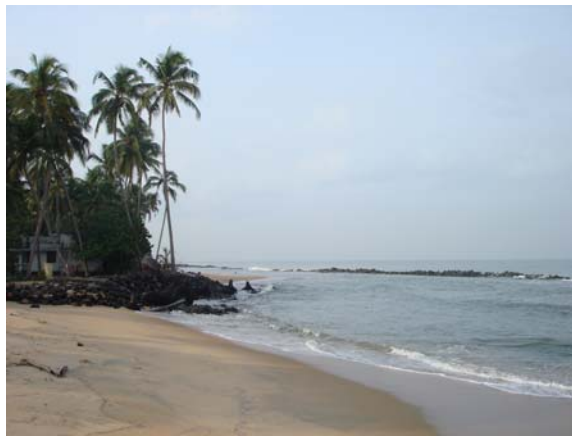
Photo 6.3. View towards north of North Anchangadi

Further north of the Anchangadi, it is observed that the seawall which was constructed earlier, the cross-section of which is shown in Fig. 6.3 has been reduced to an offshore breakwater. The existing cross-section of the seawall at this location is shown in Fig. 6.3. The view towards north and south of this stretch of coast which is thickly inhabited is shown in Photos 6.3 & 6.4. It is recommended that the existing seawall needs to be modified with a cross-section of Fig.A5 of Annexure A.

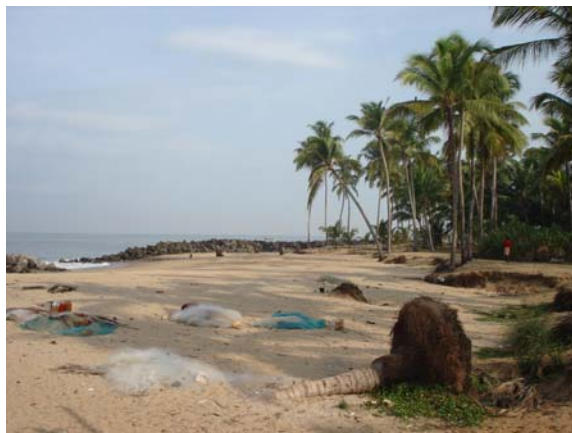
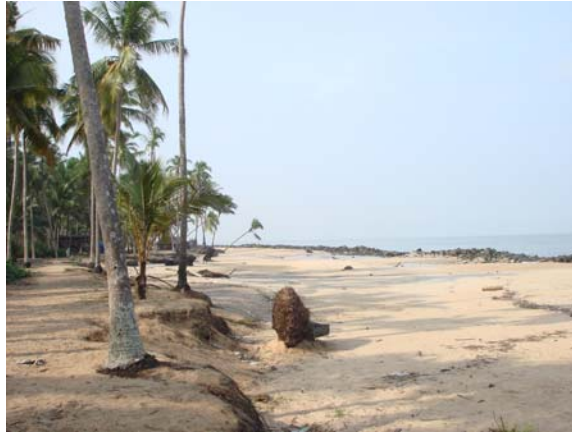
The views towards north and south of this stretch of the coast are shown in Photos 6.5 and 6.6. The cross-section of the existing seawall is shown in Fig. 6.4. It is recommended that the existing seawall be modified with a cross-section of Fig.A5 of Annexure A as discussed earlier.

Photo 6.5. View showing the breached seawall at Koolimuttam

Photo 6.6. View towards south of Koolimuttam

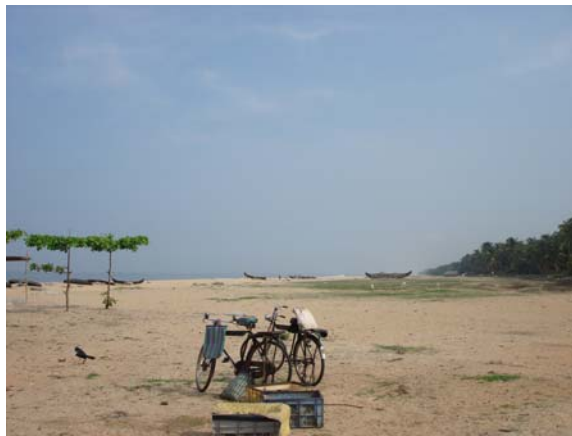
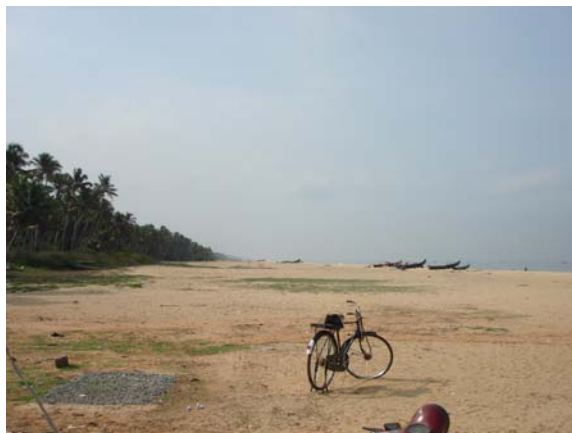
This stretch of coast is flourishing with fishing activity. The view towards north and south of this stretch of coast are shown in Photos. 6.7 & 6.8. The photographs indicate the busy fishing activity. It is proposed that this site can be developed as a fishing harbour / fish landing facility. The details of which will have to be worked out later.

Photo 6.7. Fishing activity at Koorukuzhi

Photo 6.8. View towards south of Koorukuzhi

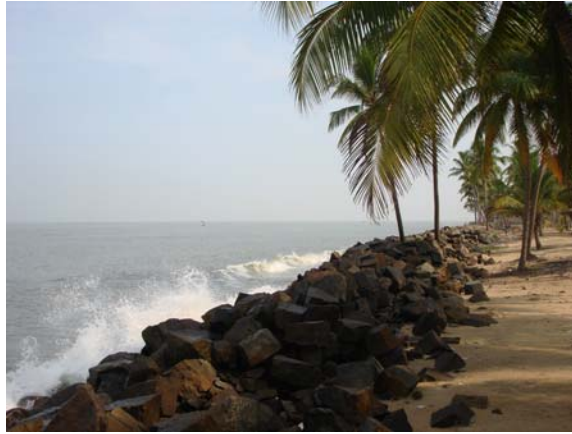
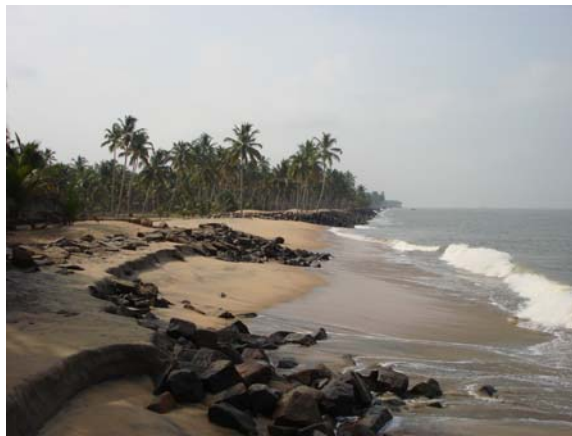
Photo 6.9. View towards north of Perinjinam

The status of the seawall north and south of this location is given in Photos 6.9 & 6.10. The original cross-section that was adopted and the cross-section at present are shown in Fig. 6.5. It is recommended that the existing cross-section of the seawall needs to be reformed with a cross-section of base width 12 m designed by IIT Madras which is given in Fig.A3 of Annexure A.

Photo 6.10. View towards south of Perinjinam showing the breached seawall

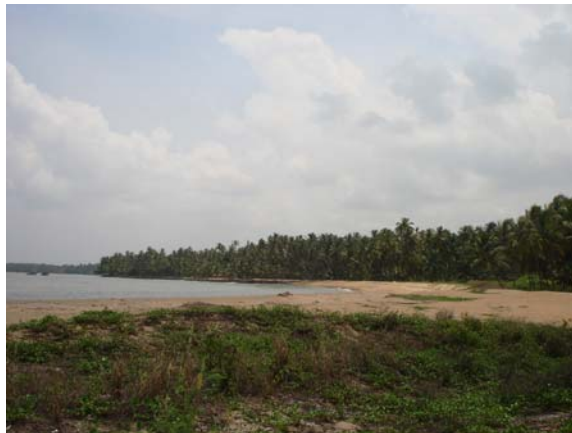
Photo. 6.11 shows the damaged portion of the seawall protecting the Island Bangalakadavu near the fishing harbour. A view of the Island Chettuva Azhi is shown in Photo. 6.12. It is proposed to rehabilitate the existing seawall with a cross-section of base width of about 12m designed by IIT Madras as shown in Fig.A3 of Annexure A.

Photo 6.11. View showing the breached seawall at Island Bangalakadavu

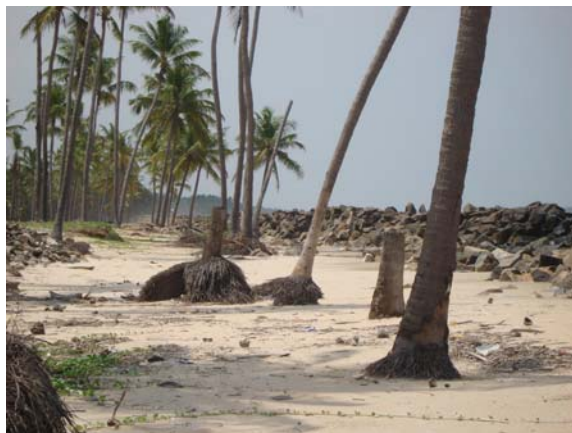
Photo 6.13. View towards north showing the existing seawall at Chettuvai

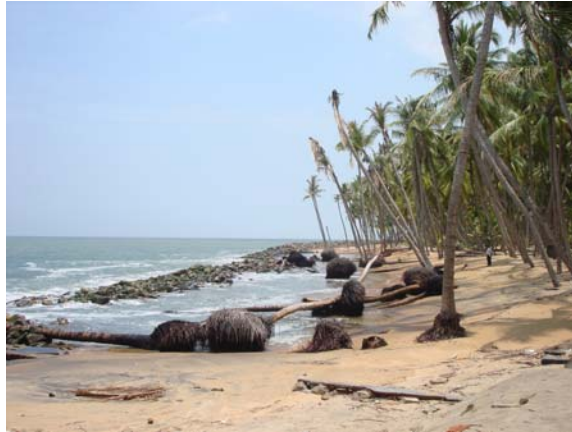
Photo 6.14. View towards south showing the breached portions of seawall at Chettuvai

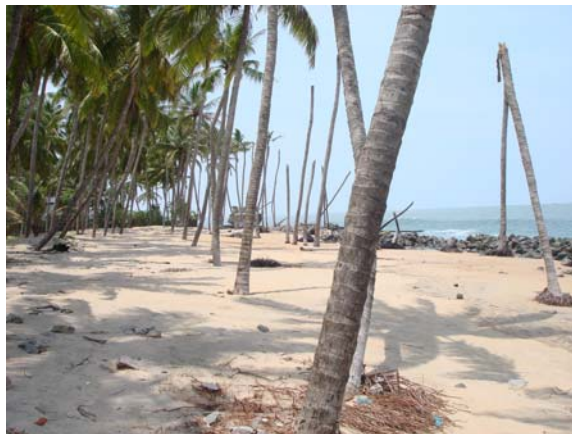
Photo 6.15. View towards north showing the breached portions of seawall at North of Chettuva Azhi

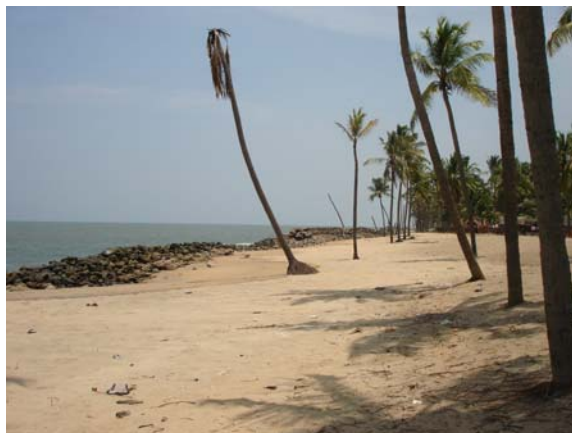
This stretch of coast is protected by a seawall which is in damaged condition. Typical views north and south of this stretch showing the status of erosion are shown in Photos 6.17 & 6.18. The shoreline is at a distance of about 30 m from the adjacent coastal road. Number of dwelling units is present in between the shoreline and the road. Hence, it is proposed to rehabilitate the existing seawall with cross-section designed by IITM of base width 12 m and top level of +3.30m as shown in Fig.A5 of Annexure. A.

Photo 6.16. View towards south showing the breached portions of seawall at North of Chettuva Azhi

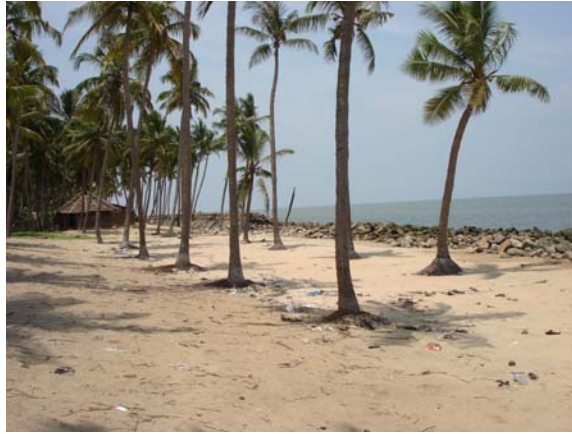
Photo 6.17. View towards north showing the breached portions of seawall at Anchangadivalavu
