PLANNING OF COASTAL PROTECTION MEASURES ALONG KERALA COAST

Final Report

GOVERNMENT OF KERALA

DEPARTMENT OF OCEAN ENGINEERING
INDIAN INSTITUTE OF TECHNOLOGY MADRAS
CHENNAI - 600 036
AUGUST 2007

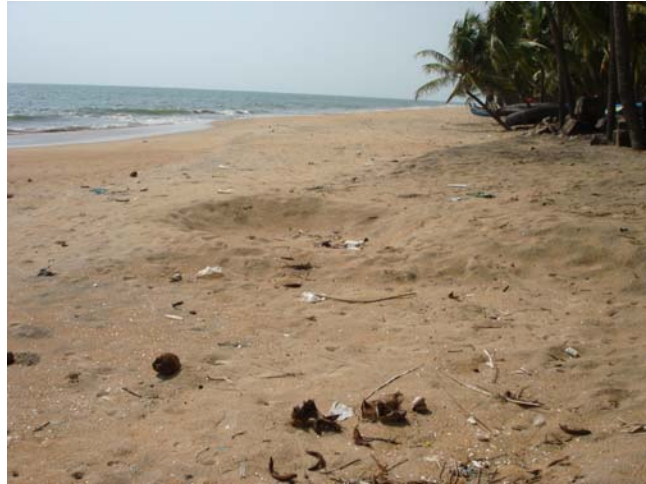
This location during the site visit is observed to have 30-40m of beach width. Typical views towards north and south showing the details of available beach are shown in Photos 7.1 & 7.2. The cross-section that was originally adopted by the KID is shown in Fig. 7.2, which is understood to have got sunk leaving only a few stones here and there. This stretch of the coast of length of about 4.0 km experiences littoral drift to an extent of about 0.5 Mm³/year directed towards the south. As the stretch of the coast is quite long and in order to trap the sediments and enable beach building up a T-groin field may be proposed which will be finalized only after a critical study. Added to the above, this will

Photo 7.1. View towards north of Kapprikad showing the existence of beach

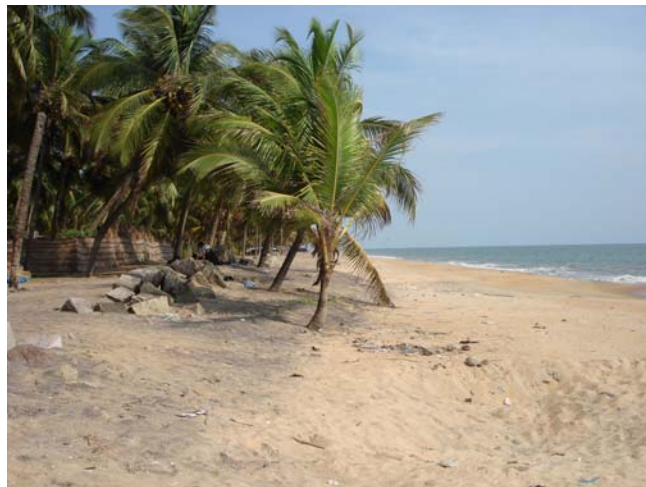
Photo 7.2. View towards north of Kapprikad showing the remains of seawall

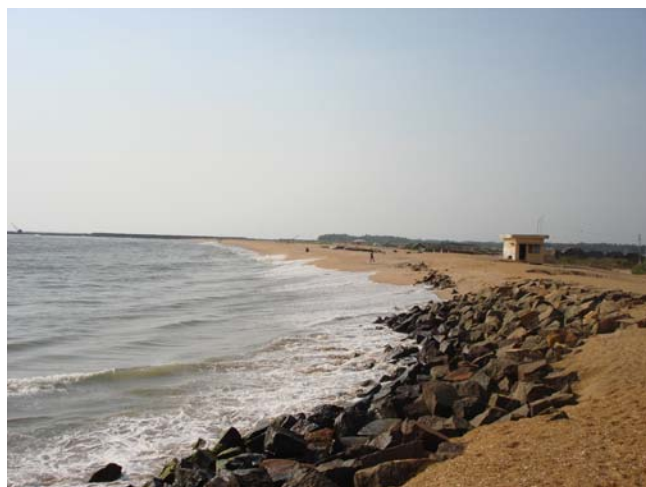
The erosion south of Ponnani harbour is due to the interception of the southerly drift by the breakwaters. The views towards north and south of this location are shown in Photos 7.3 & 7.4. The seawall constructed earlier along this stretch of coast is understood to have sunk as can be seen in the above photos. It is felt that the beach can be conserved as well as can be widened by provision of transitional groin field. The tentative layout of the proposed groin field is shown in Fig. 7.3.

Photo 7.3. View towards north showing the breakwater of Ponnani fishing harbour

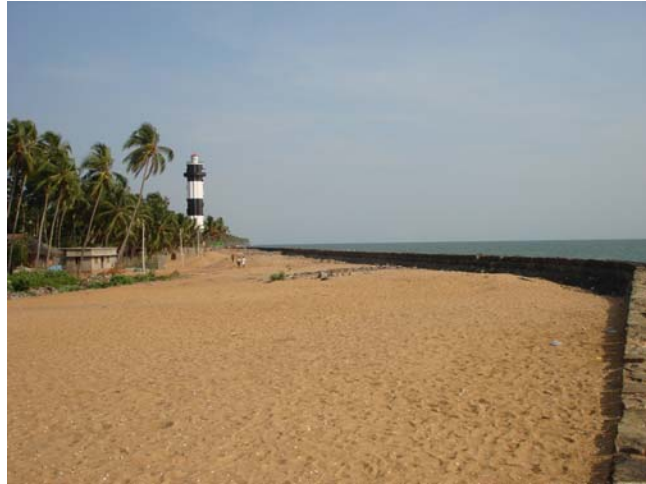
Photo 7.4. View towards south showing light house of Ponnani fishing harbour

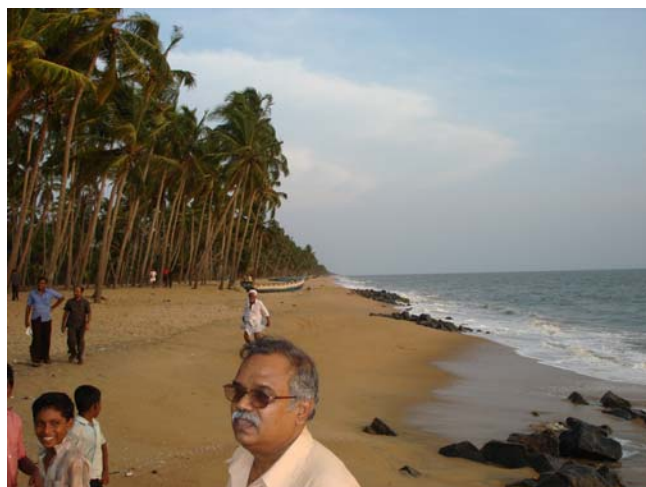
Photo 7.6. View towards south of Cheerankadappuram being showing remains of the seawall

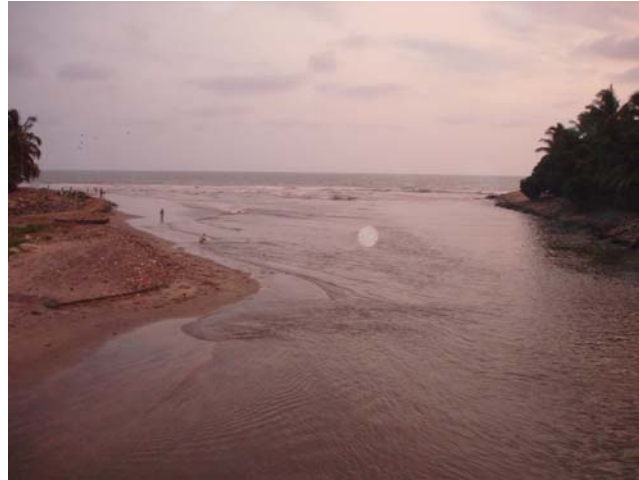
The entire flood water discharge from Calicut city drains into the Kallai river and in the event of chocking of the river mouth causes perennial problems. Typical views of the river mouth from the bridge under construction across the Kallai River are shown in Photos 8.1 & 8.2. A pair of training walls up to a water depth of about 6.0m is proposed for the prevention of sand bar formation due to the settling of sediment transported along the shore. The layout of the proposed training walls at the river mouth is shown in Fig. 8.2.

Photo 8.1 Kallai River mouth

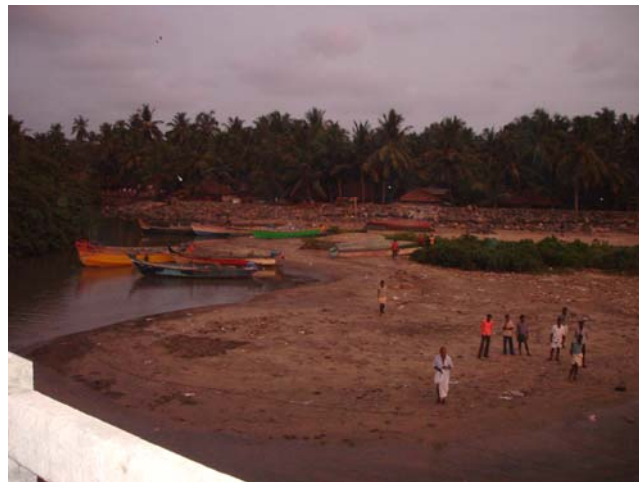
Photo 8.2 Sand depositions at the Kallai River mouth

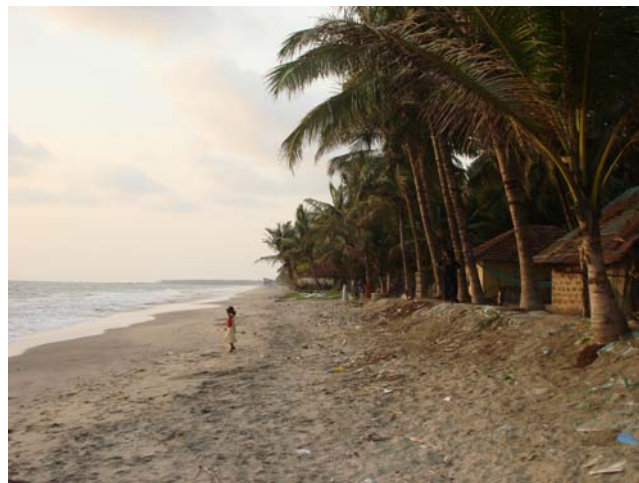
This stretch of coast was moderately affected during tsunami and is a severely eroding area. The status of the erosion along this site can be seen through Photos 8.3 & 8.4. This

Photo 8.3. View towards North of Butt road beach

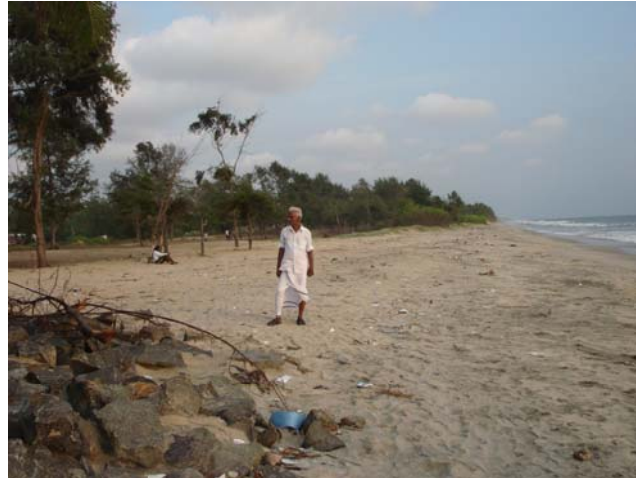
Photo 8.4 View towards South of Butt road beach

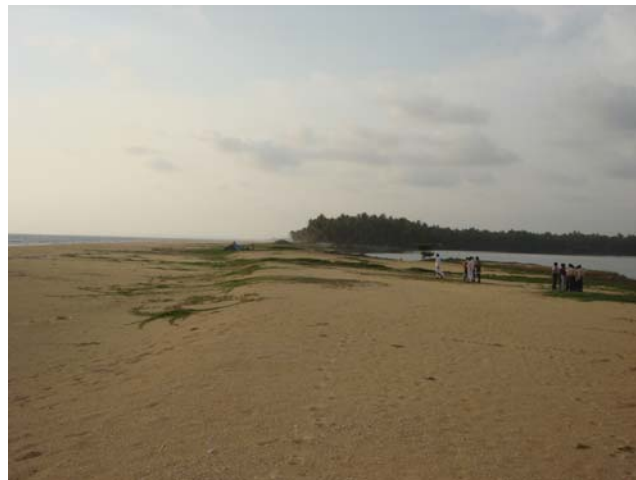
Korapuzha has had been a promising estuary for years which, unfortunately decreased due to the closure of the original mouth. The river mouth got shifted towards south over the years due to the formation of a spit owing to the southerly drift. The location of the old mouth is shown in Photo 8.5 and the existing mouth in Photo 8.6. In order to keep the mouth open there can be only one option which is the construction of a pair of training walls. For this purpose we have two locations mainly,

Photo 8.5 View towards North of Korapuzha

On the other hand, construction of the training walls near the existing mouth will lead to erosion of the private property on south which is rich in coconut plantations. Hence, the sand bar formed near the old mouth should be cut open over a width of about 100 m and a water depth of about 3m will be maintained at the site. The northern training wall will extend over up to a water depth of about 5m and the southern training wall up to 3m. The proposed scheme is shown in Fig. 8.3. The existence of an auction hall and a jetty will be an added advantage if the river mouth is kept open. If this project is implemented, the livelihood of the people will raise to greater heights.

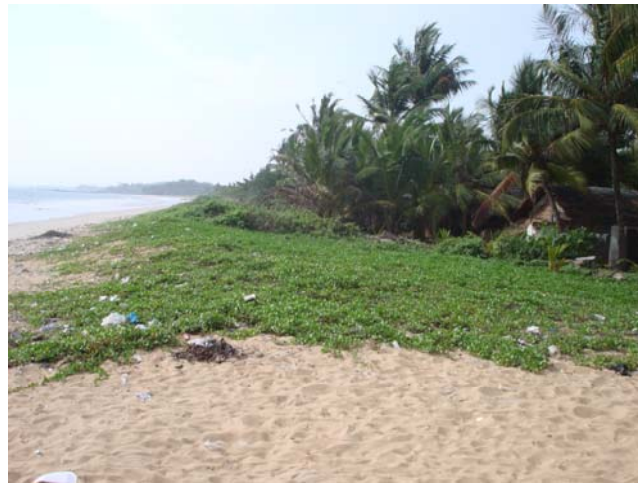
This stretch of coast is situated between Mahe on the north and Chombal fishing harbour on the south. This stretch of the coast is facing perennial erosion. Typical views showing the status of erosion at this site are shown in Photos 8.7 & 8.8. the KID has a proposal to protect this stretch of the coast with a seawall. IIT Madras recommends that seawall

Photo. 8.7 View towards north of Poozhithala

should not be planned for this stretch. Instead, in order to preserve and enhance the beach formation, a transitional groin field as shown in Fig. 8.4 is recommended.

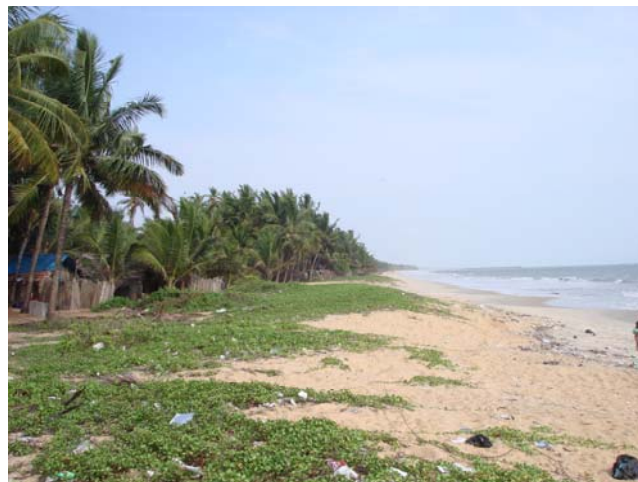
Photo 8.8. View towards south of Poozhithala

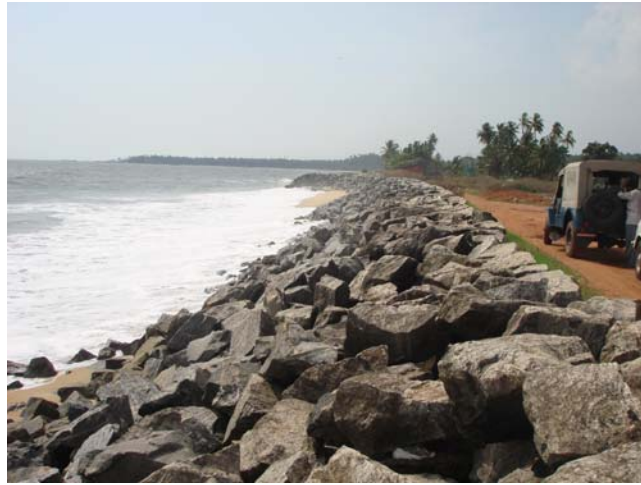
The Thalassery Municipality has a future plan to develop this area. A coastal road is in existence adjoining the seawall. The status of the existing seawall as well as the existing road on its land ward side can be seen in Photos 9.1 & 9.2. The present top level of the existing seawall is +3.64m which has to be raised by +0.4m in order to reduce wave overtopping. The existence of a small groin of about 10m length has clearly demonstrated the advancement of shoreline towards the sea as seen in the above photos. Hence, it is proposed to protect this stretch of coast for a length of about 800 m with a transitional groin field. The schematic representation of the above stretch of the coast along with the details of the proposed scheme of groin field is shown in Fig. 9.2.

Photo 9.1. View towards north showing seawall at Pettipalem

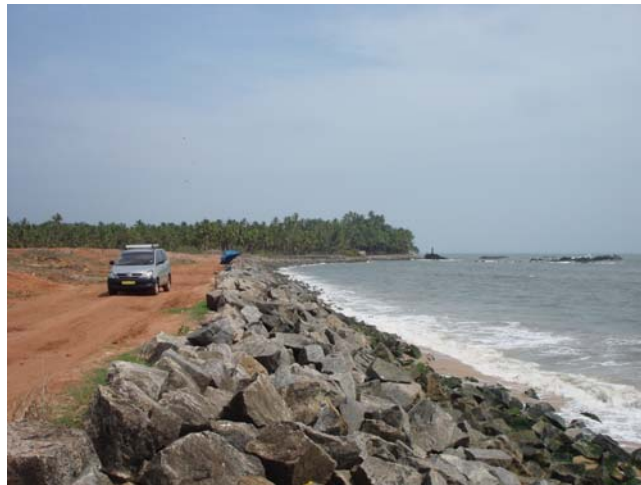
Photo 9.2. View towards south showing the coastal road at Pettipalem

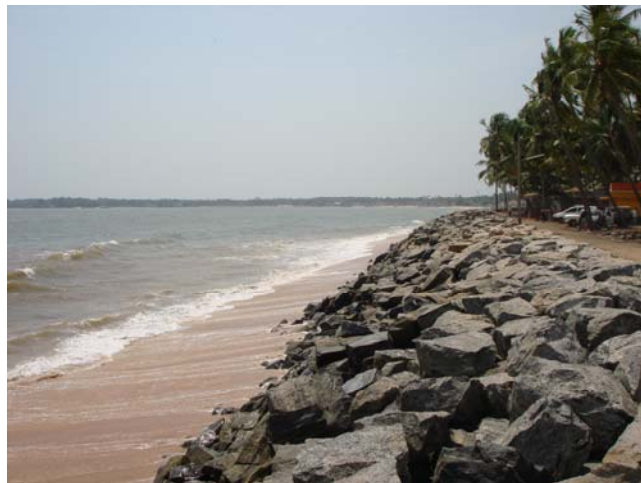
At this location, Kannampuzha river is discharging into the ocean. This site is 1.5 km south of Moplah bay fishing harbour. Typical view towards north of this site showing the headland close to Moplah bay and the existing seawall is shown in Photo 9.3. A view towards the south of this location showing the river mouth and the river (left side of the photo) is presented in Photo 9.4. Formation of sand bar at the confluence point of river and sea is shown in Photo 9.5. During the site visit, it was observed that the presence of the beach in front of the seawall is maintaining its stability to some extent. A coastal road on the landward side of the seawall needs to be protected by raising the top level of the existing seawall (+4.2) by another 1.0 m in order to reduce the continuous wave overtopping especially during monsoons. Reformation of the existing seawall has to be carried out with the KID funds. In addition, construction of two training walls near the mouth of Kannampuzha river will enhance the formation of beach on north of Northern training wall. The two training walls should preferably extend up to a water depth of 5m. The existence of two rocky out crops may also be utilized for this purpose as a part of the training walls. The layout of the training walls is shown in Fig. 9.3. The exact alignment of the training walls can be decided only after detailed numerical modeling and considering the data from KID to run the numerical model.

Photo 9.3. View towards north of Kannampuzha

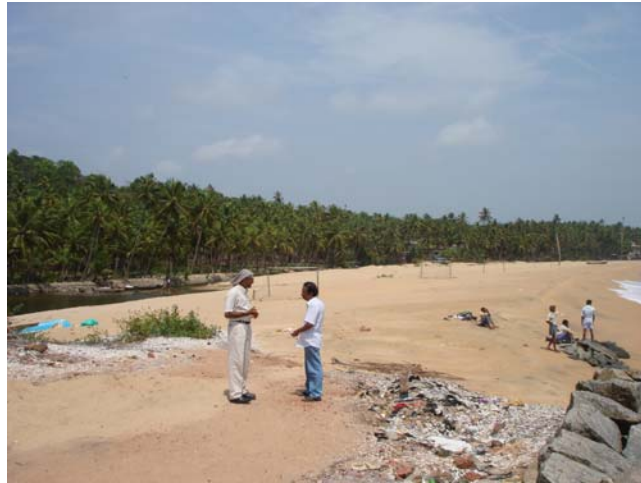
Photo 9.4. View showing the choked mouth of Kannampuzha river

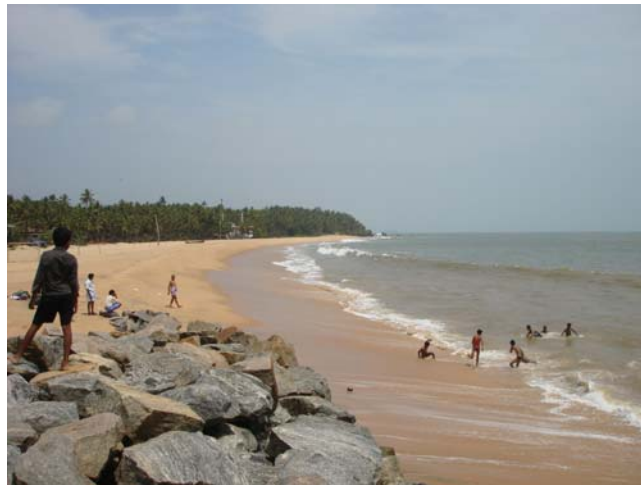
Photo 9.5. View towards south of Kannampuzha

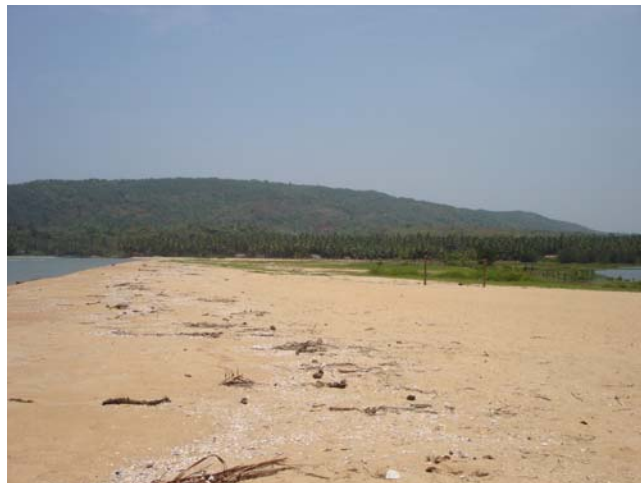
Photo. 9.6. Choked mouth of Choottad estuary

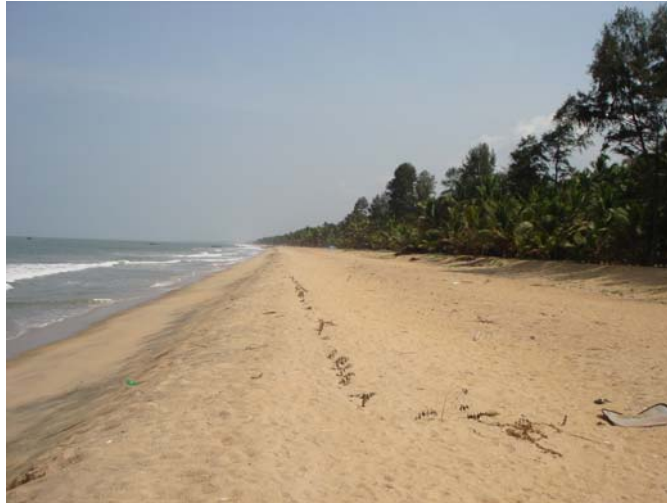
Typical views towards north and south of this site are shown in Photos 10.1 and 10.2. The existence of beach of width of about 80 m with two berms and of height +3.0 m above MSL is shown in Photo 10.3. It is recommended that the existing beach should be preserved and no protection is necessary. To increase the stability of the existing beach, plantations are strongly recommended.

Photo 10.1. View towards north of Hosdurg Kadappuram

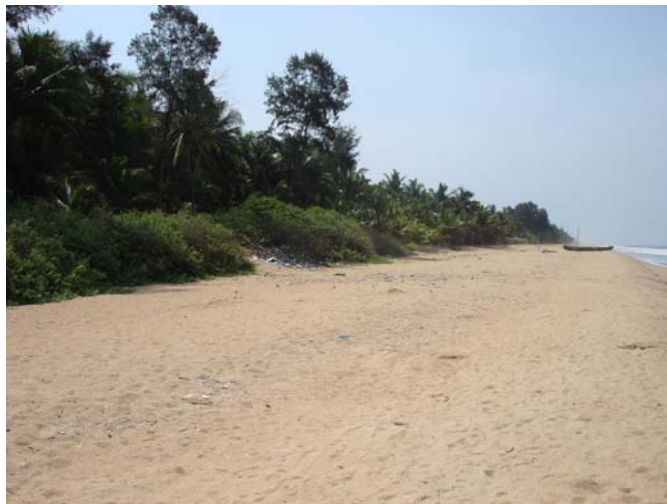
Photo 10.2. View towards south of Hosdurg Kadappuram

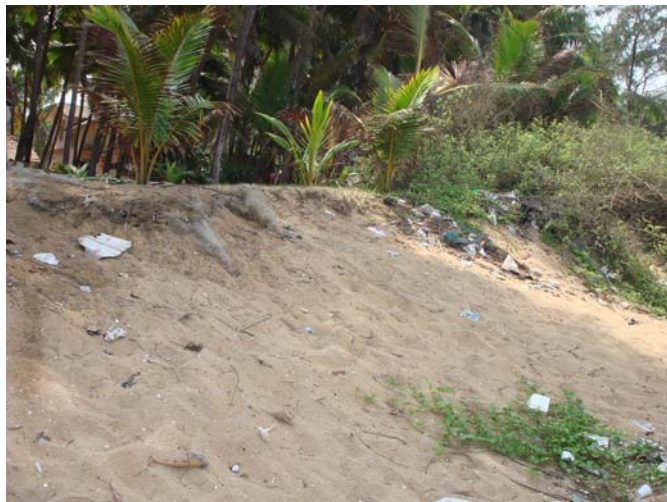
Photo 10.3. Height of beach at Hosdurg Kadappuram

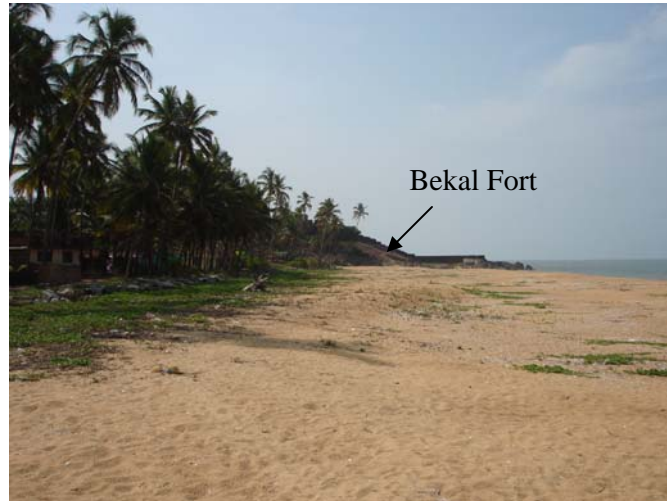
This site is located north of Bekal fort as shown in Photo 10.4. About 40m width of beach is formed as can be seen in Photo 10.5. This beach should be preserved as-it-is without any intervention by engineers. If at all overtopping is found to be very severe to the extent of ingress of seawater into near by dwelling units, the top-level of the crown of the existing sunken seawall may be raised by about 0.5m using same size of boulders that exist at the location or with gabions of 1m x 1m cross section. .

Photo 10.4. View towards Bekal fort on south

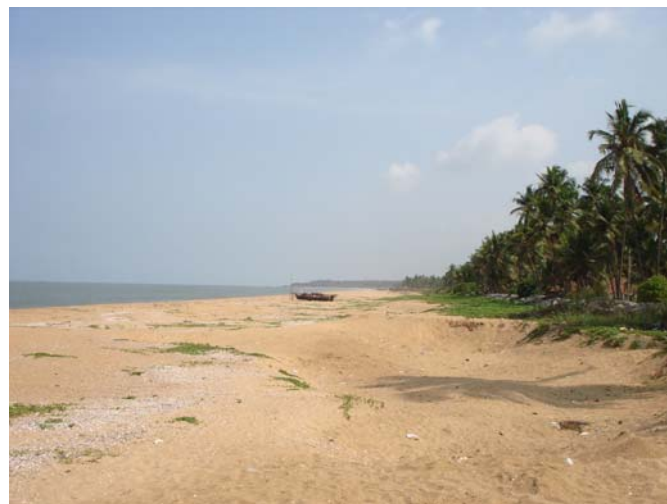
Photo 10.5. View towards North of Bekal

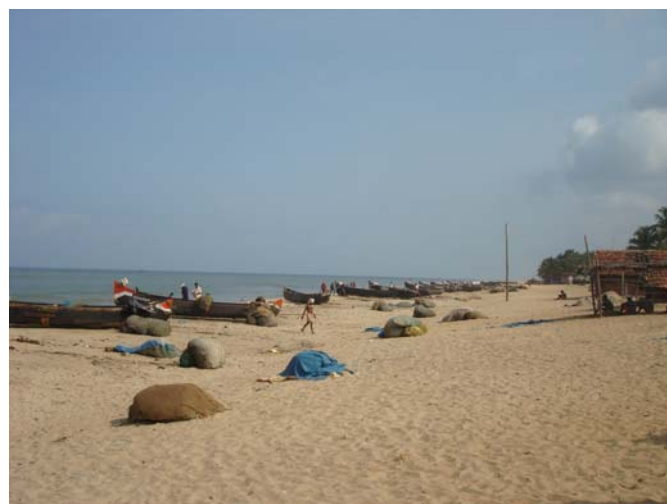
For this stretch, construction of seawall should completely be avoided. The Photos 10.6 & 10.7 depicts the extent of fishing activity along this coast. There can be two options for this stretch:

Photo 10.6 View towards North of Kasaba

2) construction of a groin field which will have 4 No.s of groins of which the groins with a maximum length of 75 m will be inclined at an angle of 10° w.r.t. shore normal. The top level of the groins will be +4.0 m. The coastal protection scheme under the suggested option 2 as shown in Fig. 10.2 would enhance the beach build up and thereby, protecting the coast from perennial erosion which, from the KID is understood to be severe particularly during monsoon seasons.

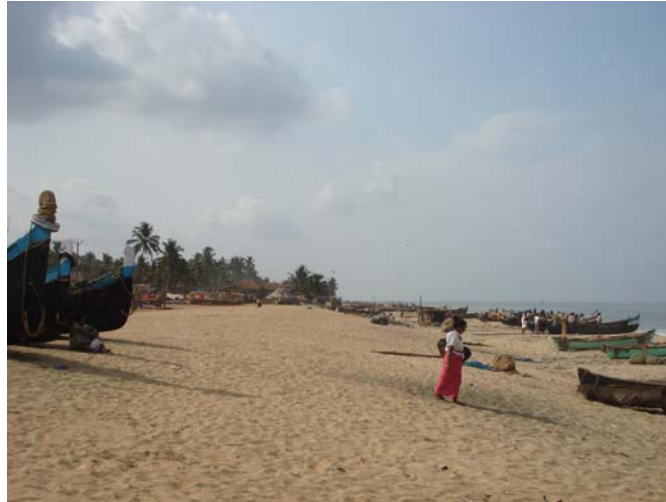
Photo 10.7 View towards South of Kasaba

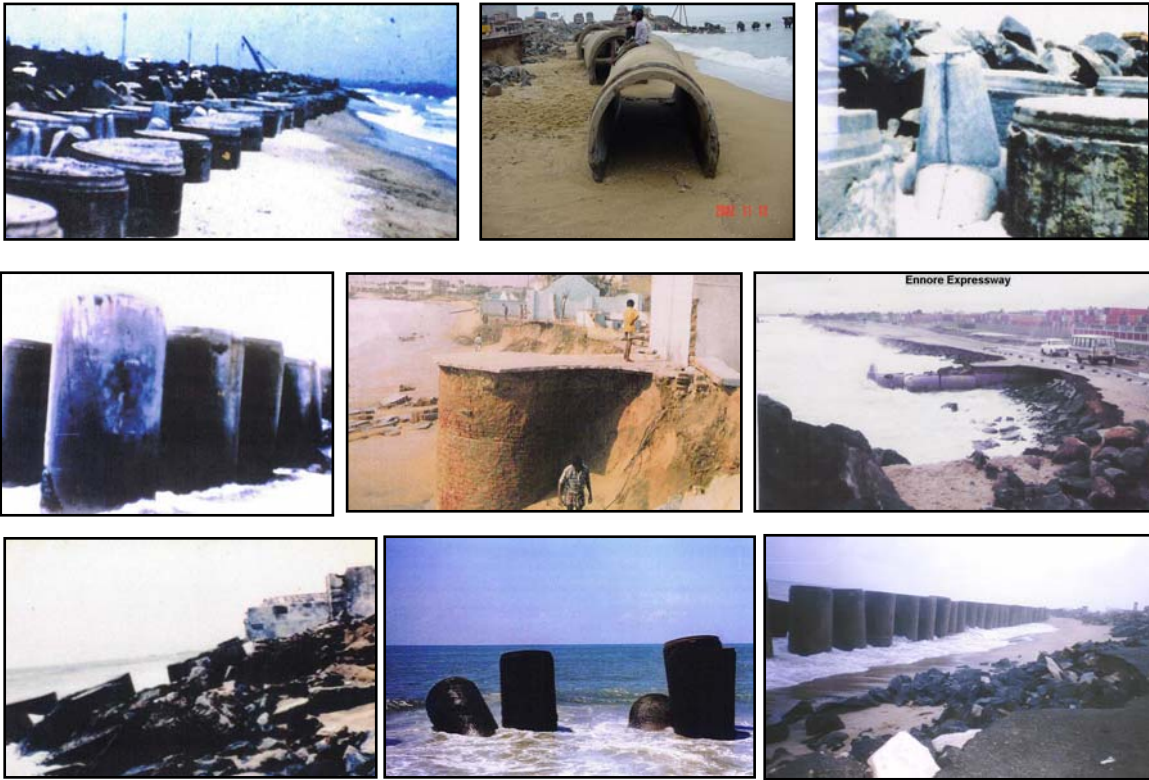
of coastal erosion. Typical damages and protection measures adopted in the past are shown in **photos. 1a & 1b**. This highway being not only the main link between the ports of Chennai and Manali but also serving as the only link to several Industries with the city that has been experiencing severe traffic congestion, many times to a stand still for hours together mainly due to the sacrifice of part of the highway to the Bay of Bengal explains the importance in protecting this stretch of the coast. Of the several options for the coastal protection, the reasons for adopting groin fields for the stretches I and II have been elaborated by the author in the report of I.H.H poondi (2002).

Photo.1a. Typical damages in the study area

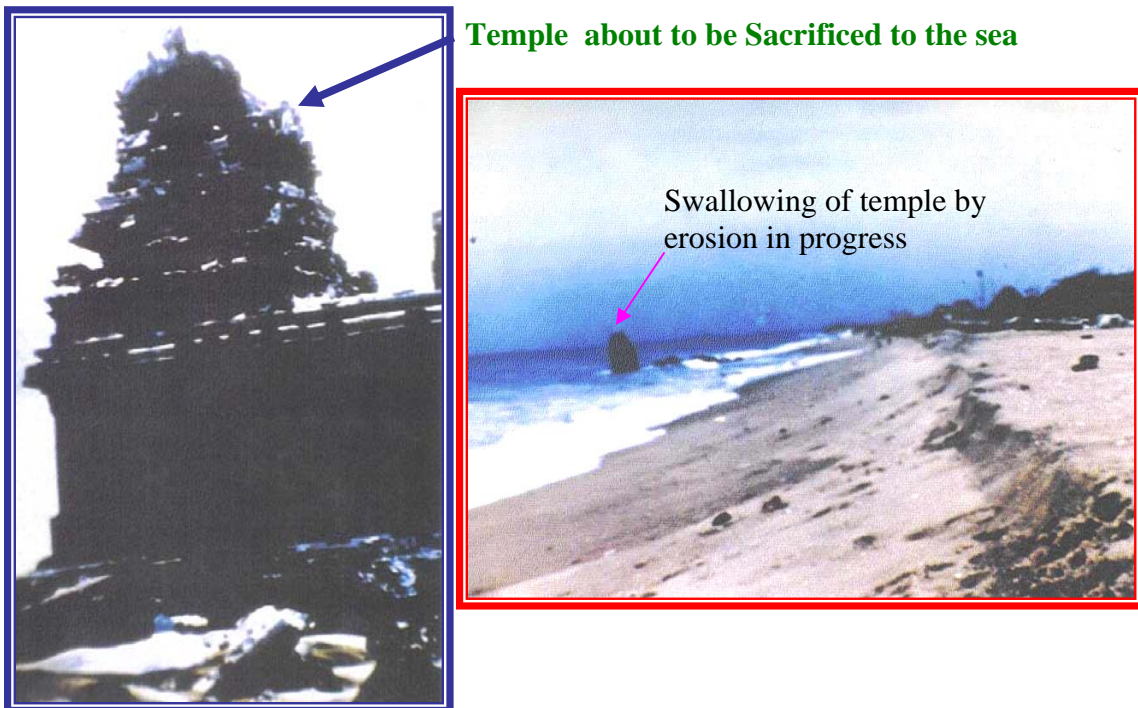
Photo.1b. Temple being sacrificed to the sea
