# India's Ageing Large Dams — Lessons from DRIP

Krishna Raja Sagar Dam

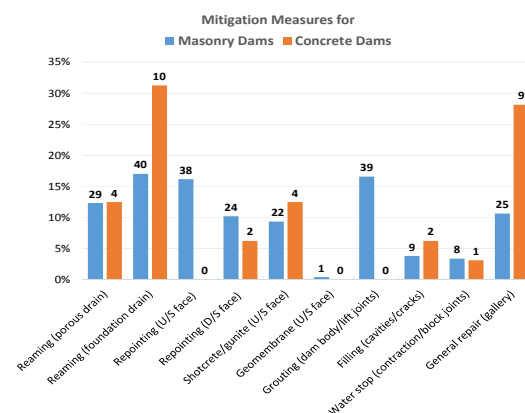
At concrete gravity dams, repairs to foundation drains (mostly reaming to unclog them) and to

Figure 24. Summary of the types and numbers of rehabilitation projects proposed for DRIP concrete and masonry gravity dams.

galleries where excessive leakage has created a variety of problems) are the most common remedial measures. Masonry gravity dams also require substantial foundation drain cleaning along with grouting of the dam body and repointing of their upstream faces to reduce seepage. Major rehabilitation efforts include grouting of the dam body as required at Chimoni Dam in Kerala (Figure 26).

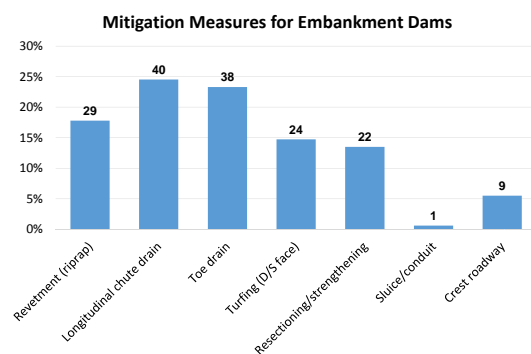
Figure 25. Summary of the types and numbers of rehabilitation projects proposed for DRIP embankment dams.

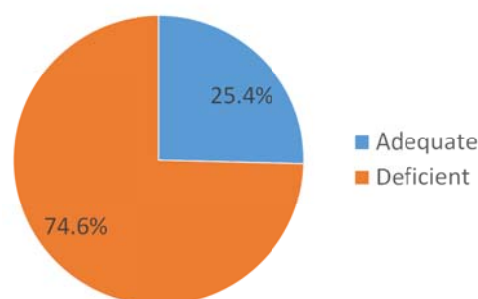
Spillway Capacity of DRIP Dams

Spillway capacities of many large dams are now inadequate because they were sized on the basis of scarce data and lower standards prevailing at the time of design. Evaluation of dams included in the DRIP program shows that existing spillway capacities are deficient for three out of every four based on revised inflow design flood requirements (Figure 28).

Figure 28. Nearly three out of four DRIP dams have insufficient spillway capacities.
