## **AGENDA FOR 3<sup>rd</sup> MEETING OF THE NATIONAL COMMITTEE ON DAM SAFETY**

**DATE : 5<sup>th</sup> December, 2023**

### **Agenda Points 3.12: Dam Failure/Incidents reported during year 2023**

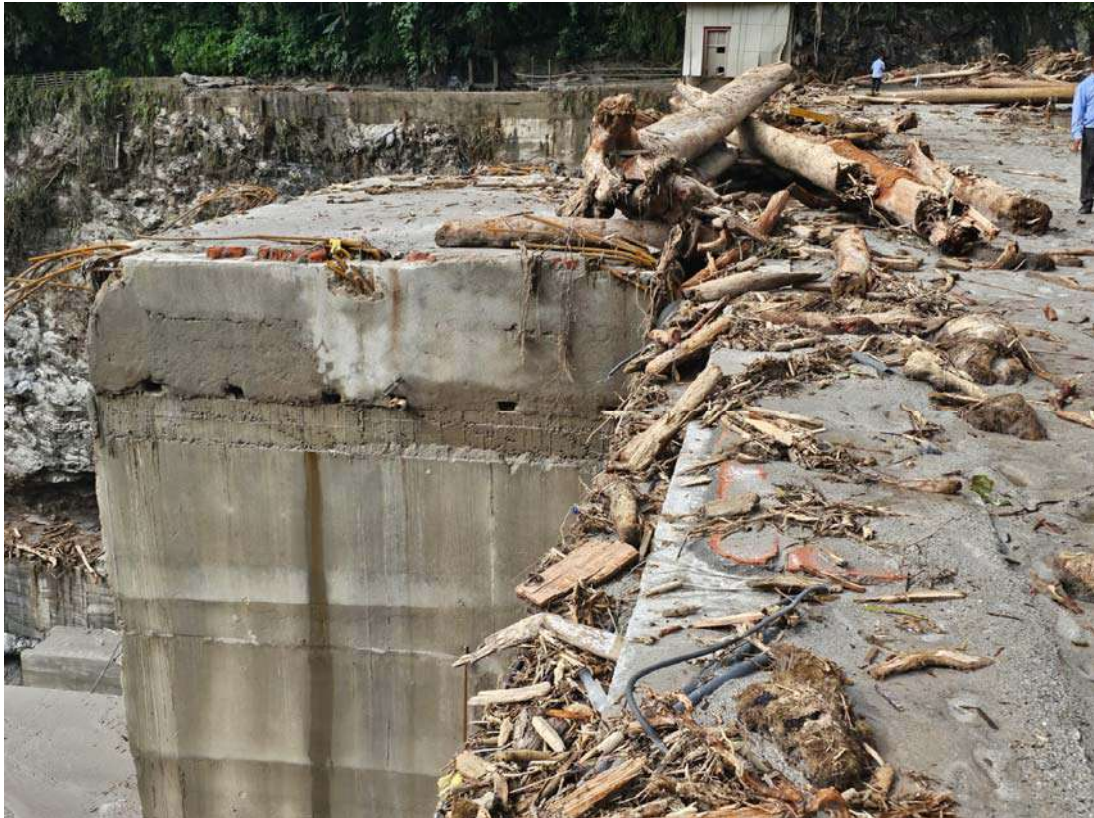
Fig.9 Teesta V Powerhouse Bridge collapse

- vi. A suspension bridge near the Powerhouse connecting the Powerhouse on the left bank and the Residential complex on the right bank is washed out due to heavy discharge. Three nos. of 400KV Transmission Towers near Powerhouse collapsed, and its associated electrical installations have been damaged. Two bridges, one upstream of Teesta-VI barrage and another at Singtham Bazar, have also been washed away.

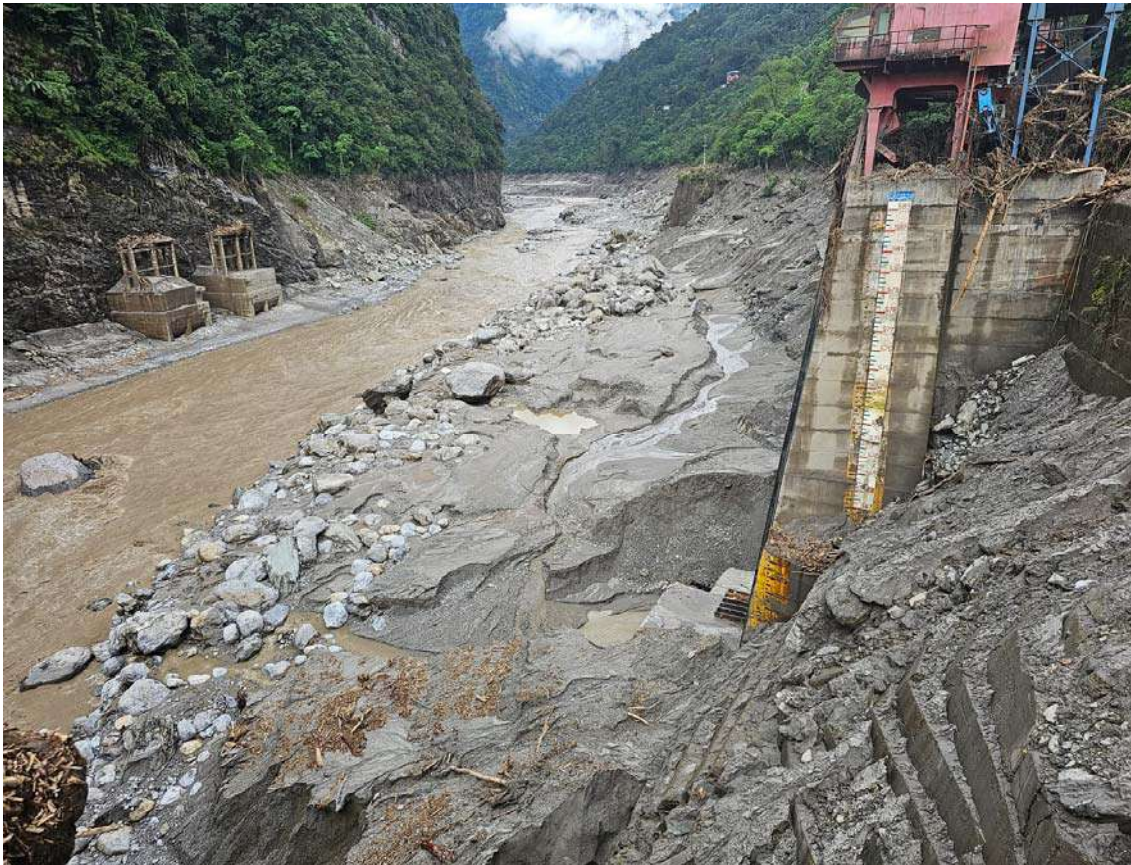
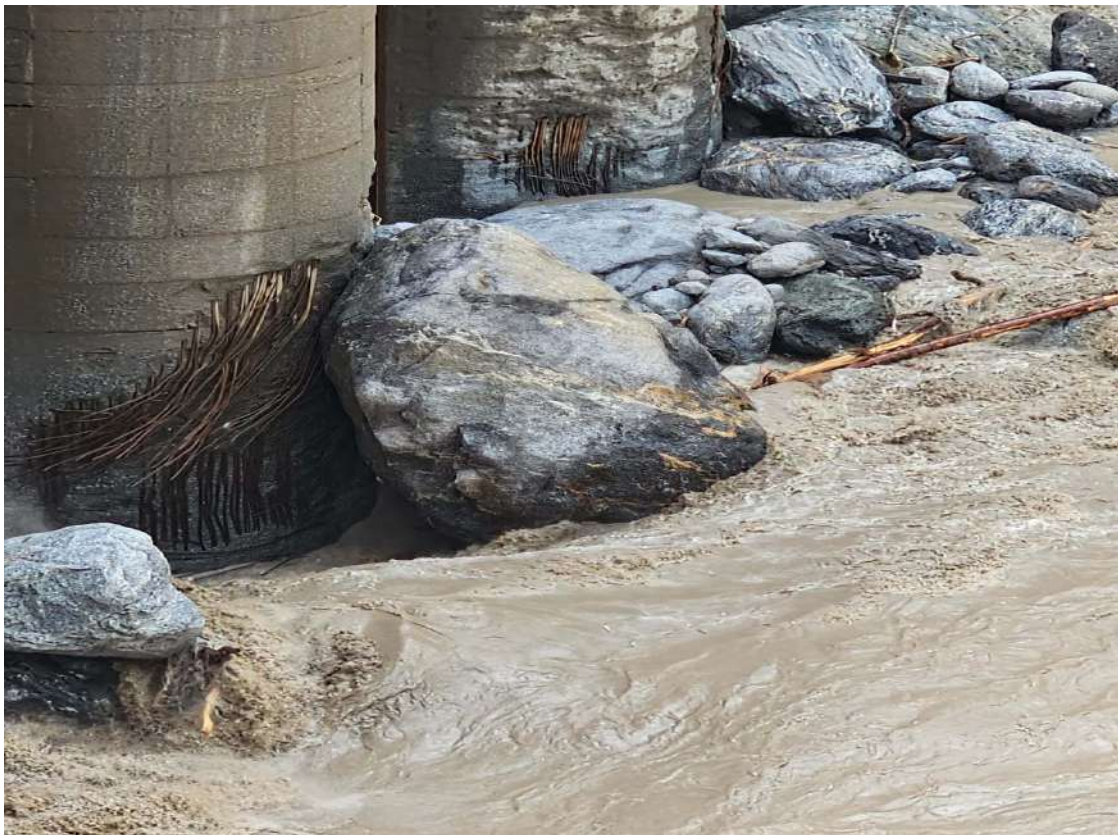
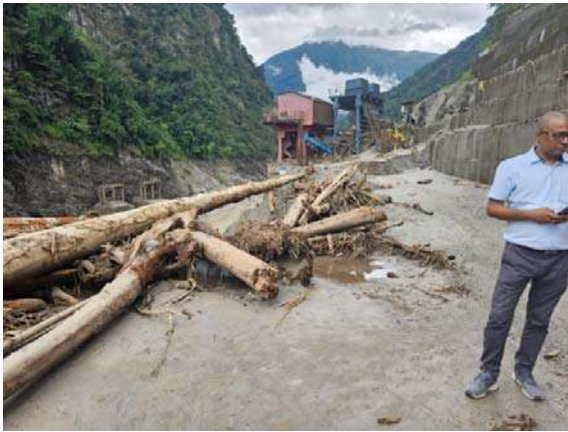
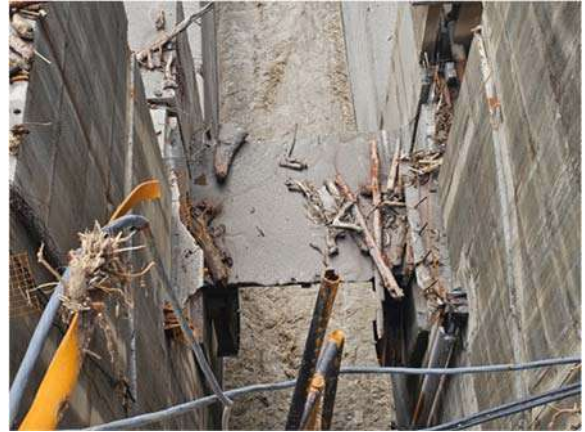
Photos of TLDP-V

- v. Most of the spillway piers of Teesta Dam -V got damaged at different locations, probably by hitting the floating boulders, tree trunks and other objects. The rest of the concrete dam portion of the Teesta -V project appears to be in good condition, but its detailed inspection is not possible due to the washing away of the dam top connecting road. All five radial gates, including their hydraulic cylinders and power packs, have been washed away in the GLOF. The gantry cranes appeared to be damaged.

- vii. The Teesta-V Powerhouse is reportedly in good condition and requires deep cleaning, including TRC. However, to restart, many significant works for Hydro-mechanical (HM works) and electro-mechanical (EM works) are required. NHPC is to assess the work needed for restarting the project.

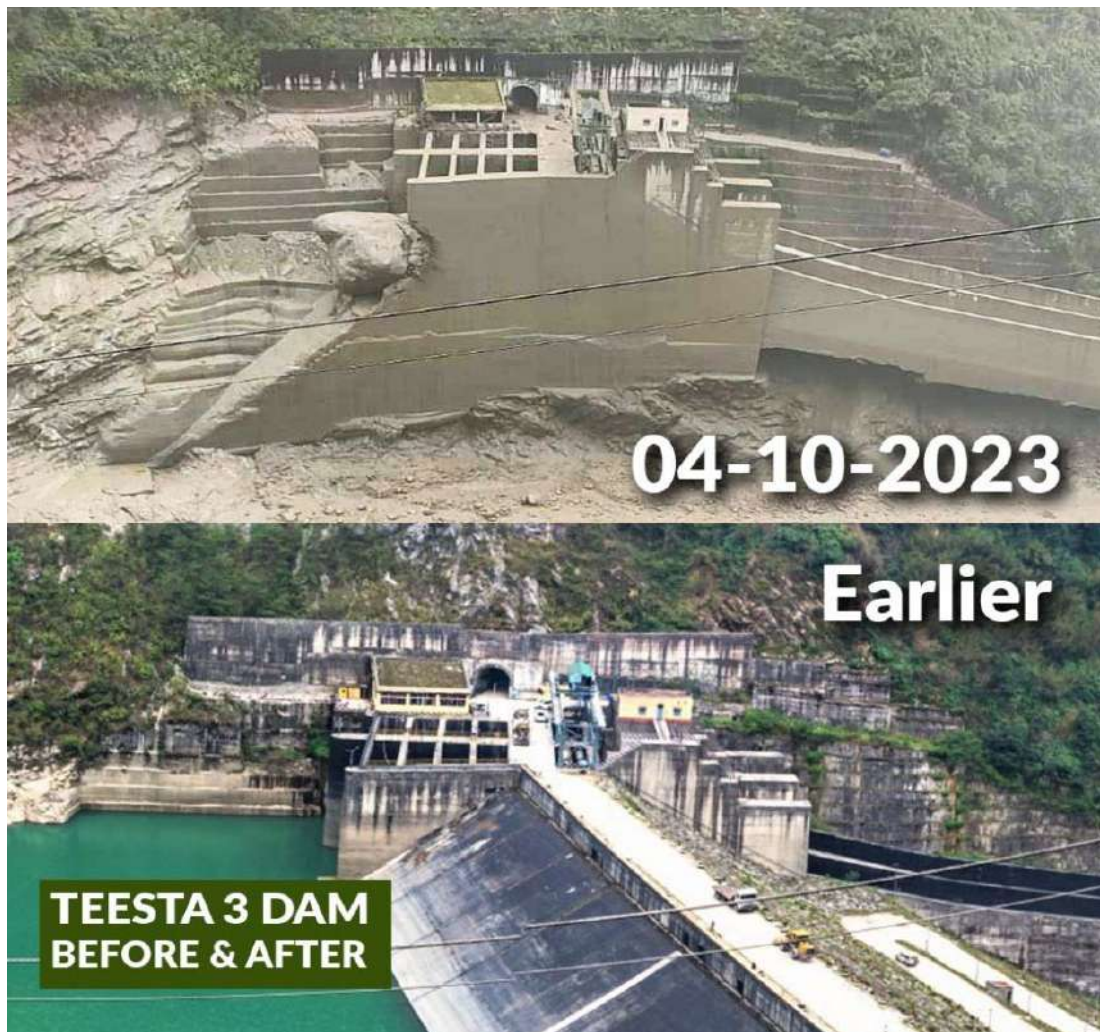
The 60 m high, 1200 MW projected was owned and operated by Sikkim Urja Ltd., a State Govt PSU. The old and current condition of the dam is shown in the following figure.

As per available information, the Teesta-III dam (about 40 km u/s of Teesta-V dam) overtopped, and a substantial portion of CFRD washed out during the flash floods. The water also entered the underground Powerhouse through MAT.

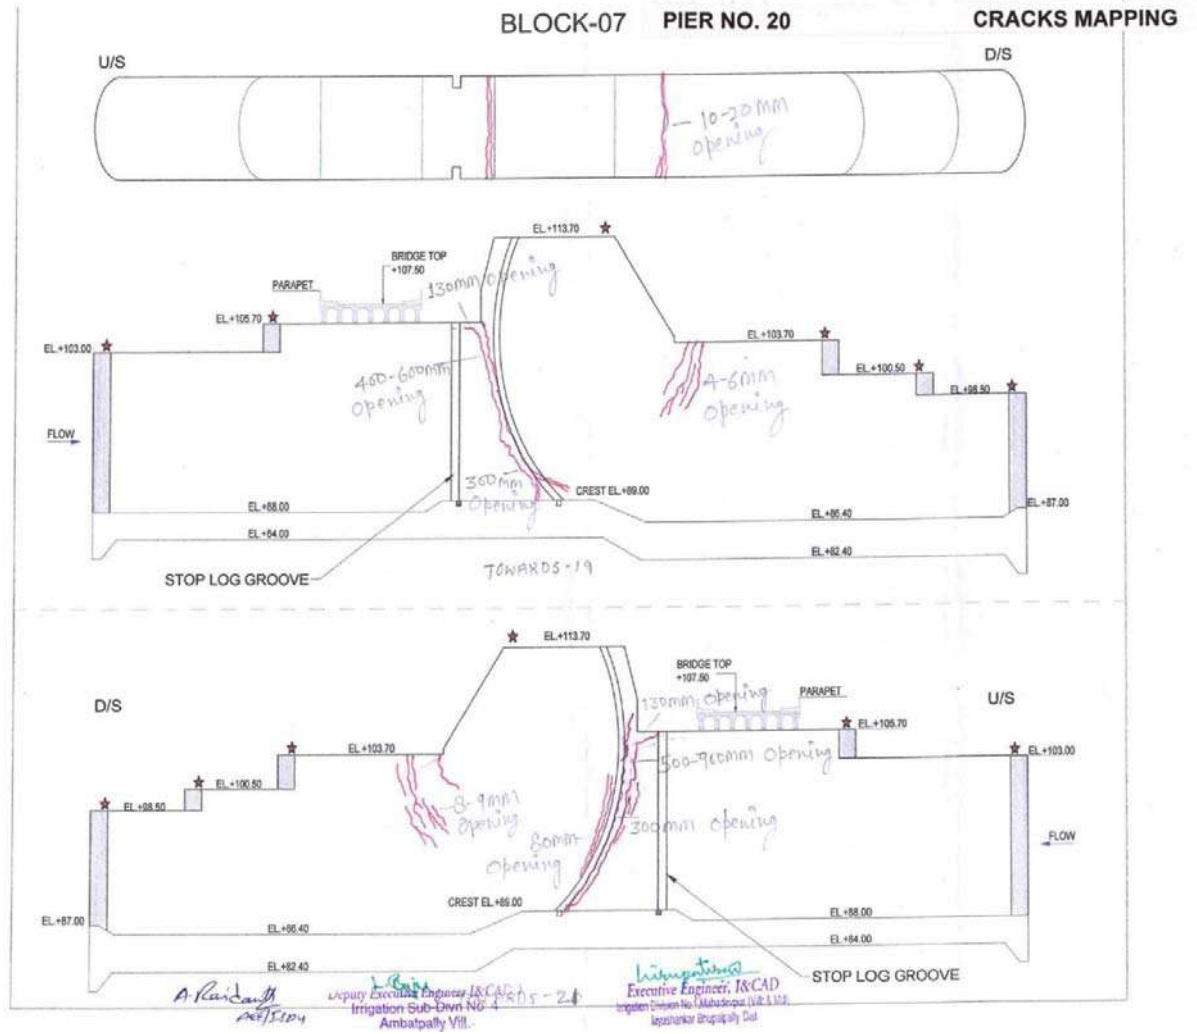
## CRACKS MAPPING

- viii) The distress condition developed in one block of the Medigadda barrage is adversely affecting the functionality of the barrage. The barrage under the present condition is rendered useless until fully rehabilitated.

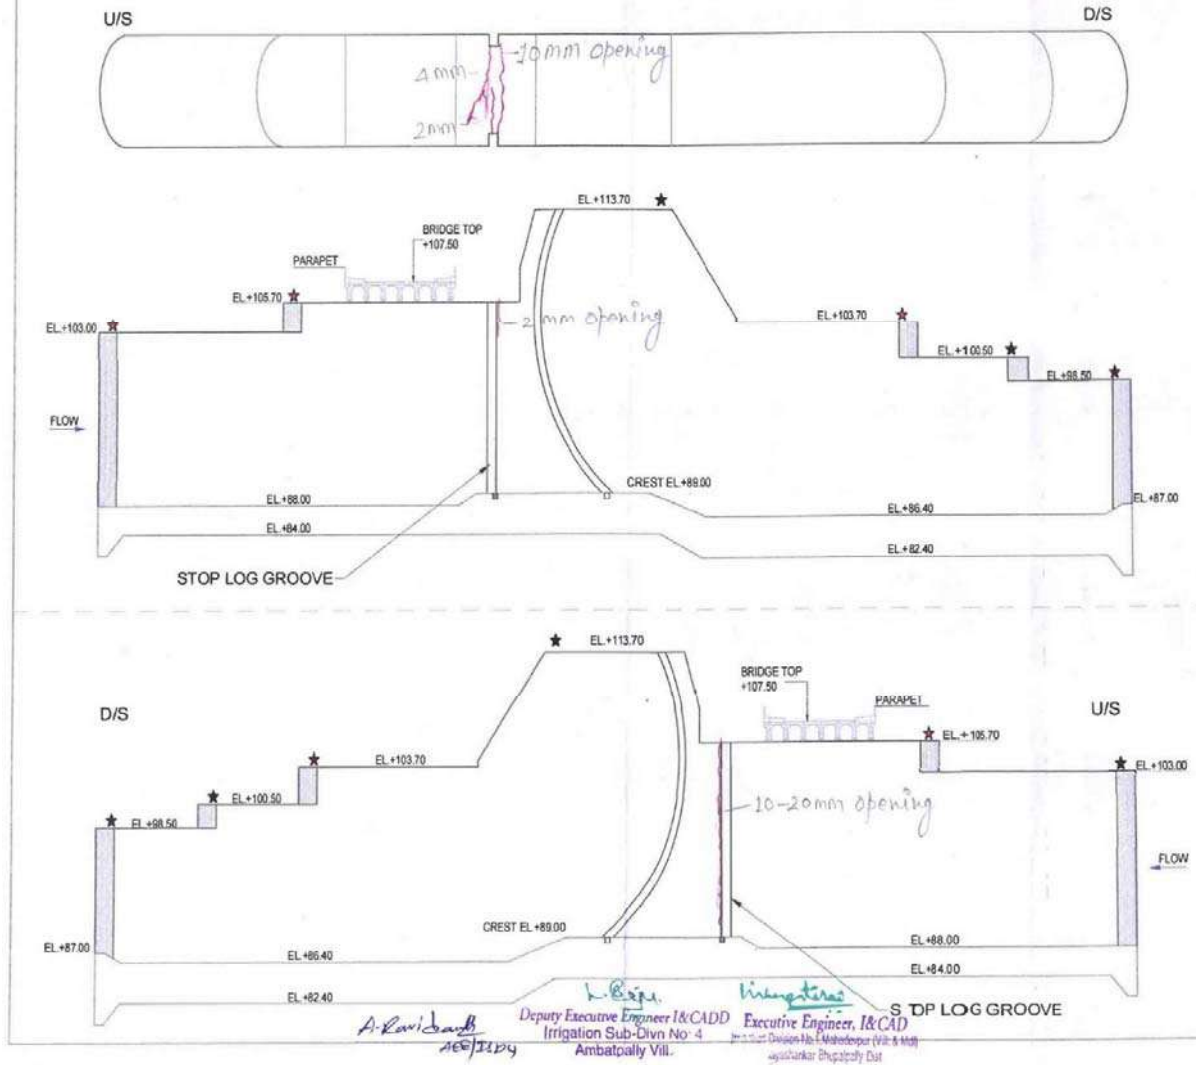
# BLOCK-07 PIER NO. 16

# CRACKS MAPPING
