PROTECTION MEASURES FOR TAMILNADU COAST

Final Report

PUBLIC WORKS DEPARTMENT

PROF. V. SUNDAR

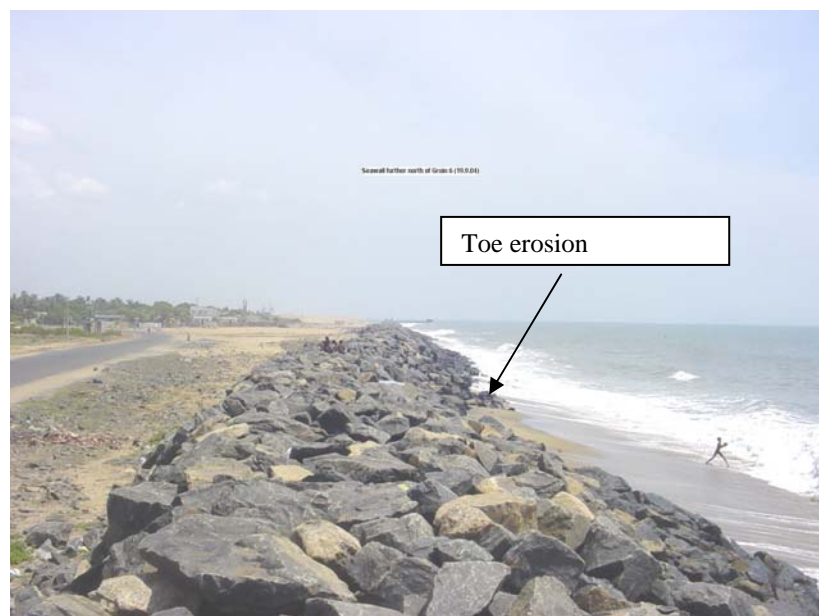
Photo. 1.2. Seawall beyond Ernavur experiencing toe erosion

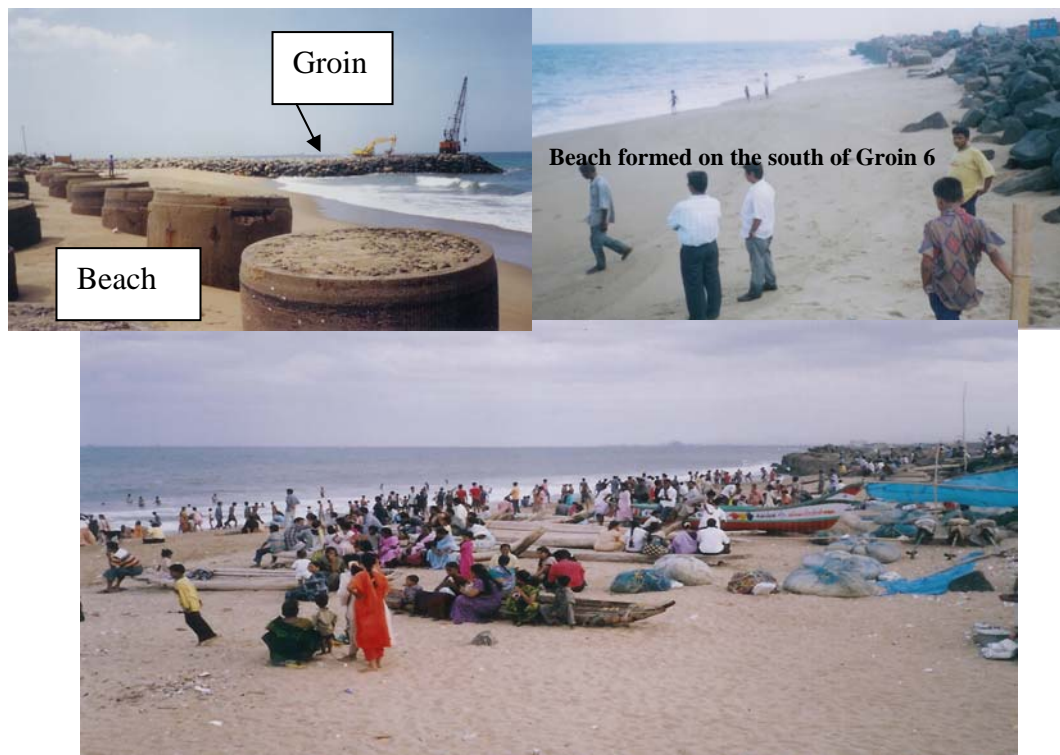
Photo. 1.10. Effect of Groin field in winning the beach (Royapuram, Chennai)

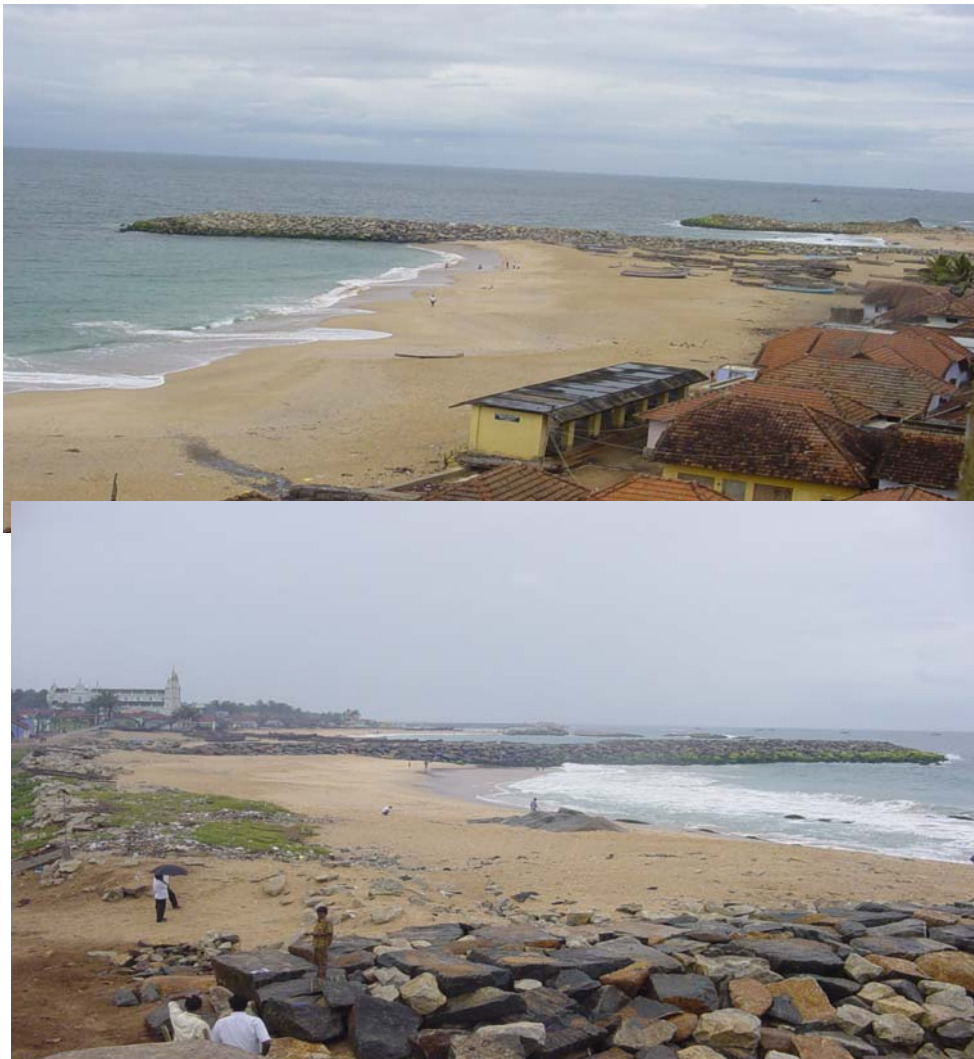
Photo.1.11. Effect of groins as an effective coastal protection measure
(Kankumari District)

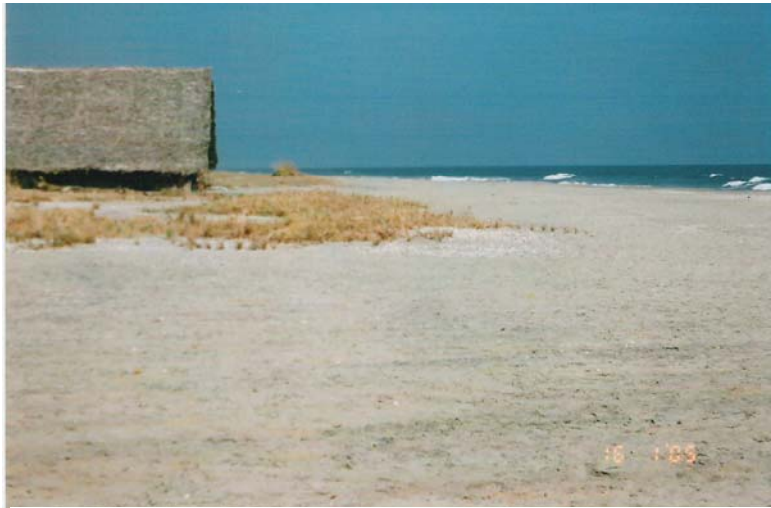
This village is situated on the north of Ennore Port and south of Pulicat lake. During tsunami, water wall of height 3 m has penetrated about 300 m into the coast. A view of the present beach at Kaatupallikuppam is shown in **photo 2.1**. The stretch of the coast north of ennore along with the location of this village is shown in **fig.2.1**. As the Ennore port breakwaters are intercepting the net northerly littoral drift, there is slight erosion at this village. This erosion may be magnified if not tackled. **Hence, soft measures like plantations and sand nourishment (dredged spoil from Ennore port) are recommended.**

Photo.2.1. A view of beach at Kaatupallikuppam

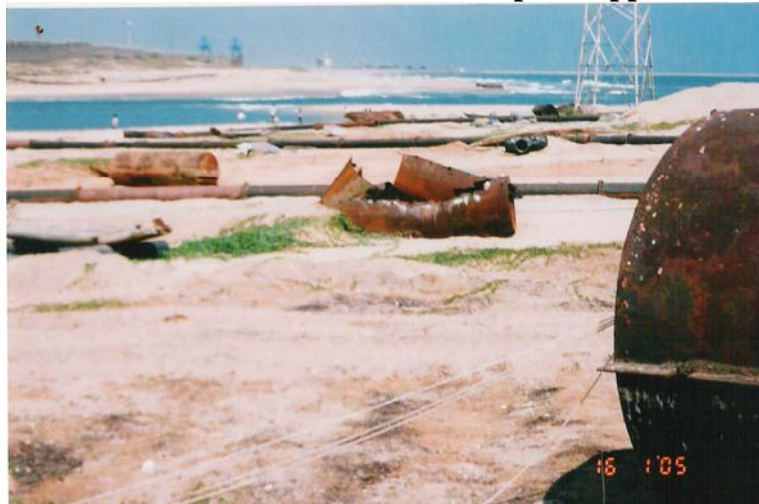
The river Kosasthalayar discharges into the Bay of Bengal at Ennore. The Ennore port is located on the north of this river mouth. The breakwaters of Ennore port are acting as permanent littoral barriers and hence trapping the sediments in to the river mouth. These trapped sediments have choked the river mouth. However, during the tsunami, the mouth of this river was opened due to the penetration of water mass from the ocean which is shown in **photo 2.2**. Presently, the dredging in full swing is in progress as can be seen in **photo 2.3**, in order to keep the river mouth open. During the site visit, it was seen that the dredged spoil was being disposed on the south of the mouth of the ennore creek, which was found resettling into the mouth. This exercise is futile as it is clear that the net littoral drift along the East coast of India is directed towards north. **In order to achieve a better solution two groins one on each side of the mouth as training walls need to be**

Photo 2.2 A view of the sand bar formation at the mouth of Ennore

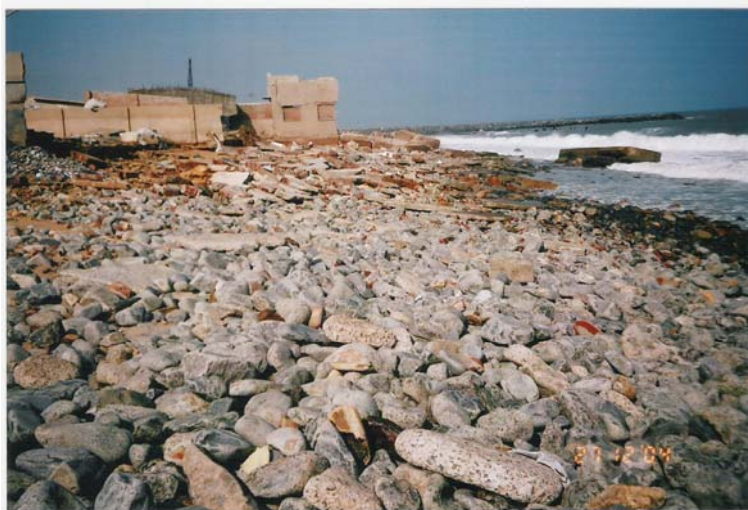
Photo 2.5. A view of the existing depleted seawall

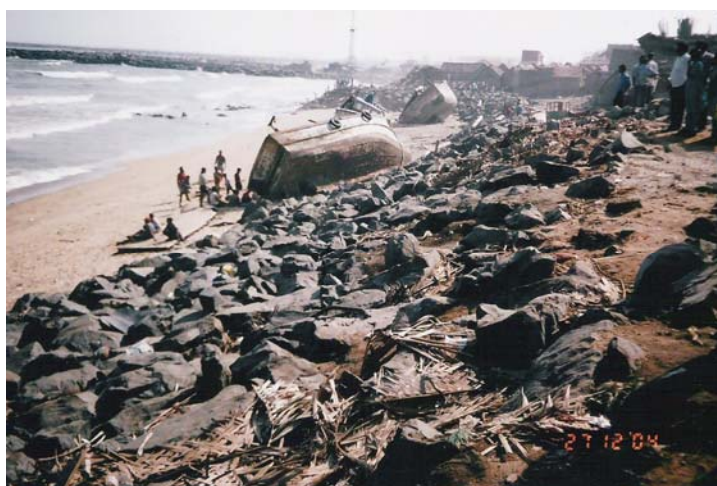
**Photo 2.6. A view of the existing depleted seawall north of
Chennai fishing harbor**

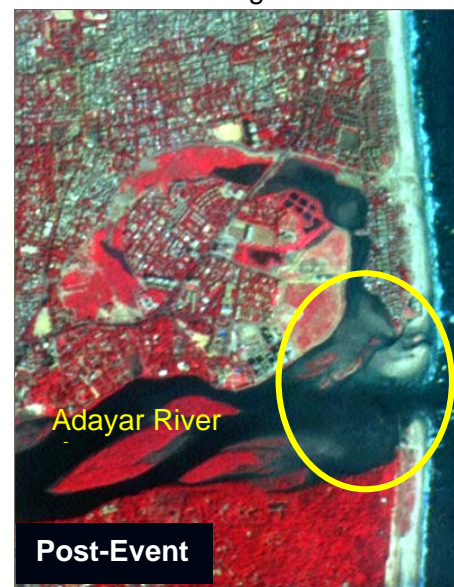
mouth of adyar river prior to the tsunami and after the tsunami are projected through the satellite imageries in **photos 2.8a and 2.8b** respectively. The stretch in between these two river mouths need plantations.

Photo 2.8 Status of river Adyar a) Before b) After tsunami

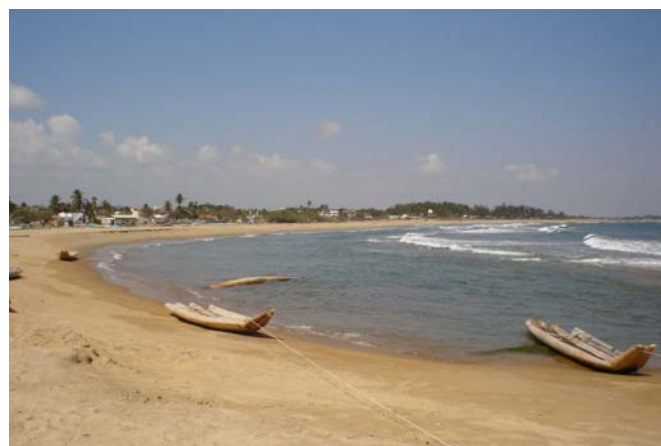
Photo.2.9. A bay like formation at Kovalam

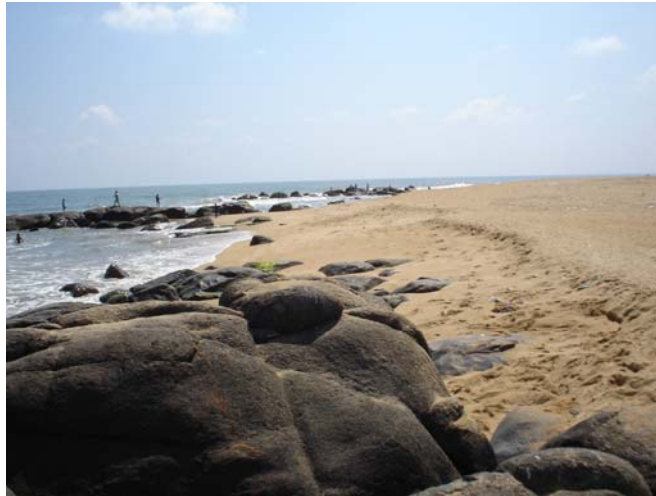
Photo 2.10. Outcrops acting as littoral barrier at Kovalam

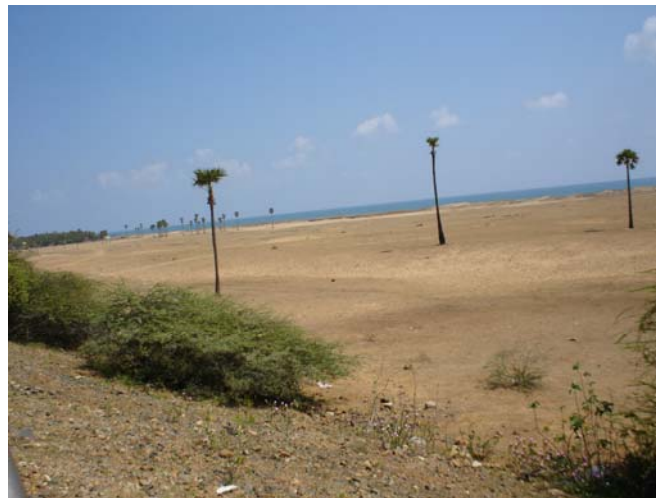
Photo. 2.11. Wide beach conducive for plantations

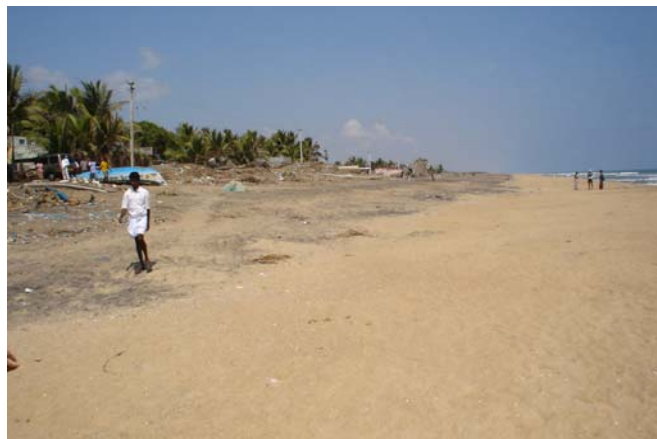
Photo 2.12. Flat beach at Devaneri

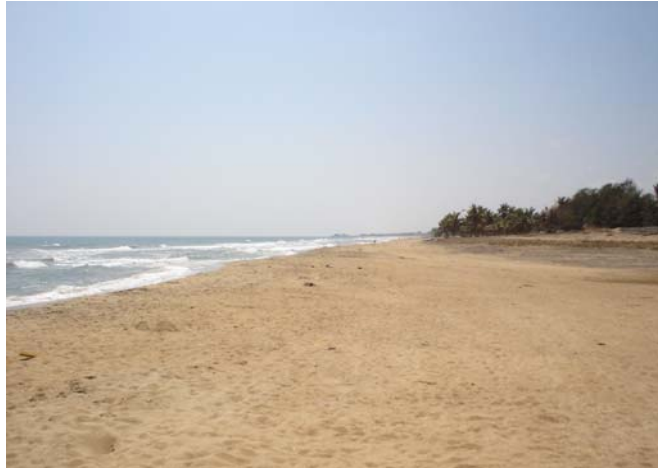
Photo 2.13. Existing plantations acting as natural barriers

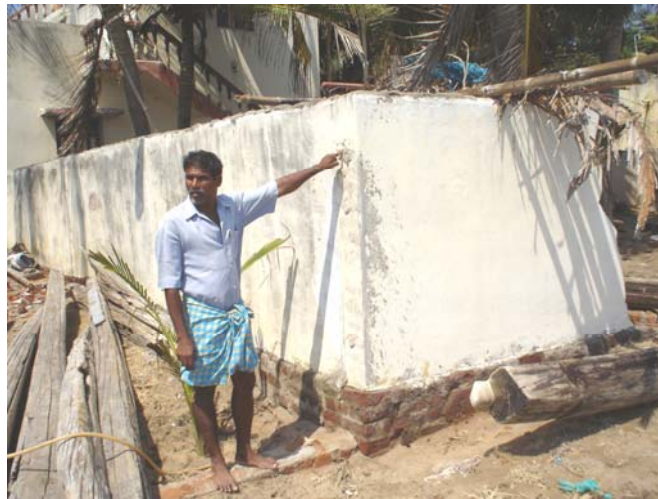
Photo 2.14. A local villager showing the tsunami run-up mark on the compound wall

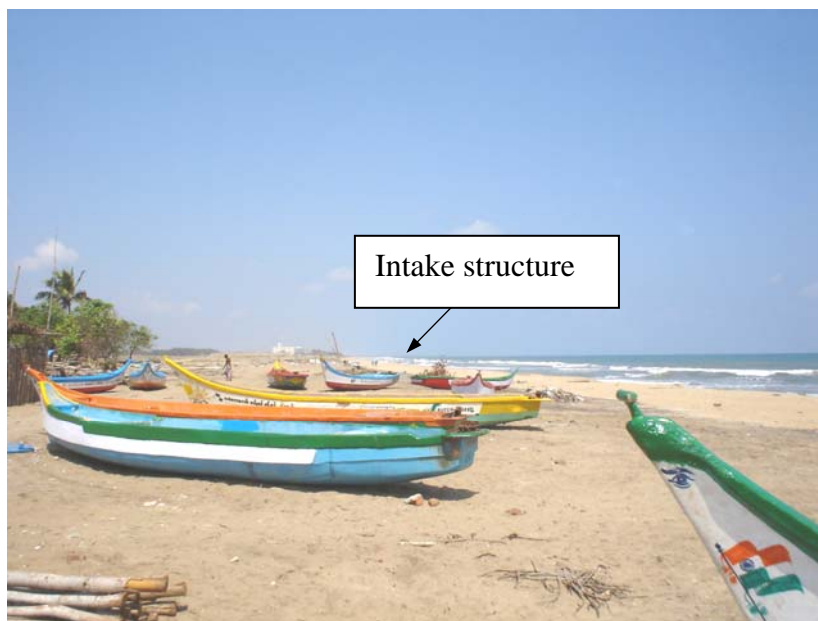
Photo 2.15. The local public reported that the water level receded up to the intake structure during tsunami

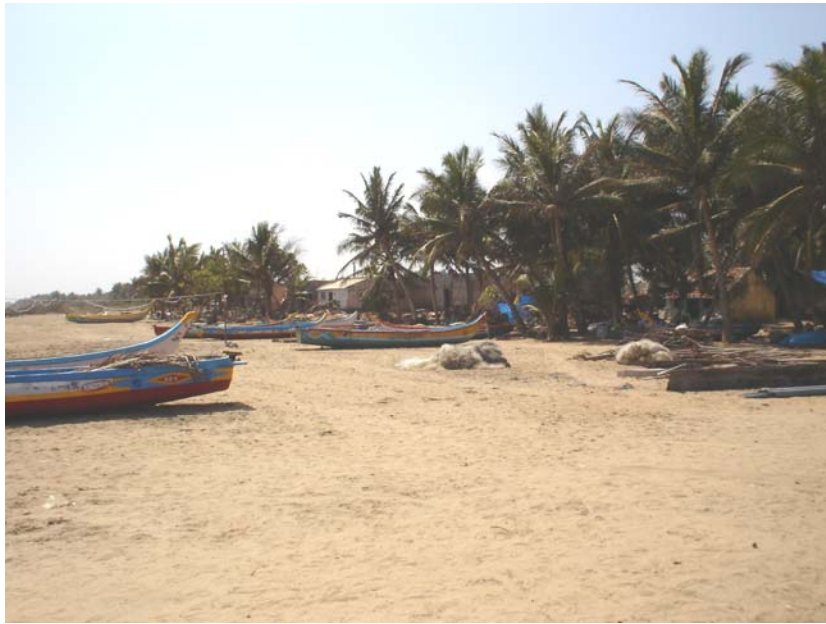
Photo 2.16. Thick coconut plantations, which acted as barriers

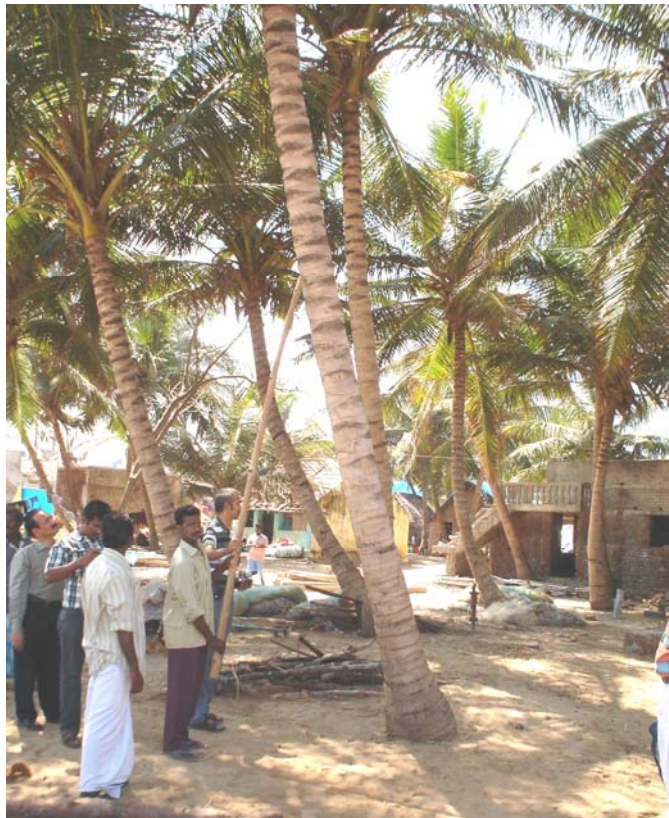
Photo 2.17. A local villager showing the tsunami run-up mark on a coconut tree

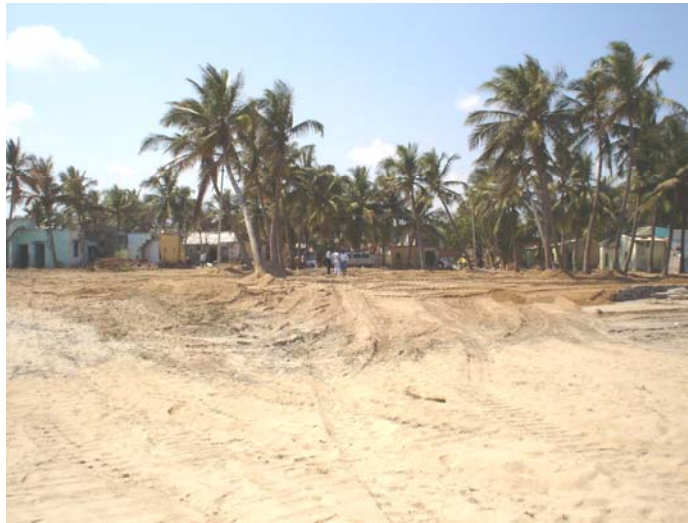
Photo 2.18. Leveling of the ground and clearing of debris in progress in Oyyalikuppam

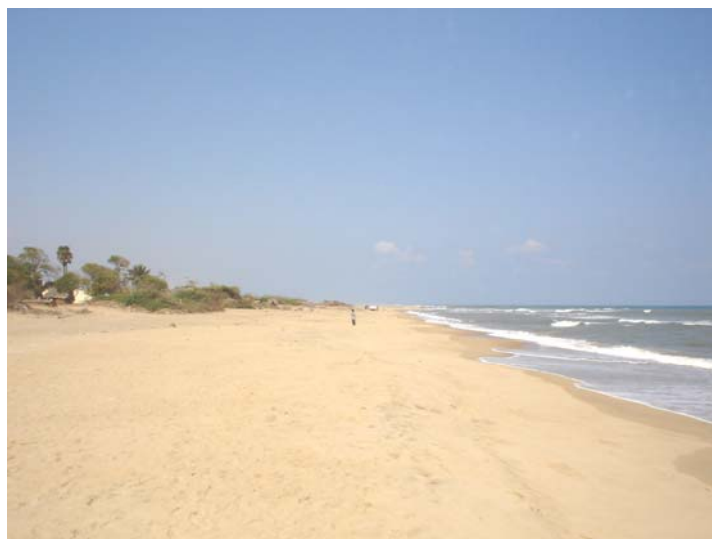
The width of the beach south of river Palar of Chinnakuppam is shown in **photo. 2.20**. However, this area is experiencing only marginal erosion. **Two training walls upto a water depth of about 4m near the mouth of the river Palar is recommended.** The training walls of river Palar will stabilize the beaches of Chinnakuppam and Periyakuppam. After monitoring the shoreline evolution due to these training walls, a decision can be taken to provide further protection. **As a long-term solution, plantation can be started in between these two villages, as there is enough barren land.** The plantation can be as dense as shown in **photo. 2.21**, the location of which in between these two villages, is slightly far away from the shoreline. The Palar river mouth which was discussed earlier shows the formation of shoals and sand bar near its mouth (**photo. 2.22**) which needs two training walls as shown in **fig. 2.12**.

Photo 2.20. Beach width south of the river Palar

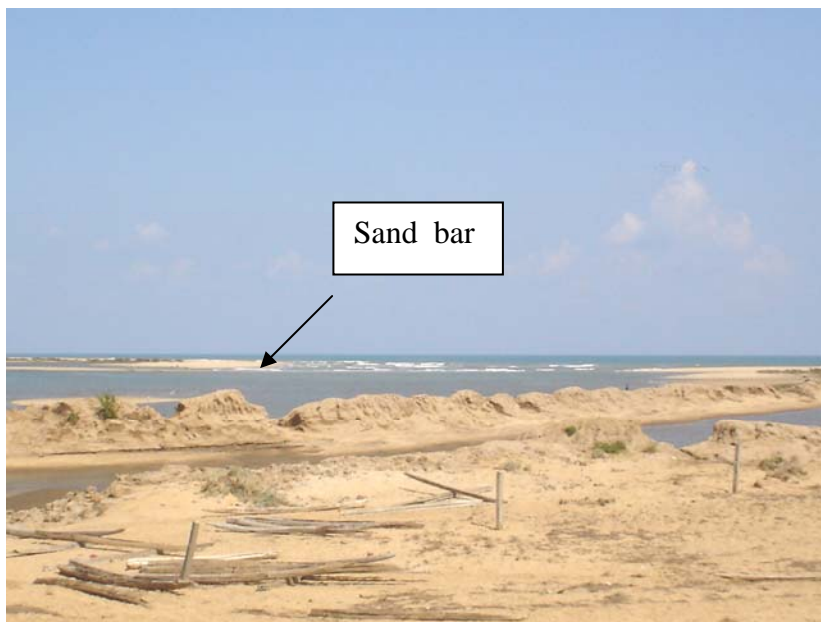
Photo 2.22. Sand bar formation at the mouth of river Palar

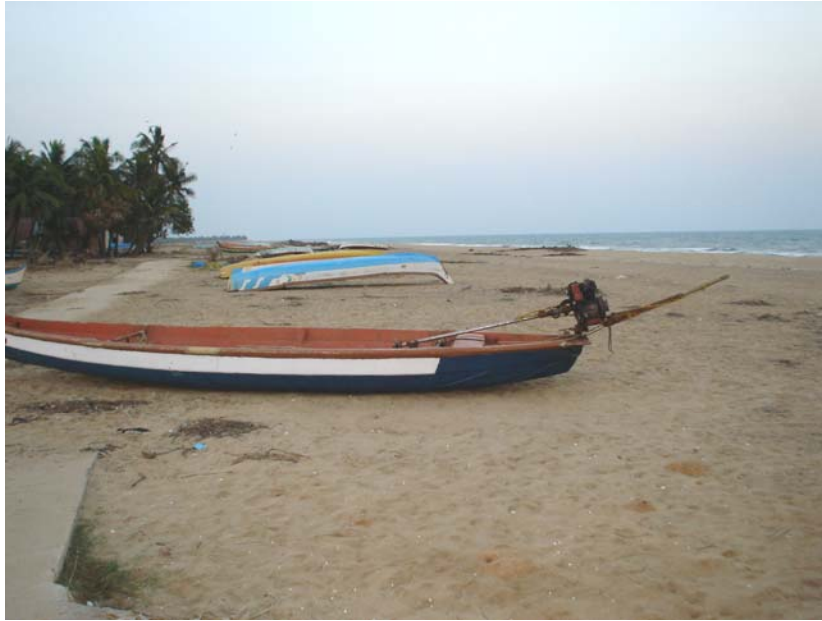
The beach widths along this stretch are shown in **photos 2.29 and 2.30**. This stretch exhibits the existence of sufficient beach width for which a soft measure like plantation should be taken up immediately. Damages due to tsunami are shown in **photo.2.31**.

Photo 2.29. The beach width North of Mudhaliyarkuppam

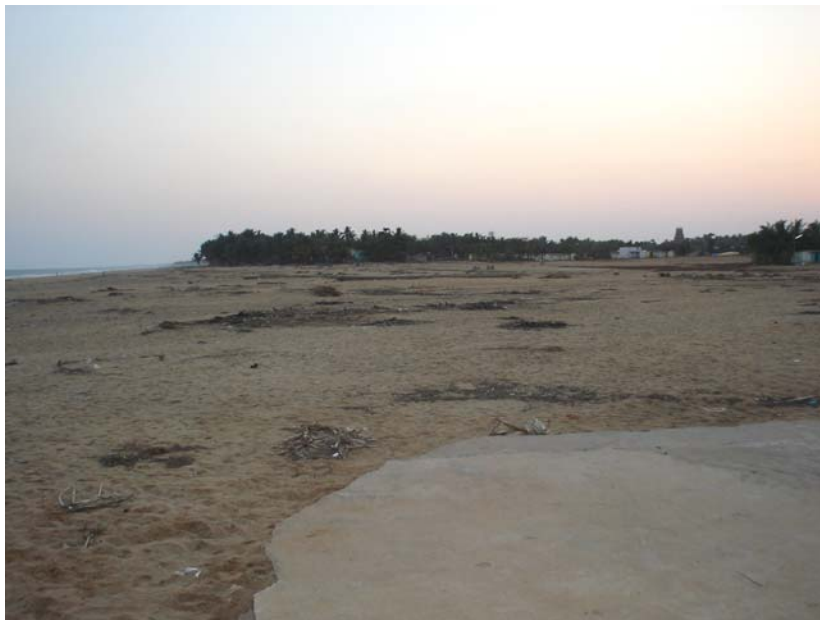
Photo 2.30. The beach width South of Mudhaliyarkuppam

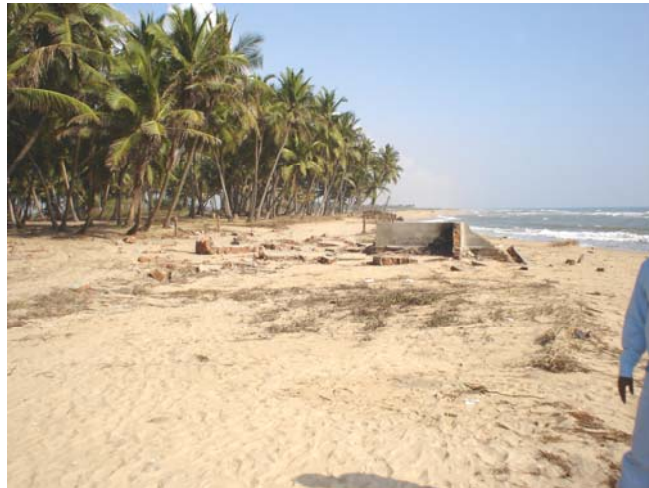
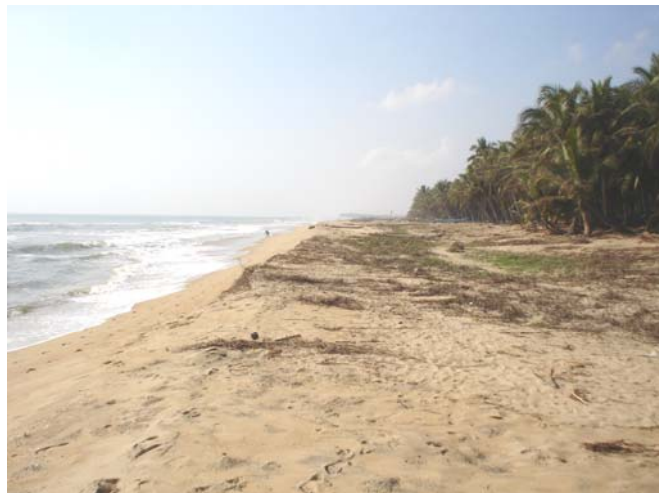
The views of the beach north and south of this village are shown in **photos 2.32 and 2.33** respectively. Although, the beach is about 30m wide and coconut trees have given some amount of relief, about 300 to 400 families living in this village have suffered loss of property and life due to the tsunami. The PWD officials have stated that, the beaches formed during the visit get eroded during other seasons. The tsunami has removed all the beaches upto the coconut trees and a number of coconut trees and houses were completely damaged. (**photos 2.34a and 2.34b**). There is an urgent need to protect this coast. The village is also not at an elevated location. The river (pennaiyar) training works would consist of **a pair of training walls of lengths of about 250m** which need to be constructed that has to be discussed with the Government of Pondicherry as the stretch on the north of mouth of this river comes under the jurisdiction of state of Pondicherry. **On the southern side of the mouth, a long groin is proposed followed by a groin field for a distance of about 3km upto Devanampatinam. This would consist of 8 groins with an average length of about 150m and training walls of about 250 m at the mouth of river Gadilam.** The PWD officials have started temporary protection measures by driving trunks of Palma rah trees parallel to the shoreline (**photo 2.35**). The trunks are of 6m length and driven 4m into the sea bed. If these trunks had only been driven normal to the shoreline, at regular intervals, it would have served as a permeable groin field allowing the sand to get deposited in between them leading to the formation of a beach. The respective S.E of PWD has been advised accordingly. **photos 2.36 a & b** show the choking of the mouth of pennaiyar river. Nearly 350 people have died in these villages and **hence for a stretch of 3km needs protection with a combination of groins and a high crown seawall.** Only the concept of the protection measure to be adopted for the stretch of the coast between Thazhanguda Village and Devanampatinam are shown in **fig.2.16**. Initially the groins should be constructed, followed by the seawall after monitoring the

Photo 2.32 & 2.33. Beach widths North and South of Thazhanguda

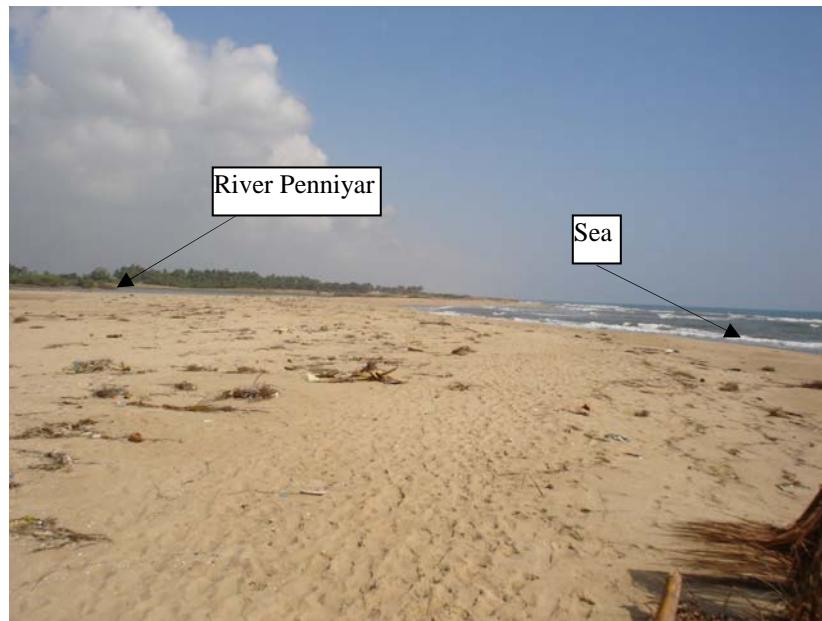
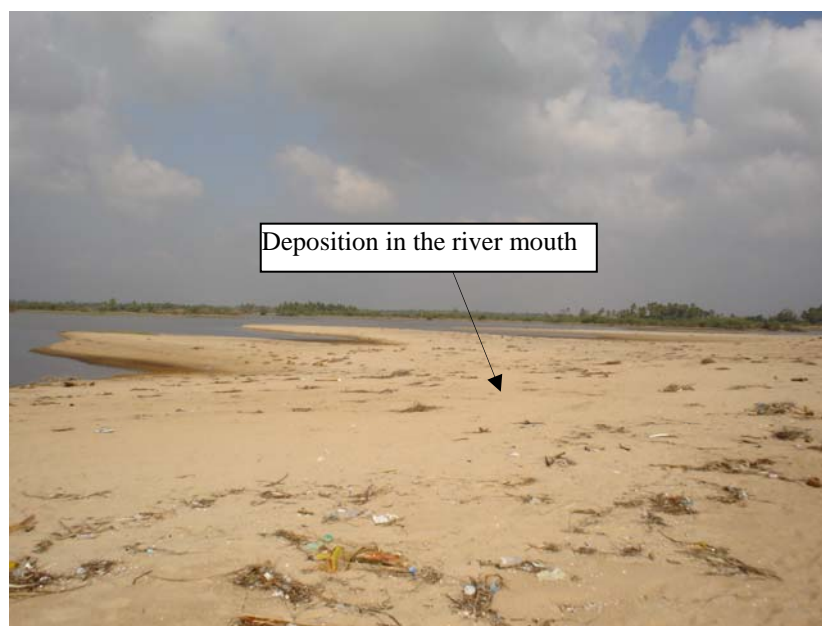
Photo 2.36 a & b. Deposition at the mouth of river Penniyar near Thazhanguda

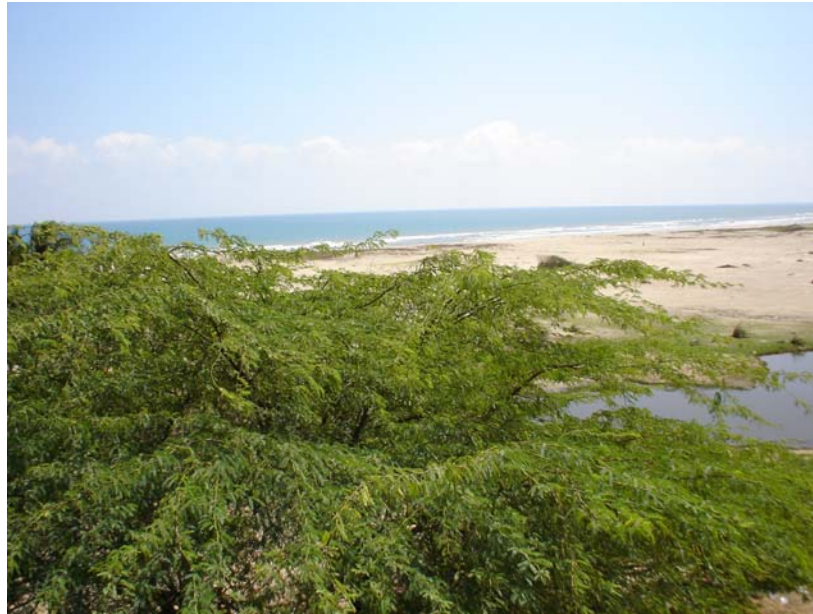
Photo 2.37. Open Barren land north of Cuddalore port

The north of the northern breakwater of this port has a wide-open barren land (**photo.2.37**), **which can be protected with plantation**. The houses are in a much-elevated location. The tsunami has not reached the dwelling units from the sea. However, most of the damages to the village Singarathoppu, located close to the banks of Uppanar river (**fig.2.17**), from which the tsunami penetrated to result in a huge damage. **Hence, immediate steps are to be taken to shift the dwelling units to the elevated locations.**

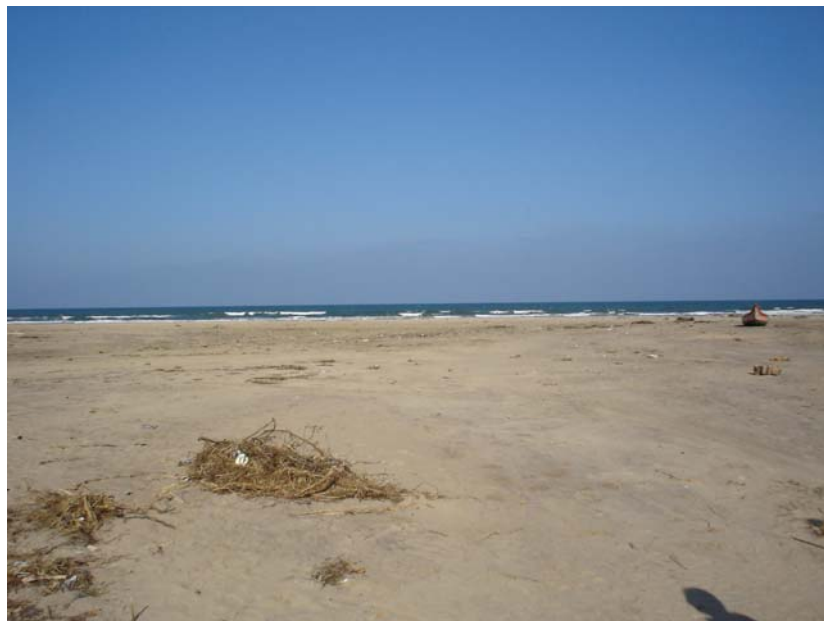
During the tsunami, water penetrated about 1km into the land, causing a death toll of about 200 and severe damage to the property. The beach is very flat (**photo 2.38**) for a stretch of the coast of 10km north of Parangipettai upto Samiyarpettai. The houses are located at a distance of about 500m from the shoreline except for a public convenience shown in **photo 2.39** that had been completely submerged during the tsunami. The barren land shown in this stretch of the coast as can be seen in **photo.2.40** has not offered any protection from the tsunami run-up. **Hence, dense plantations are proposed.** As dwelling units are located mostly about 200m away from the shoreline and as the seabed is very flat, without much shoreline oscillations as per the information gathered by local public, conventional hard measures like seawalls or groin field would not serve as coastal protection measure. In the case of groins, they have to be quite long in order to pierce the surf width. In the event of tsunami, the aim of the protection measure should be to reduce its speed, **for which masonry buffer blocks (4m x0.5mx0.5m) and can be constructed in two rows at a distance of 200m from the shoreline and in between these blocks and shoreline plantation as already mentioned could act as front line soldiers to reduce the speed.** The priority in this case would be plantations followed by the buffer blocks. The concept are projected in **fig. 2.18**.

Photo 2.38. Flat beach at Pudukuppam

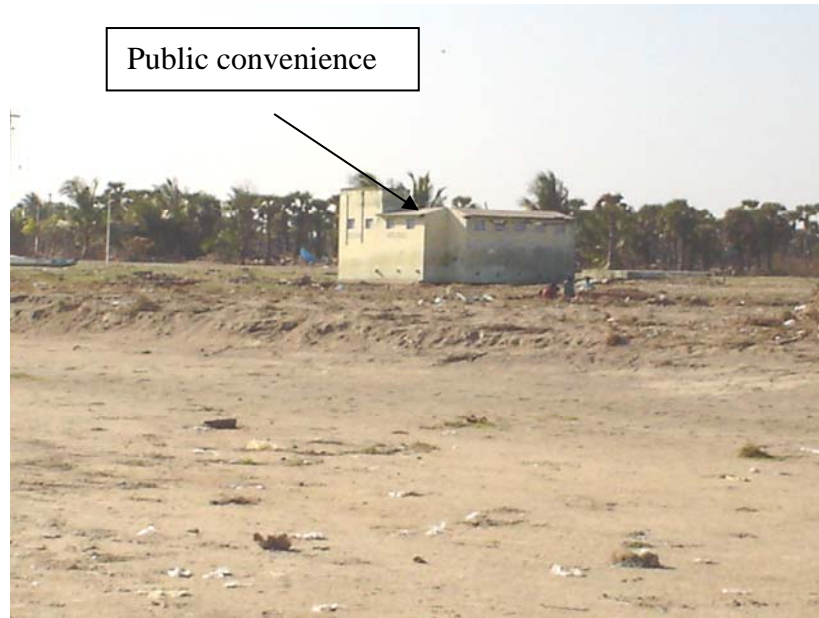
Photo 2.39. View showing the public convenience adjacent to shore

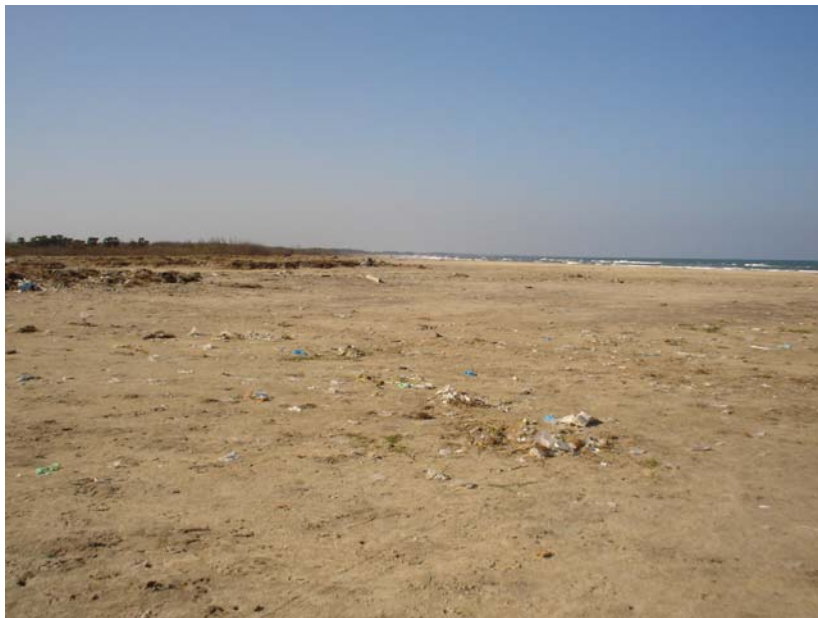
Photo2.40 Barren land adjacent to shore at Pudukuppam

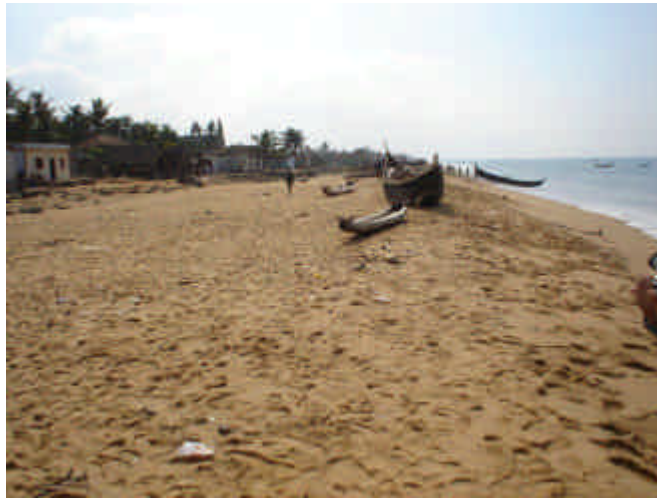
This stretch of the coast from Neerodi colony to Erayamunthurai, situated in the West coast of Tamilnadu state is shown in **fig. 3.2**. A number of dwelling units just close to the coast are facing threat of erosion. The width of the beach along this stretch of the coast is about 30 m as can be seen from the **photo 3.1**, gets washed away during the South-West (SW) monsoon leading to the entering of seawater occasionally into the dwelling units. It is observed that the beach slope in this stretch is quite steep. An existing sea wall for a length 1km is in a collapsing stage.

Photo 3.1 View showing the width of the beach at Neerodi Colony

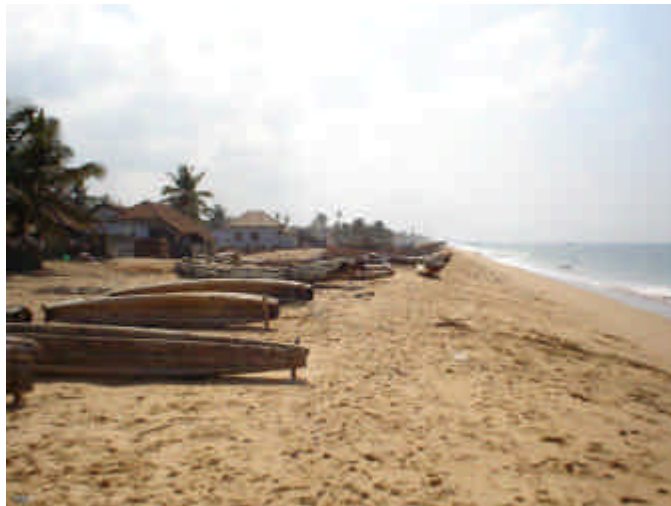
The stretch of the coast from Neerodi colony to Erayumanthurai covering a total distance of about 8 Km have already been protected by a seawall (**photo 3.2**), which has sunk.

Photo 3.2 View showing a number of catamarans parked adjacent to beach at Marthanduthurai

This hamlet is located on the Western side of the confluence point of the river Kulithuraiaar (**photo 3.5**). **For all of the above stretches it is recommended that the existing seawall should be stabilized or replenished, in particular Poothurai and Erayumanthurai which got affected due to tsunami.** Also, it is further recommended to fill the gaps between the seawalls as it is reported by the local public that these gaps allowed the tsunami into the land which caused damage. **It is to be recalled that the existing depleted seawall has to be rehabilitated including the raising of the top level to +5.35 m above MSL similar to that in Vallavalai.** *The scheme suggested for protecting the entire stretch from Neerodi colony to Erayumanthurai as a long term measure would be to protect with about 15 groins with an average length of about 200 m as shown in **fig. 3.3**. However, this remedial measure can be taken up under phase II.*

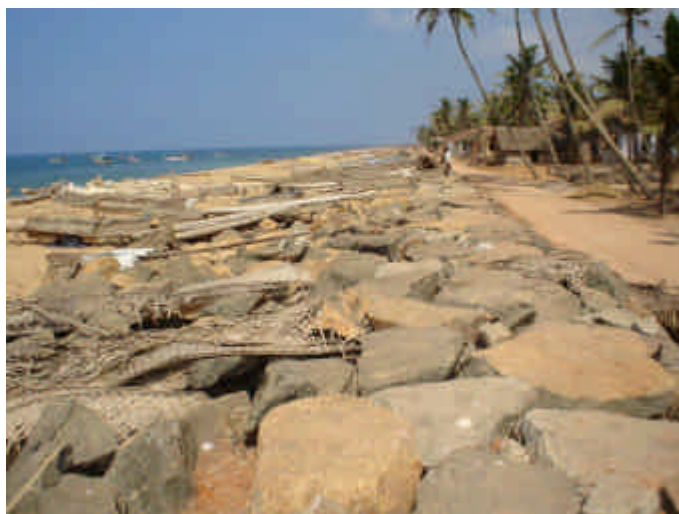
The seawall constructed by PWD based on the design of IIT Madras, is found to be intact with the beach width of about 15 m in front of the seawall (**photo 3.3**). The top of the seawall is found to be effectively used by fishing community for drying fish as can be seen in **photo 3.4**.

Photo 3.3 The existing seawall at Chinnathurai

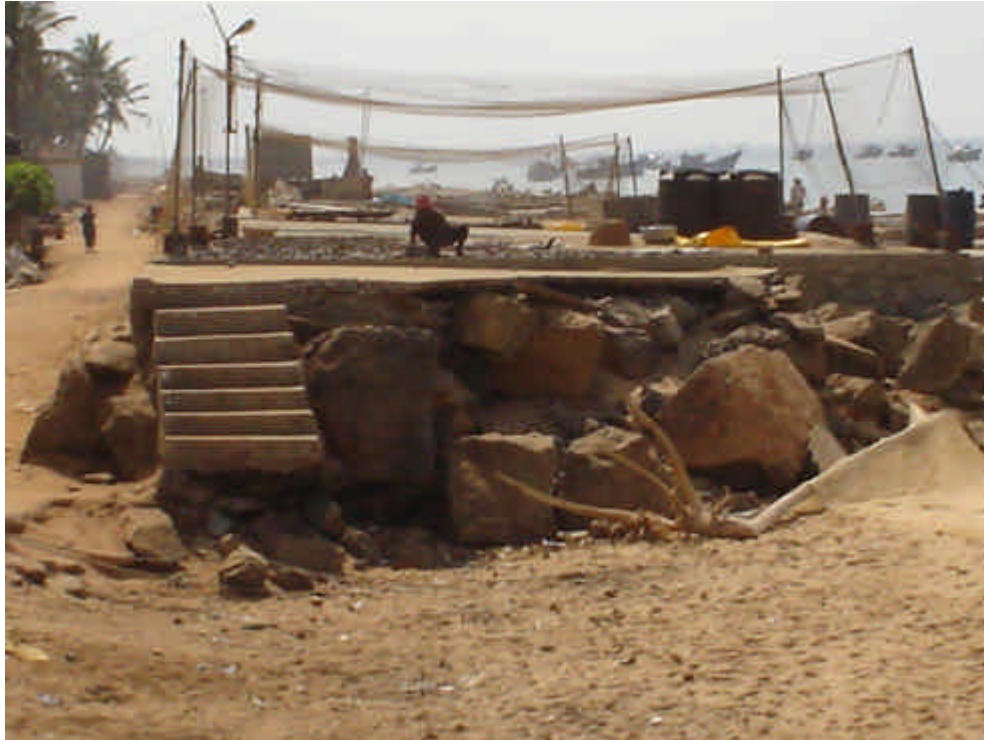
Photo 3.4. The top of the seawall being effectively used by fishing community

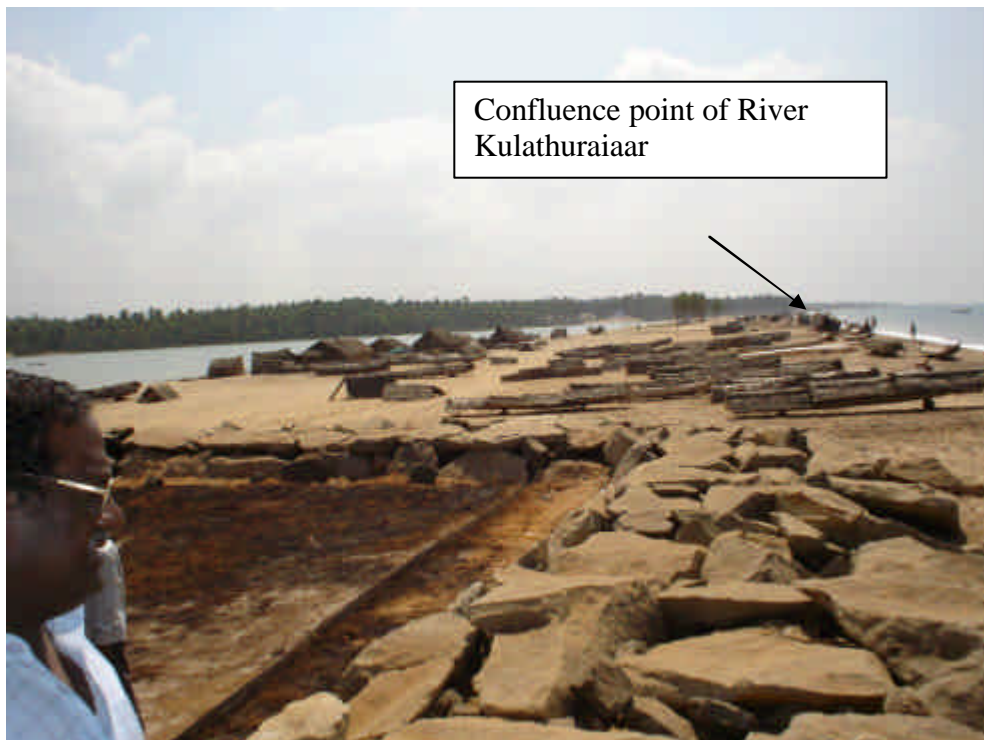
Photo 3.5 View showing the confluence point of river Kulathuraiaar at Erayumanthurai

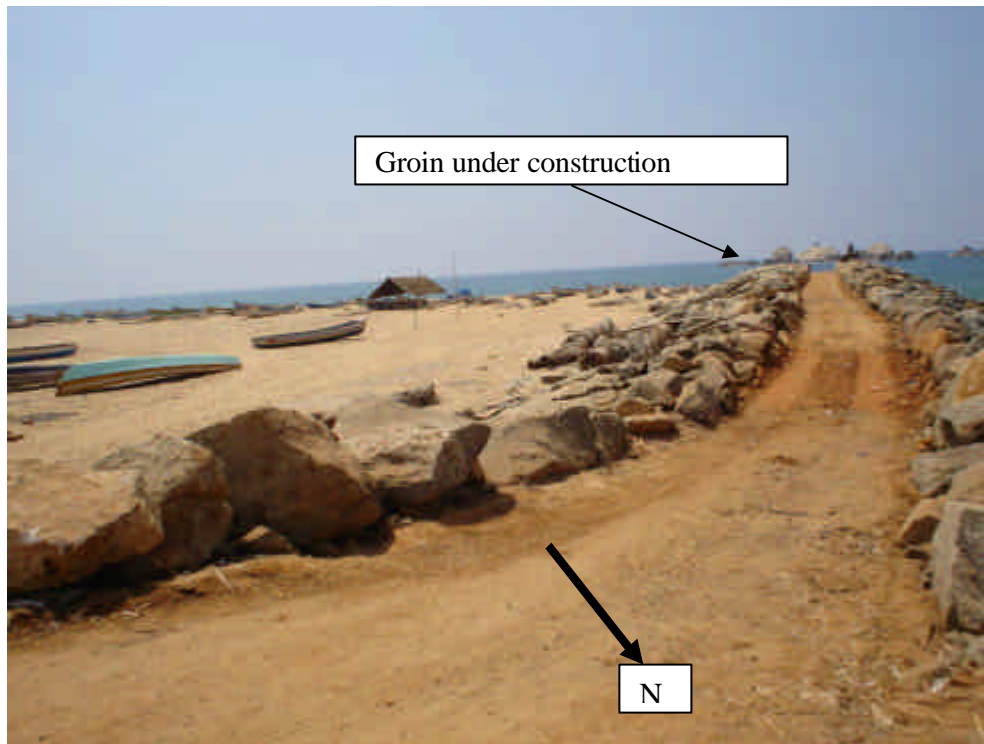
The enlarged version of the stretch of the coast from Enayam to Muttam is shown in **fig. 3.4**. A groin at Enayam is in progress and is likely to be completed by April, 2005. The beach formed on the Eastern side is being used for parking the boats as can be seen in **photo. 3.6**. The western side of this groin has a number of dwelling units very close to the shoreline facing a constant threat due to the progressive ocean waves (**photo 3.7**). The seawall constructed is not effective in protecting the coast. The groin under construction, as per the local people, has saved the village on its lee side due to tsunami. Because of the presence of this groin, the propagation of tsunami on its western side must have been attenuated, and hence there was no damage to dwelling units adjacent to the shoreline. **A distance of 1 Km on the West of this groin has to be protected by groin field consisting of 6 short transition groins with an average length of 75 m as shown in **fig 3.5****

Photo 3.6 View showing the beach formed on the Eastern side of the groin under construction at Enayam

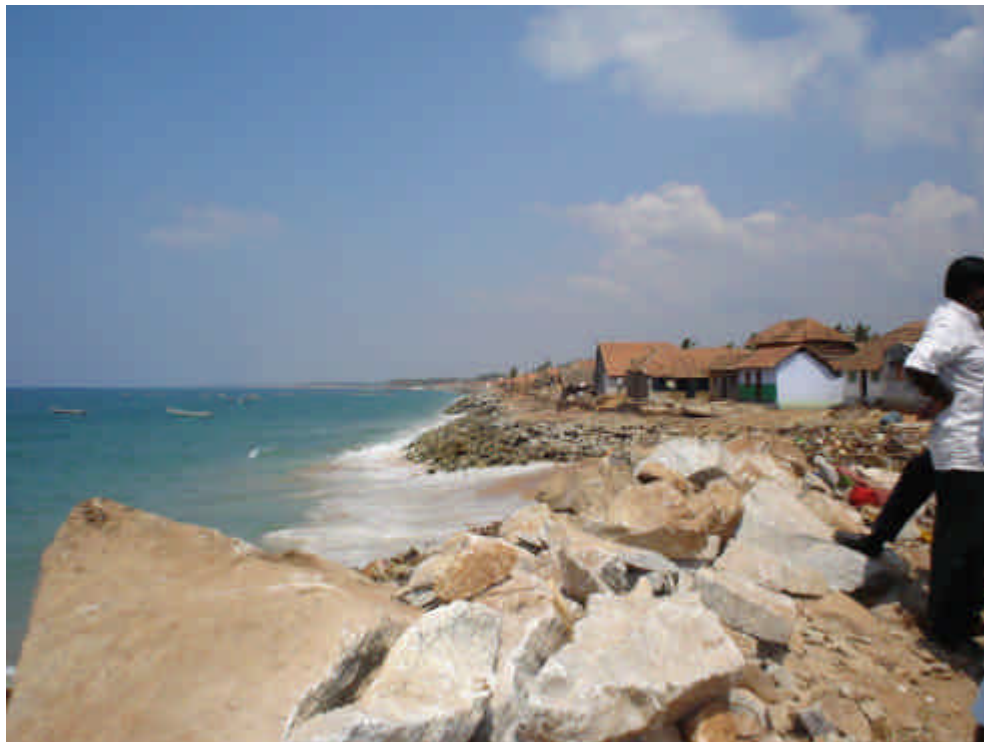
Photo 3.7 A number of dwelling units on the Western side of the groin, under threat

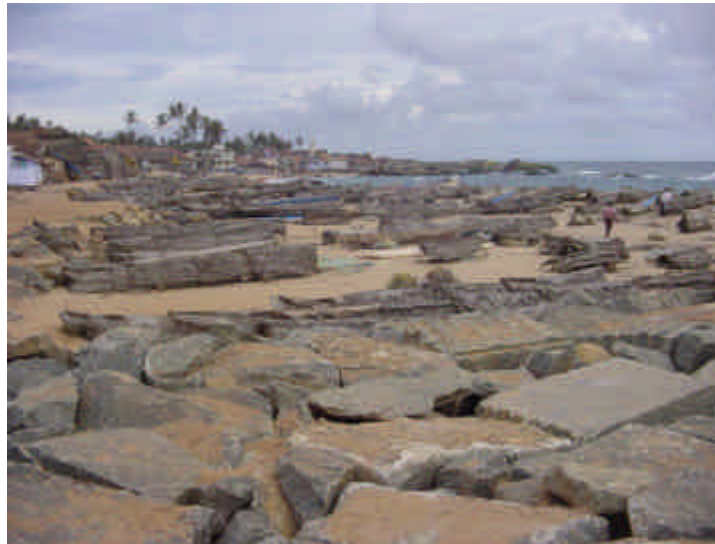
G7-G8 (**photo 3.8**) so as to serve as an additional groin is still pending with the PWD. **This recommendation may be taken by PWD immediately.** The above said recommendation is shown in **fig.3.6**.

Photo 3.8 Outcrops east of G1G2 of Kurumbunai to connected to serve as a groin

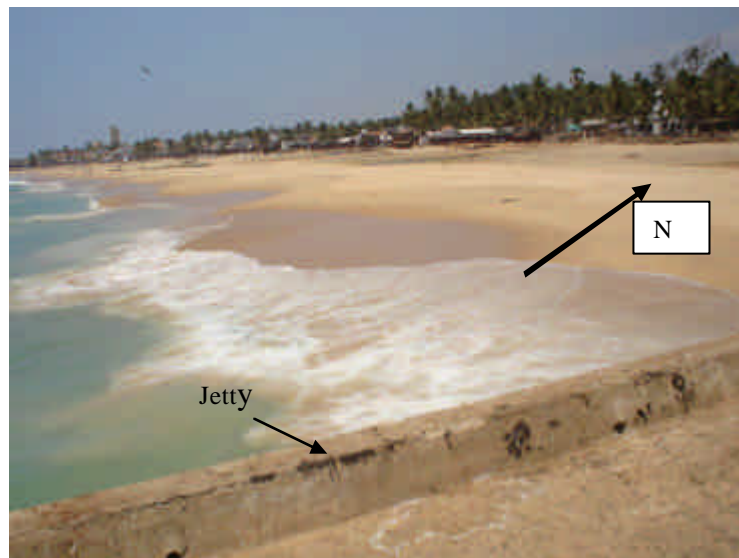
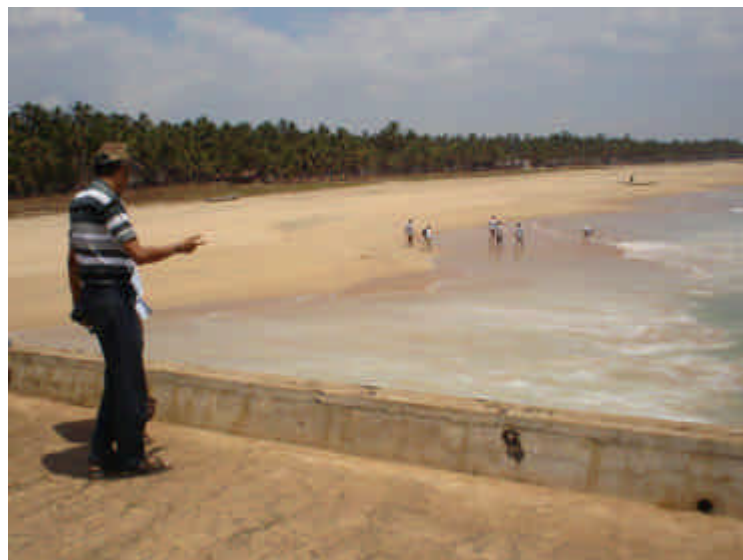
The beach is found to be very flat on either side of the jetty as can be seen in **photos 3.9 and 3.10**. The beach can be used for plantations. A pair of groins with a crest elevation of about 6.0 m from MSL locally called as thoondil valaivu can serve as a protection measure against severe waves particularly during cyclones and natural hazards. This proposal will also serve as a landing facility for boats and catamarans, the concept of which is projected in **fig.3.7**. The existing jetty can more effectively be used if the above proposal is implemented. The length of the coast that should be covered under this proposal will be about 1km. The effect of the penetration of tsunami on the flat beach is shown in **photos 3.11, 3.12 and 3.13**, which shows the damaged buildings about 100 m from shoreline, beyond the existing road.

Photo 3.9 View of the flat beach on western side of Colachel Jetty

Photo 3.10 View of the flat beach on Eastern side of Colachel
