PROTECTION MEASURES FOR TAMILNADU COAST

Final Report

PUBLIC WORKS DEPARTMENT

PROF. V. SUNDAR

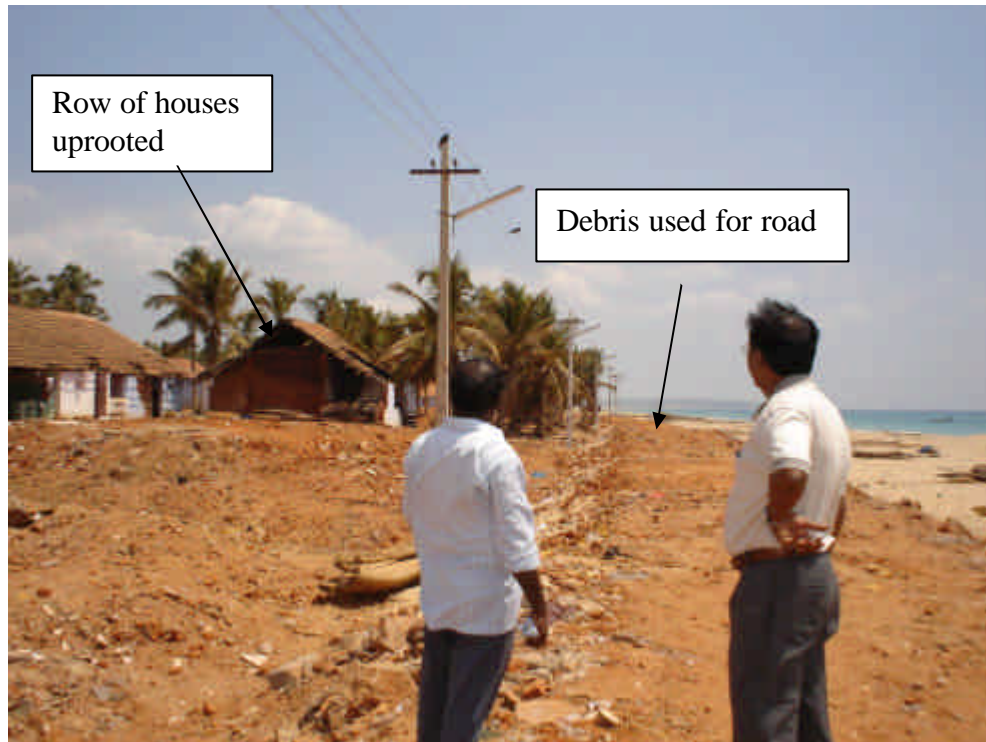
This is one of the worst affected villages of the coast of Kanyakumari district due to tsunami and has resulted in a number of casualties about 200. About 4 rows of houses collapsed is shown in **photo 3.14**. A road is formed with the debris removed along the coast as seen in the above photo. The local public have reported that the canal, which is running parallel to the shoreline has acted as a death trap, as the people trying to escape from the attack of the tsunami should have got stranded and drowned as the number of bridges or escape routes available are less. The measurements of certain important area were made and the plan showing these details is shown **fig. 3.8**. This area needs to be protected against wave run-up during cyclone and tsunami. Local people are strongly recommended to move on to the landward side of the canal. This has to be treated as the most urgent strategy. In case the implementation of the above stated strategy is not possible, the following are recommended.

Photo 3.14 View showing a road formed with the debris removed along the coast at Kottilpadu

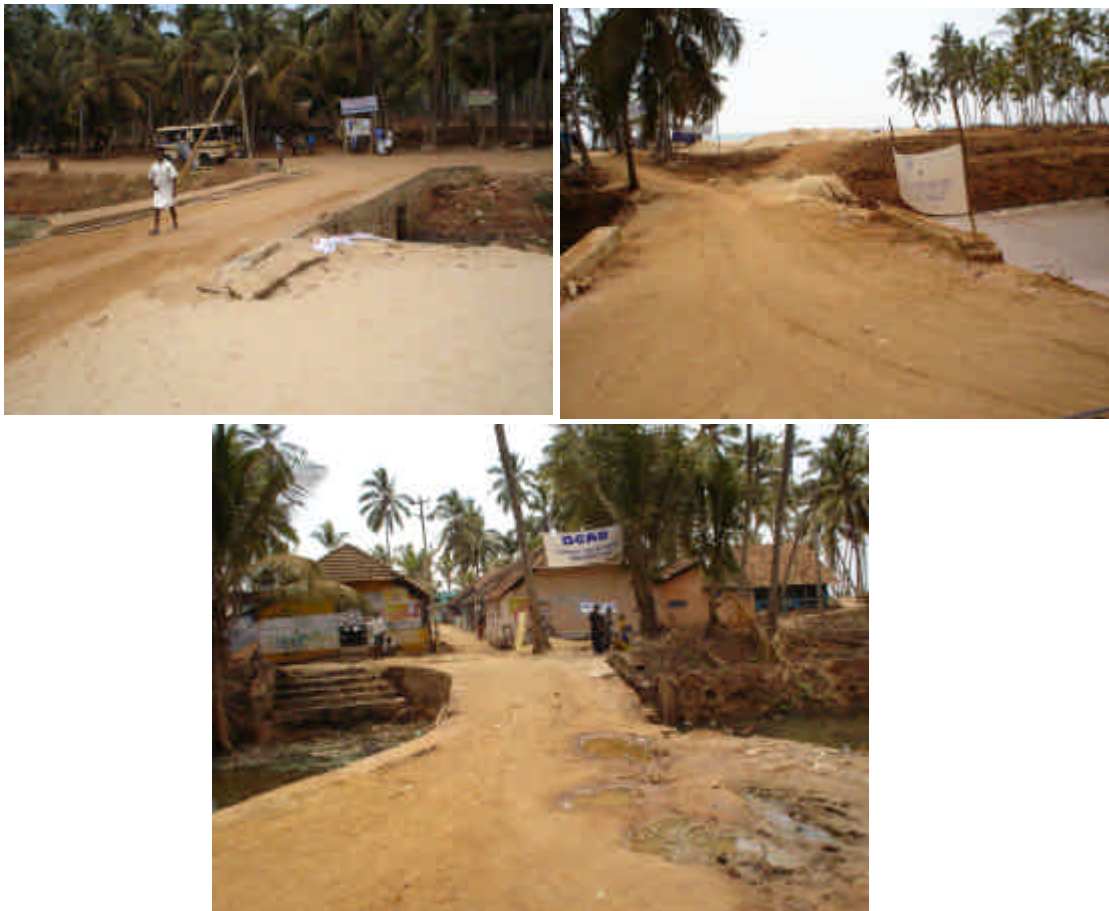
Photo 3.15, a, b & c. Views of the bridges at Kottilpadu, Colachel.

- **One more bridge adjacent to the existing one, with a higher deck slab of atleast about 1m above the present level and of greater width is recommended. The existing bridges are shown in photos 3.15 a, b & c.**

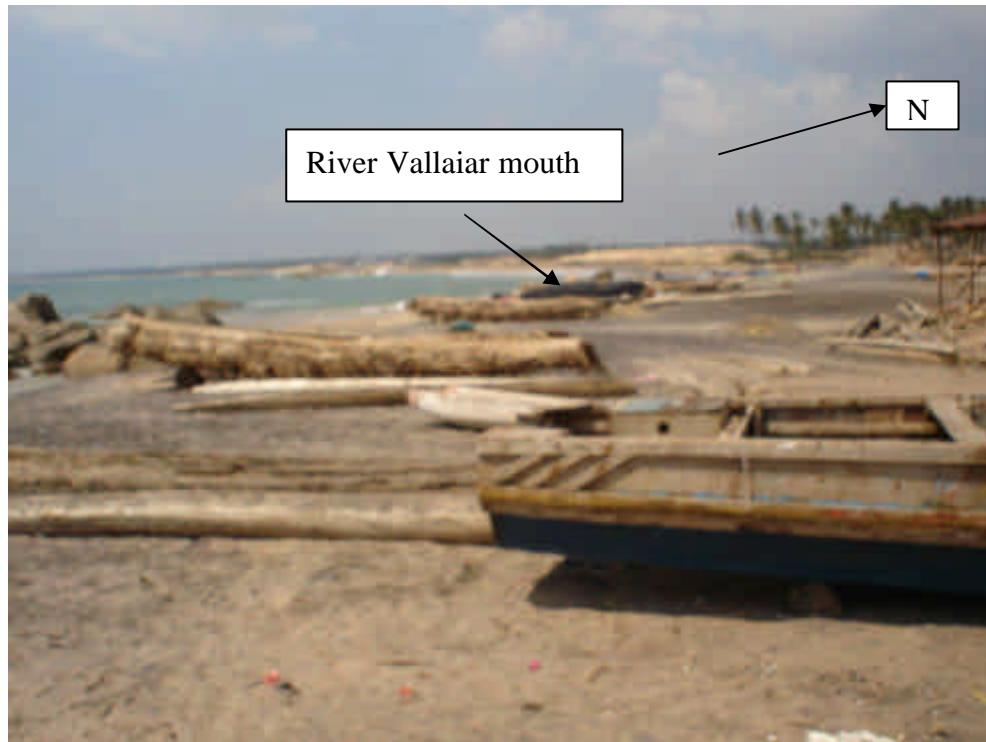
This stretch of the coast lies at the confluence point of the river Valliar (**photo 3.16**). It is proposed to construct two groins as training walls for this river mouth as shown in **fig.3.10**. The existence of natural outcrops can be seen in the **photo 3.17**, if supplemented by rock fill to serve as groin, should be considered.

Photo 3.16 The confluence point of the river Valliar at Kadiapattinam

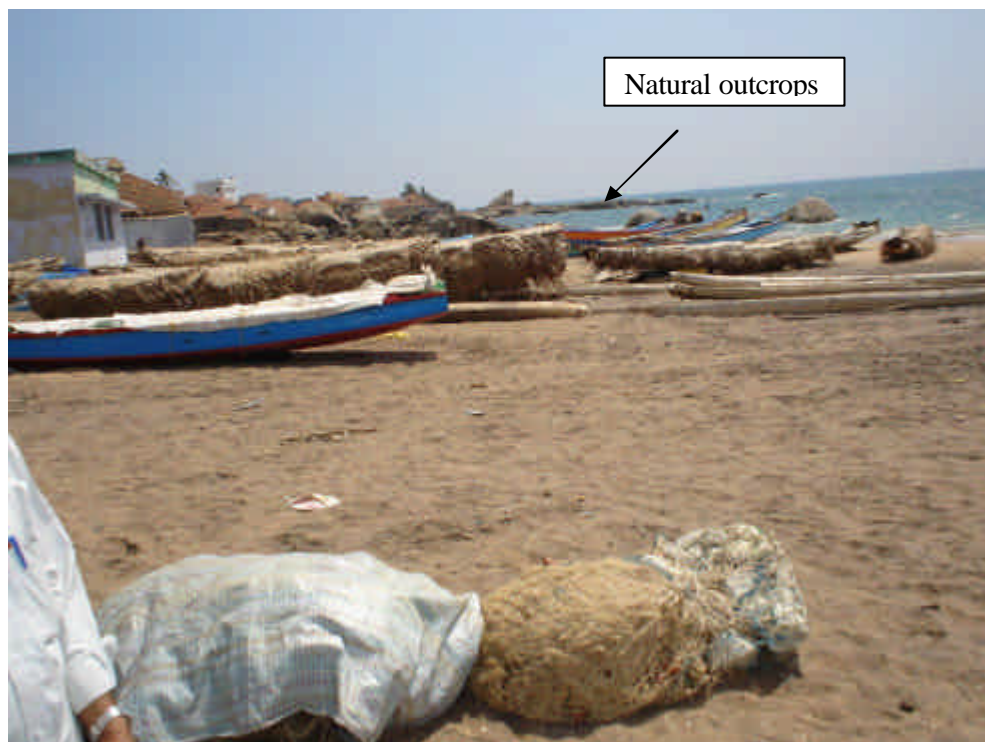
Photo 3.17 Rocky outcrops acting as groins near Kadiapattinam

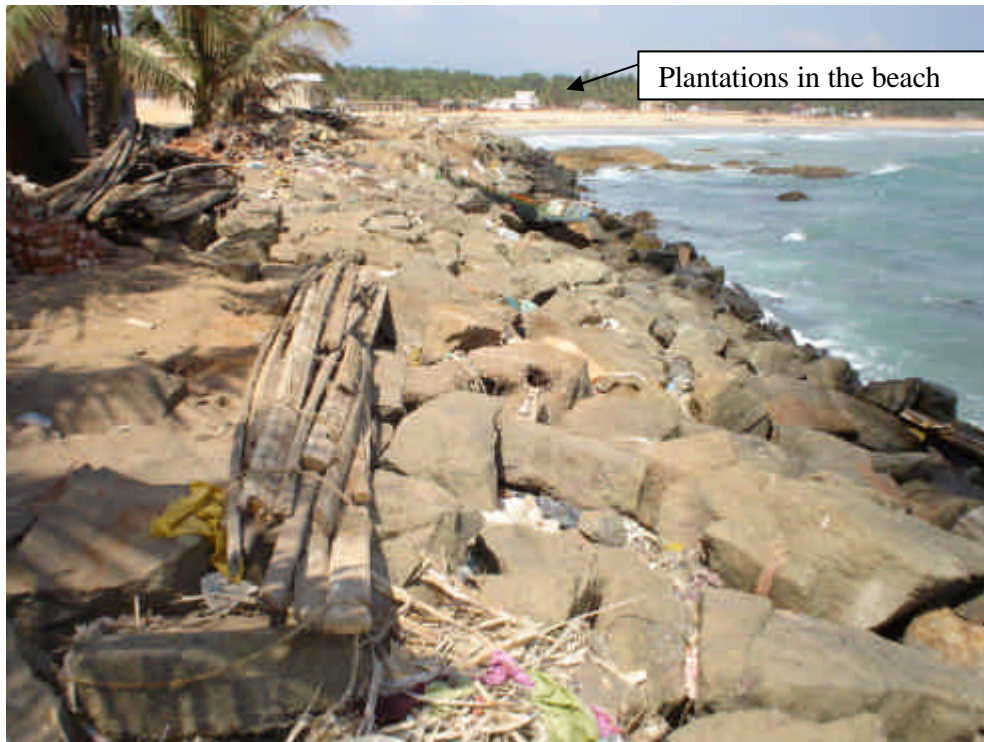
Plantations are recommended on the East of Muttam stretch consisting of Pillathopputhurai, Melathurai and Alikkal. A close view of the existing seawall at Muttam is shown in **photo 3.18**. The crest of the seawall and land along this stretch are at same elevation. During monsoon, overtopping is reported by the local people. *Hence, raising of the crest elevation by about 1 m is recommended (II nd phase).*

Photo 3.18. A close view of the existing seawall

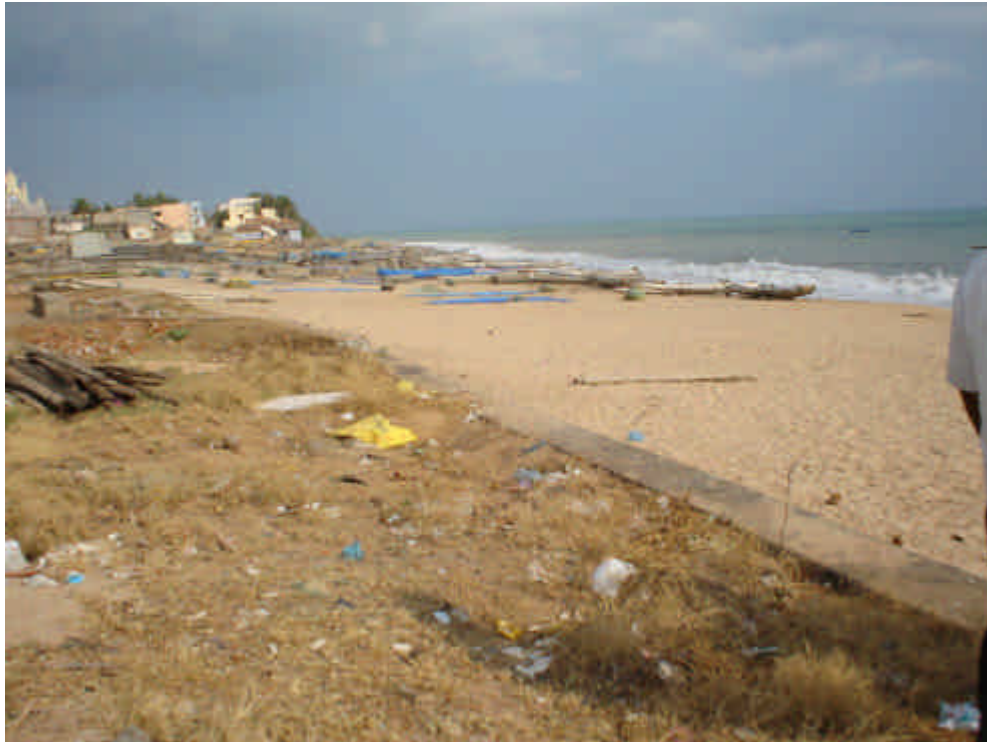
Damages to the houses land ward side of the shore is shown in **photo 3.19**. The beach which is formed, where the catamarans are parked as can be seen in **photo 3.20**, is of

Photo 3.20 View of the seasonal beach where catamarans are parked

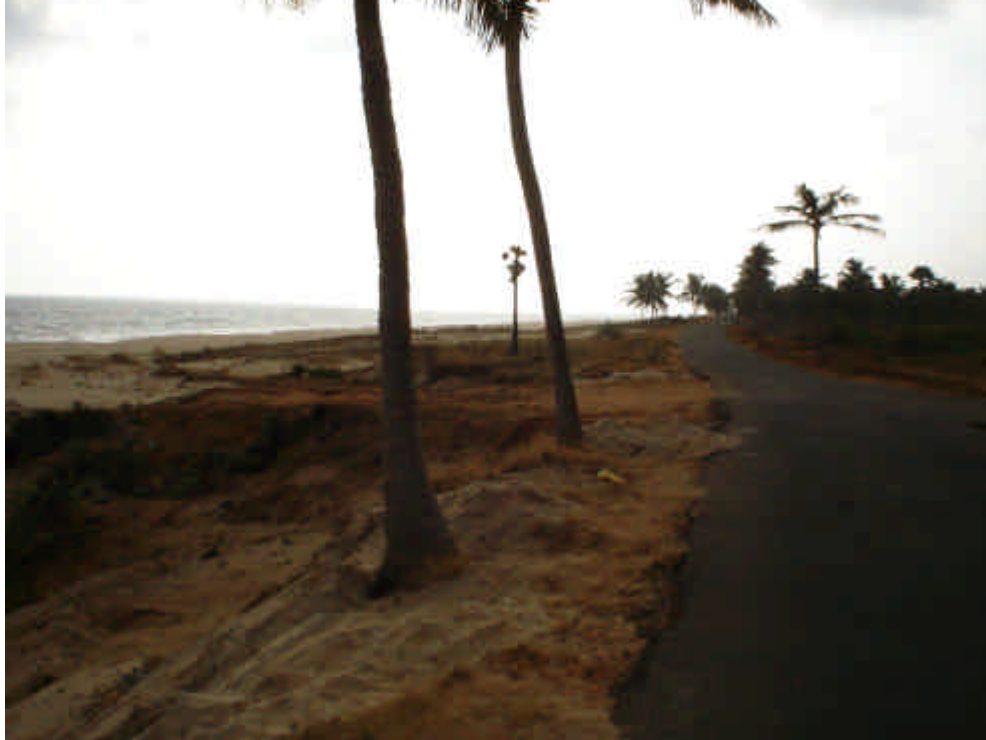
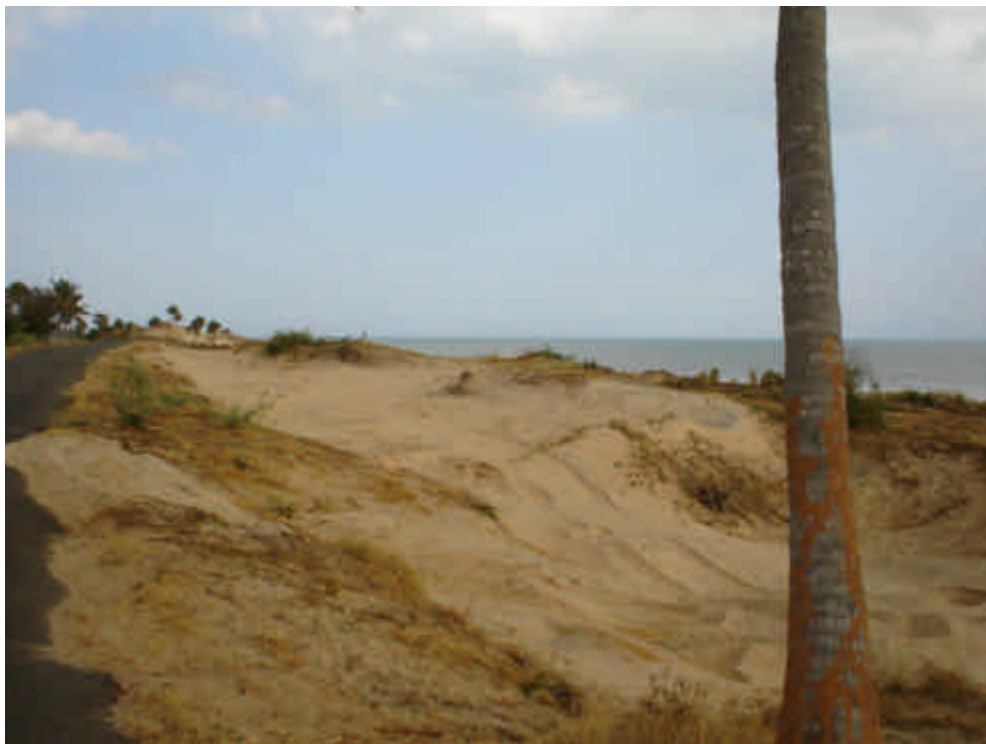
**Photo 3.22 a & b Views showing the sufficient beach widths at
Mezhamanakudithurai**

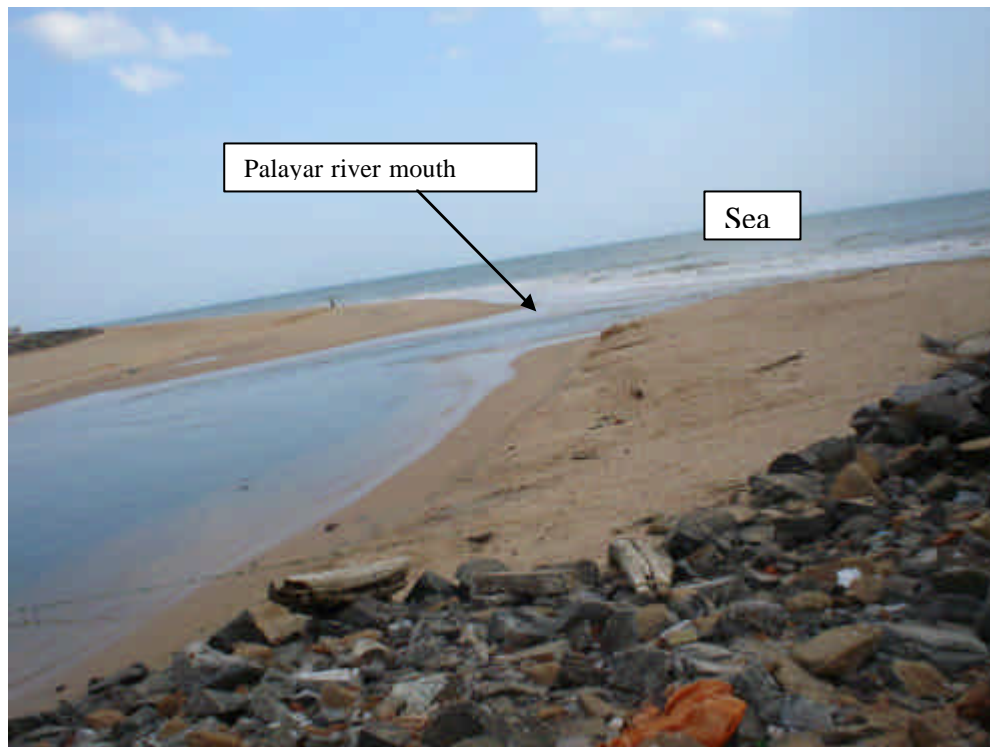
Photo 3.24 View of the Palayar river at Mezhamanakudithurai

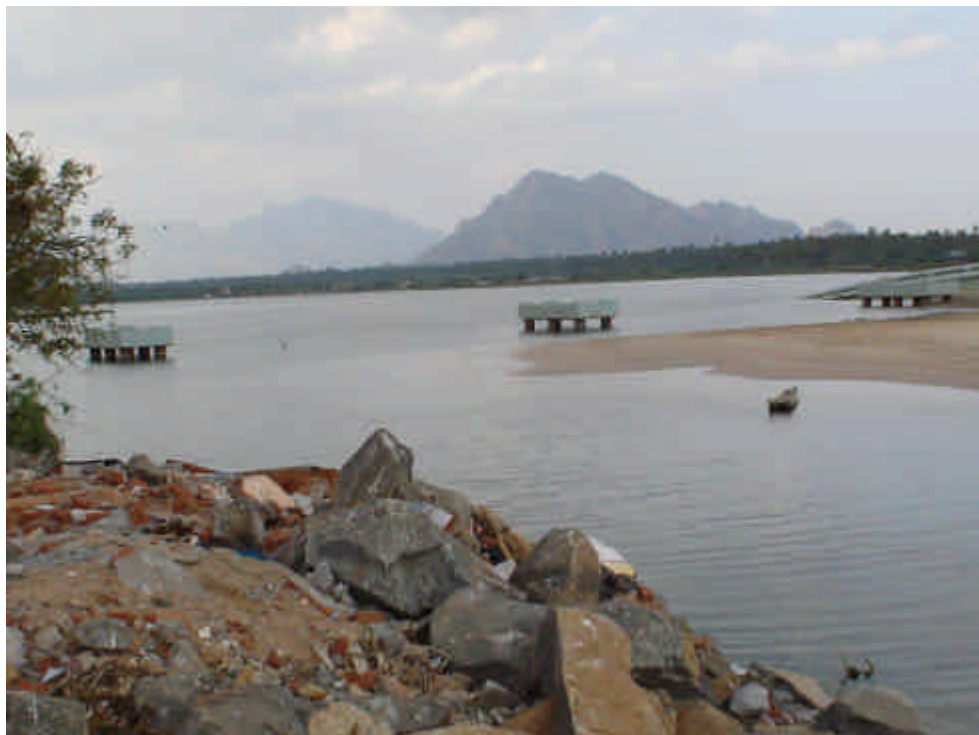
Photo 3.25. The collapsed bridge on Palayar river

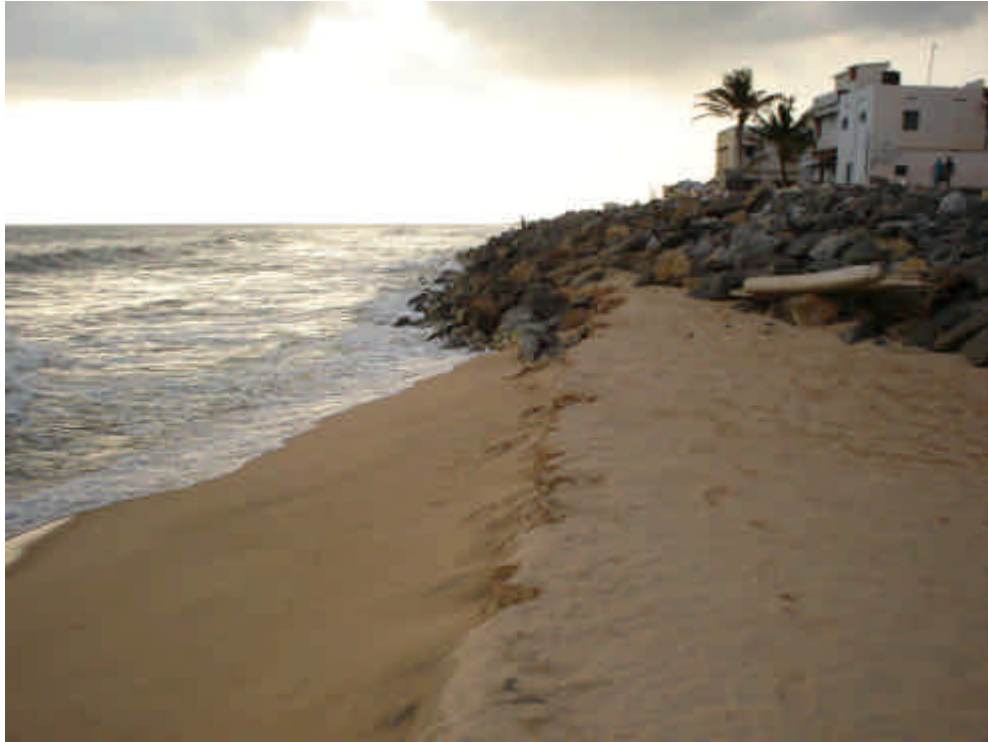
Photo 3.26. Erosion at the tip of the seawall

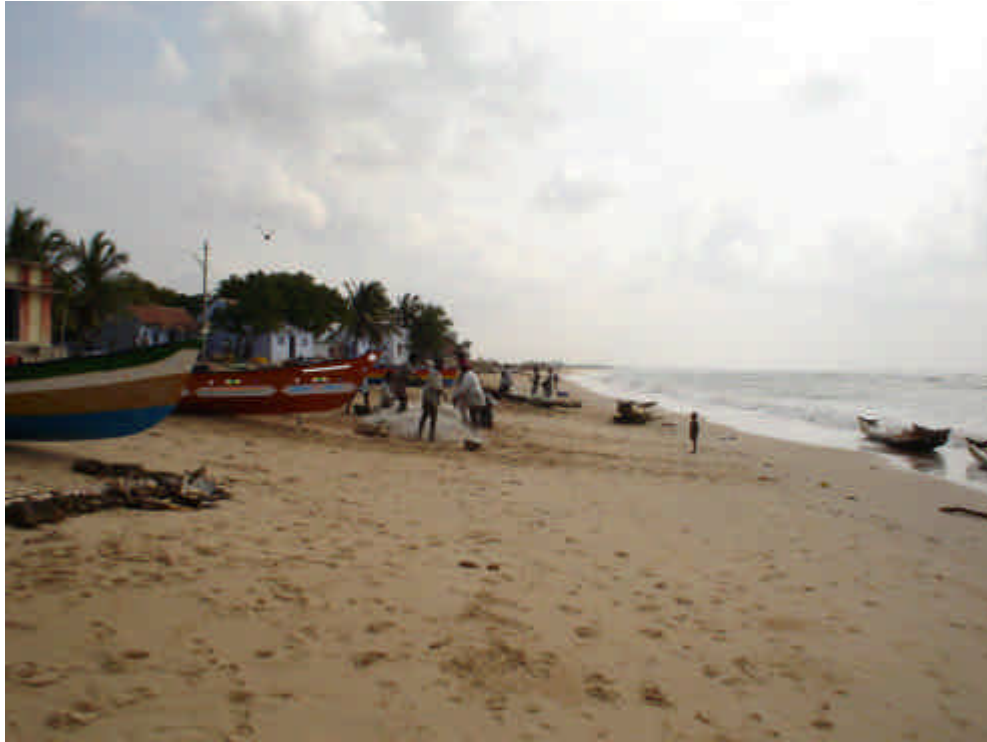
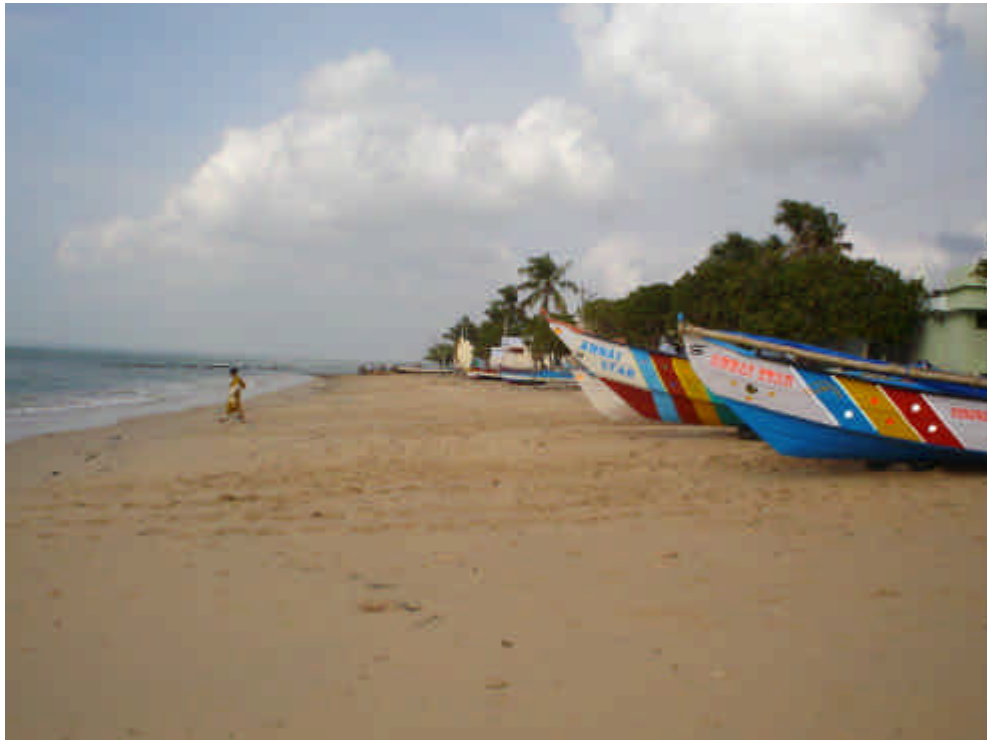
Photos 3.30 & 3.31. Views showing Beach widths North and South of Kootupuli.

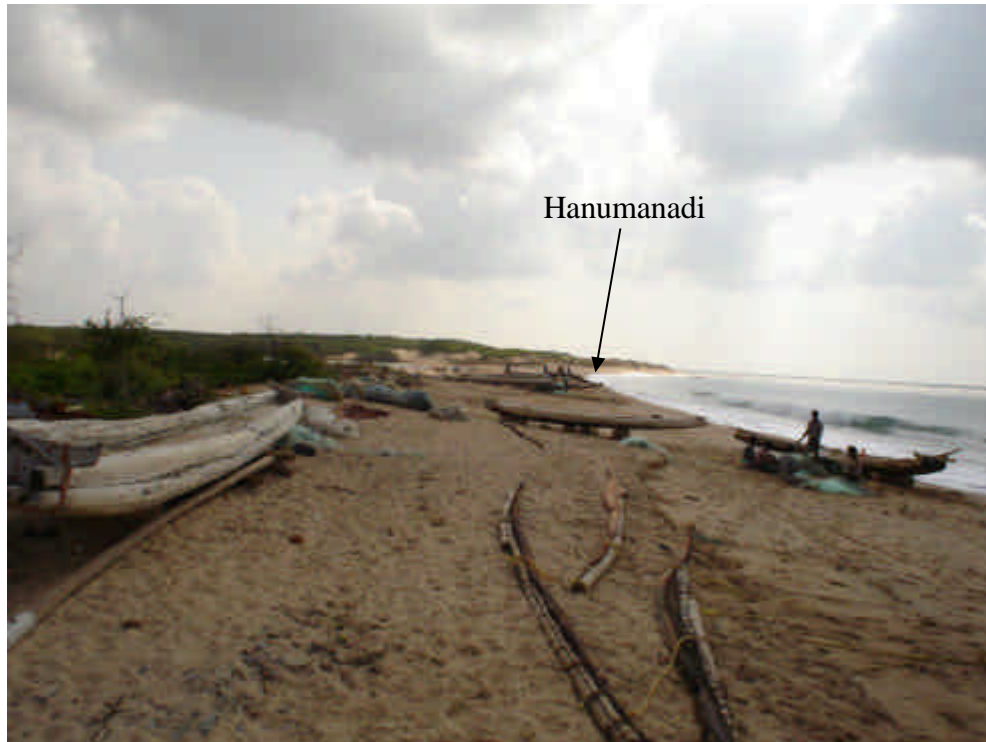
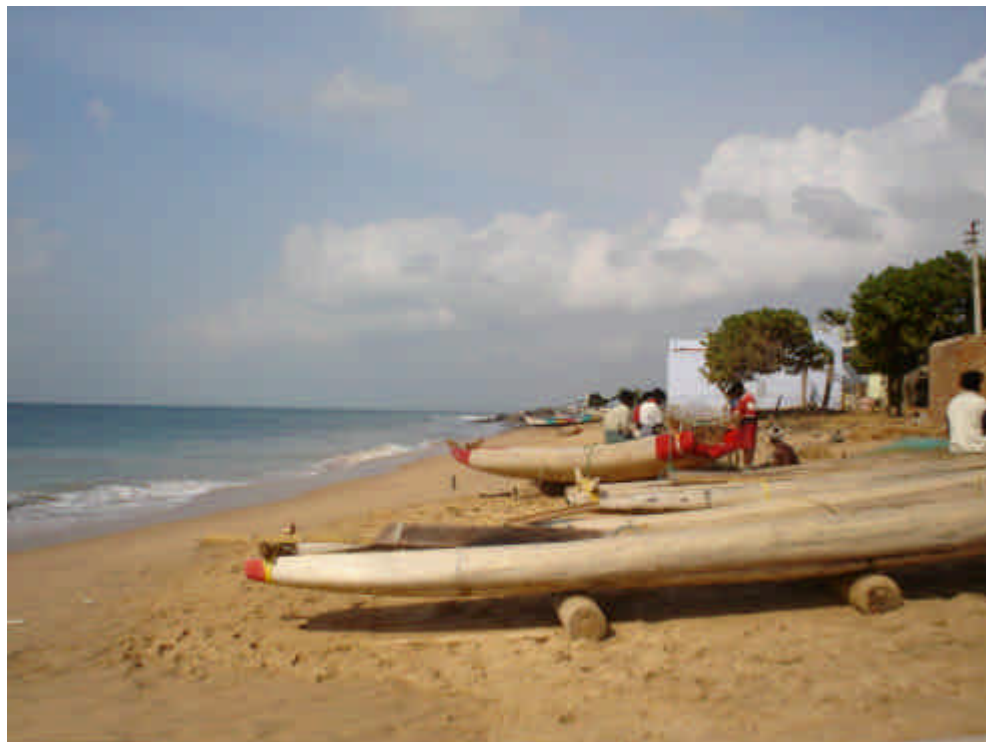
Photos 3.32 & 3.33. Views showing Beach widths North and South of Perumanal.

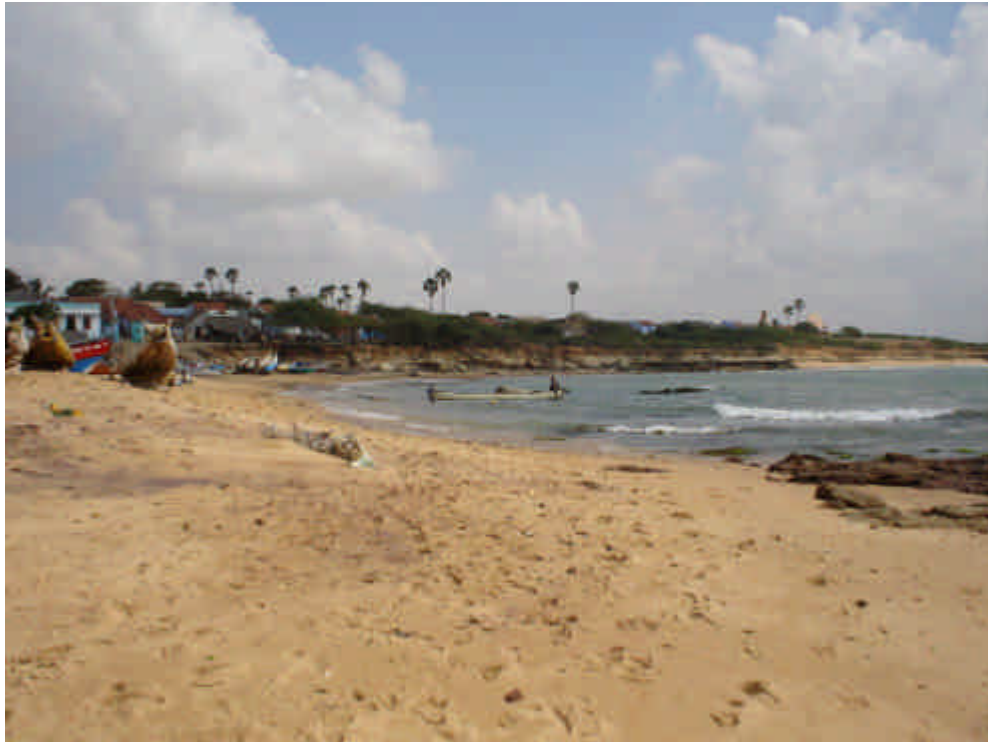
Photo 3.34. A view showing the bay like formation at Idinthakarai.

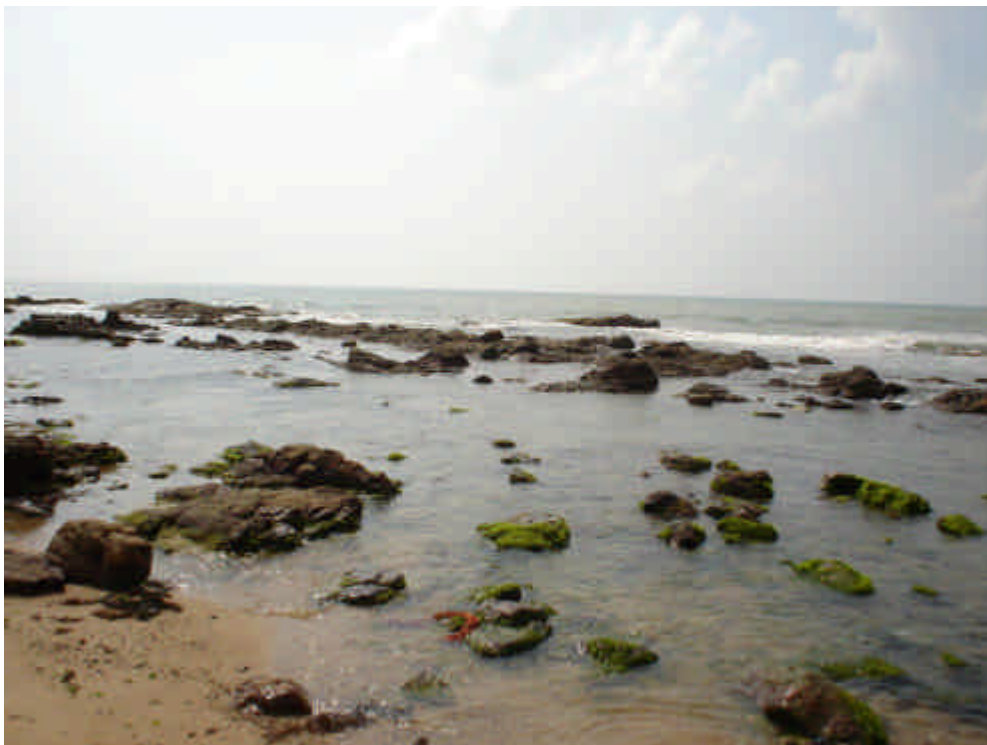
Photo 3.35. A view showing the rocky outcrops at Idinthakarai.

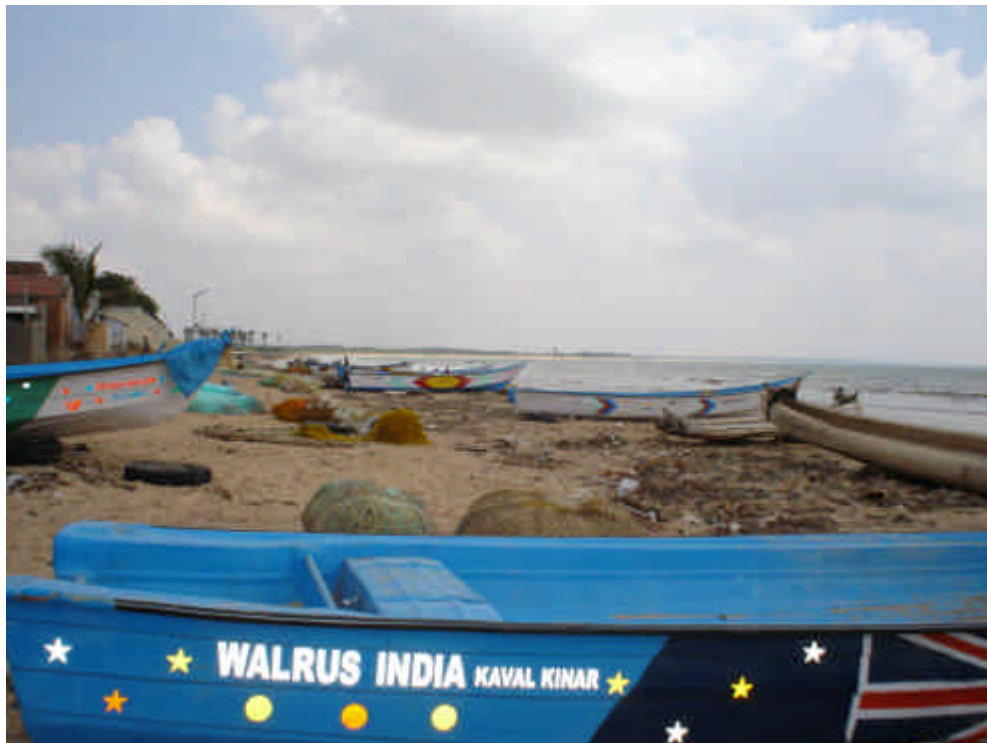
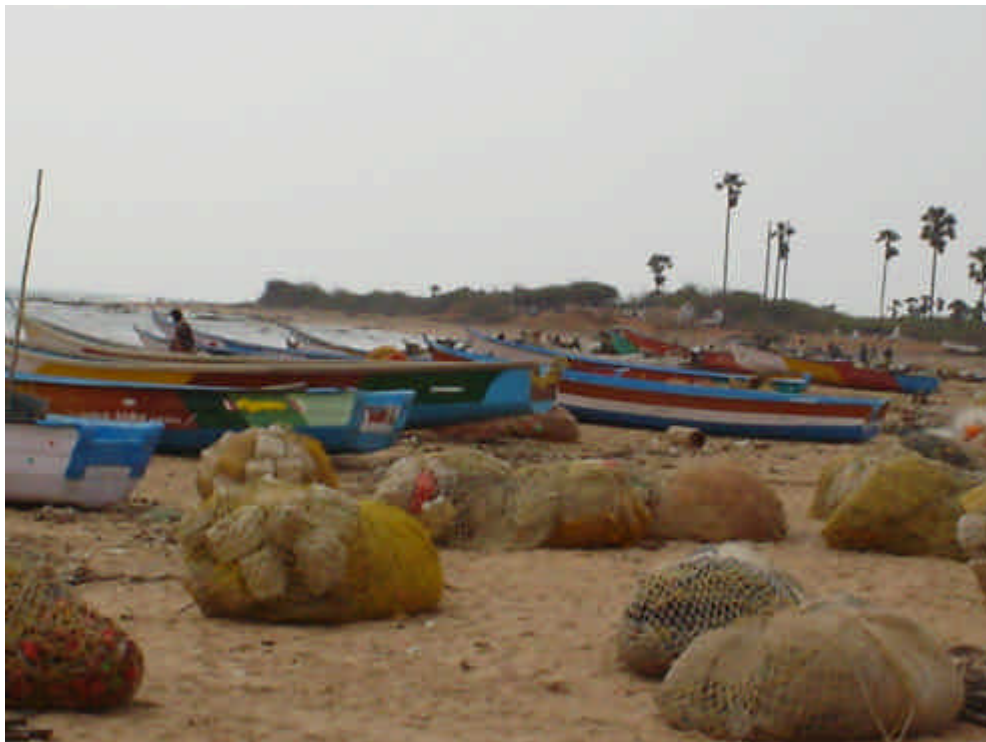
Photo 3.36 and 3.37. Views showing the beaches on the North and South of Koothankuli

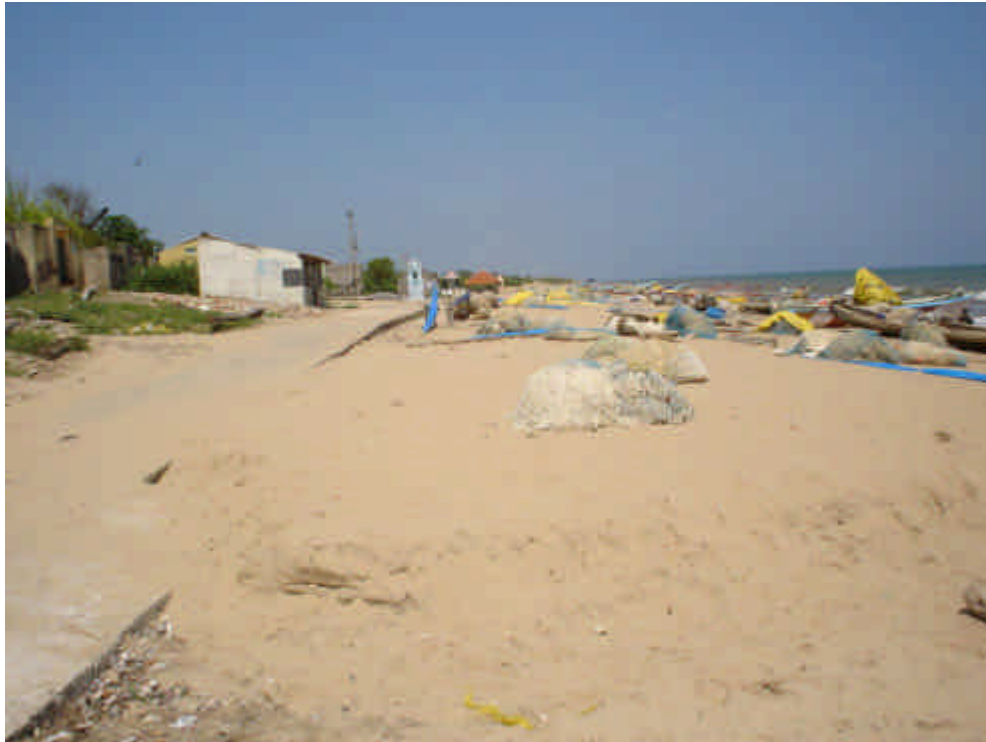
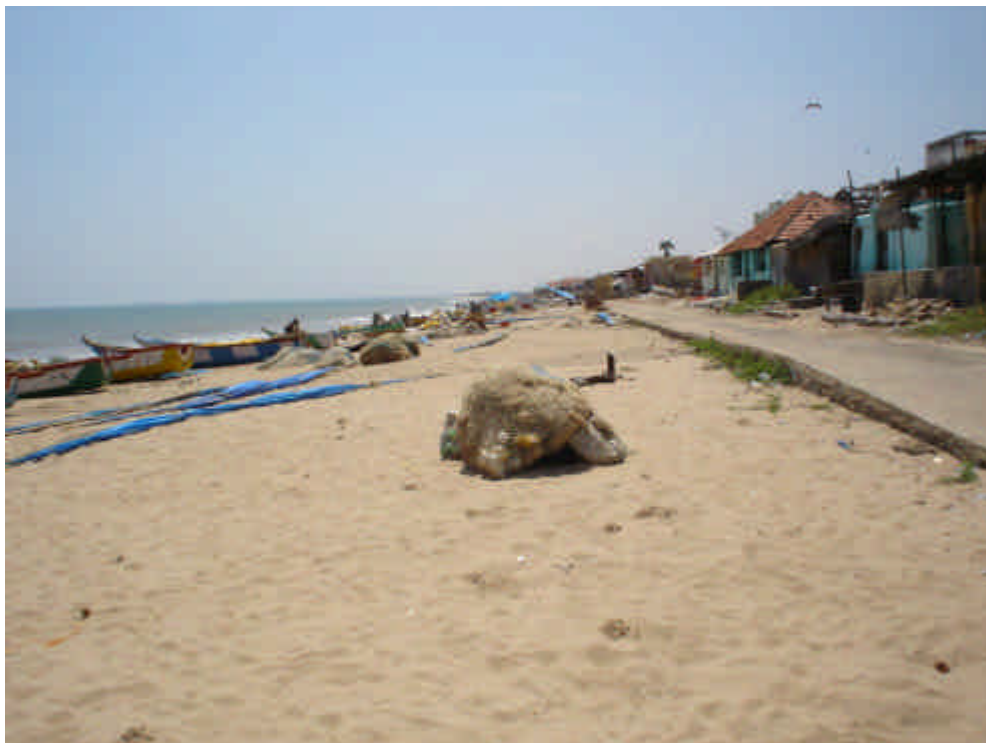
Photo 3.38nd 3.39 Views showing the beaches on the North and South of Allanthalai

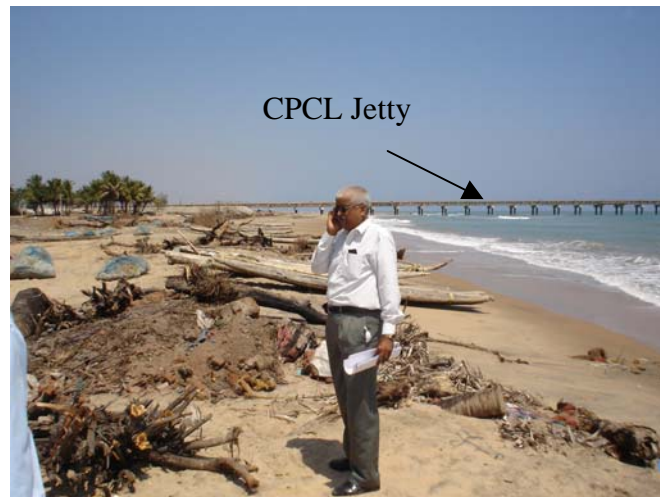
Photo 4.2 The CPCL loading jetty at Nagoor

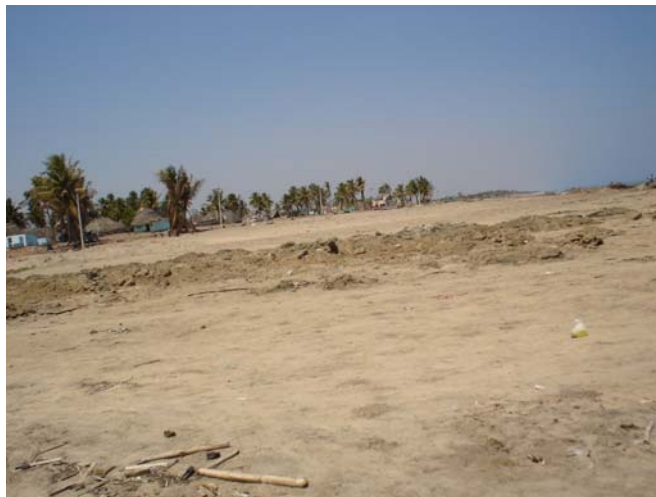
The barren land North of Nagapattinam port shown in **photo 4.5**, is an excellent place for dense plantations. The presence of the vertical wall (top level +2.7 m MSL) as shown in **photo 4.6**, constructed for the Nagapattinam port at a distance of about 60 m from the shoreline has acted as a barrier only marginally against the powerful tsunami. In spite of the presence of this wall, a number of boats were carried away to the land and water on its rear side has moved to a distance of 300 m and a height of about 8 m. The damaged boats behind the vertical wall are shown in **photo 4.7**, and the damaged portion of the vertical wall is shown in **photo 4.8**. The remedial measures are discussed in sec.4.1.2.

Photo 4.5 View showing the barren land North of Nagapattinam port

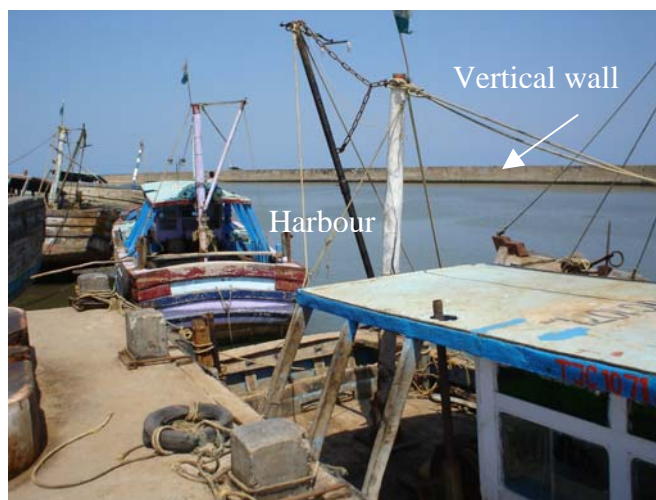
Photo 4.6 Presence of Vertical wall constructed at Nagapattinam

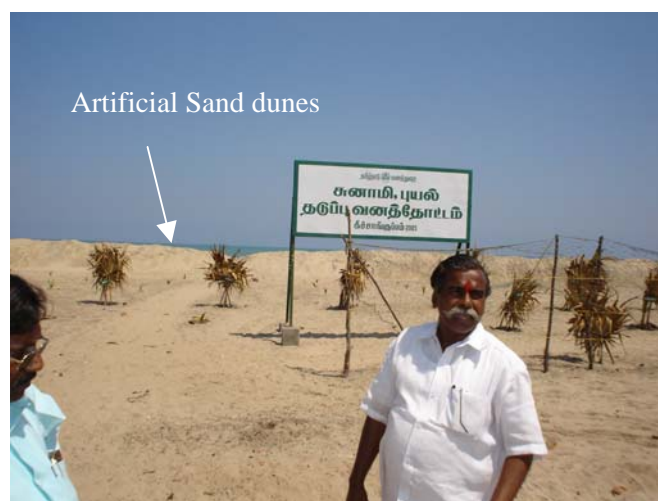
This is the worst affected area with in the **stretch 'A'** due to tsunami and a number of casualties and loss of property were reported. The plantations as shown in **photo 4.9** have just begun along the coast. The artificial sand dune at this stretch is shown in **photo 4.10**. It is to be stated that the plantations should be denser compared to what has been done as of now. The tsunami has resulted in uprooting of several bridges and houses along this stretch (**Photos 4.11 a & b**). The remedial measures are discussed in sec.4.1.2.

Photo 4.9 The Coconut plantations planted post tsunami rear side of the sand dunes at Keechankuppam

Implementation of Coastal Regulation Zone (CRZ) Act, now that the area is already been cleared, has to be enforced on top priority. Dense plantations as a long-term measure for a distance of about 9 Km is recommended (Nagoor to Keechankuppam) protecting about 6 villages with in this stretch of the coast. The recommendation is made for the two stretches namely, **(between Kallar and Kaduvayar river mouths)** and **(Nagore to Kaduvayar river mouth)**. As littoral drift in this stretch is more towards the North and the coast is of sandy type, T – shaped groins would certainly trap the sediments and also retain the same with in them for the stretch between Kallar and Kaduvayar river mouths. In order to minimize the inundation of sea water into the land, a seawall is recommended. As the coast is just 0.6 m above MSL, a seawall is also recommended for the entire stretch of the coast. The details of the proposed layout for the stretch between the rivers Kaduvayaar and Kallar to protect the stretch of the coast in Keechankuppam are shown in **fig. 4.2a & 4.2b**. **The average length of the groin**

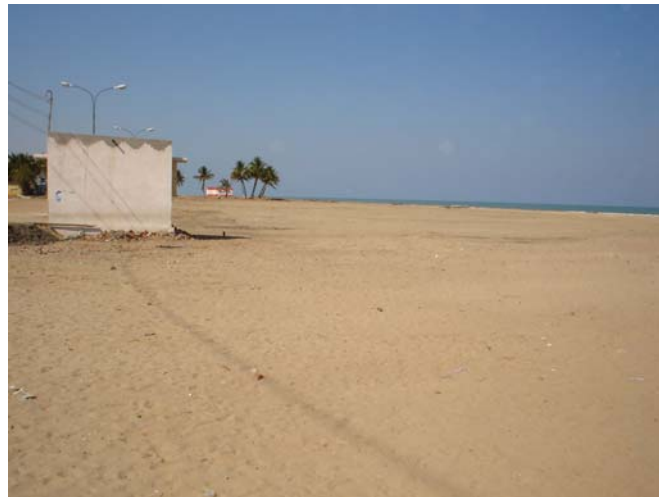
The damaged bridge connecting Nagapattinam and Kallar in the **stretch ‘B’** is shown in **photo 4.12.** The hutments close to the beach have been washed away by the recent tsunami. A clear width of beach is available as can be seen in **photo 4.13.** The river Vellayar (**photo 4.14**) joins the sea adjacent to this stretch of the coast and is shown in the above photo. **It is recommended to dredge the mouth of river Vellayar and nourish the beach on its Northern side as well as to construct a sand dune. Plantations backed up with sand dunes and masonry buffer blocks are recommended for this stretch of the coast as shown in the fig. 4.6.** Both plan and sectional elevation of the proposed are shown in the above figure. The buffer blocks may also serve as a relaxing facility for the pilgrims and locals. After monitoring the shoreline for a period of about 2 years, a decision can be taken up on the necessity of a hard measure.

Photo 4.13. The flat beach North of Velankanni

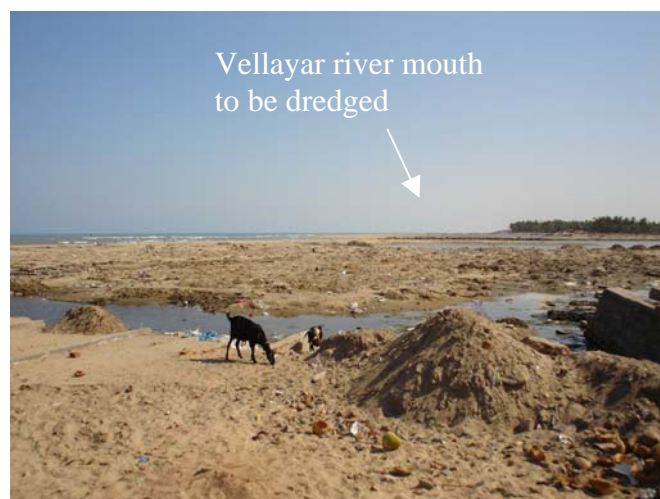
Photo 4.14. The confluence point of river Vellayar South of Velankanni

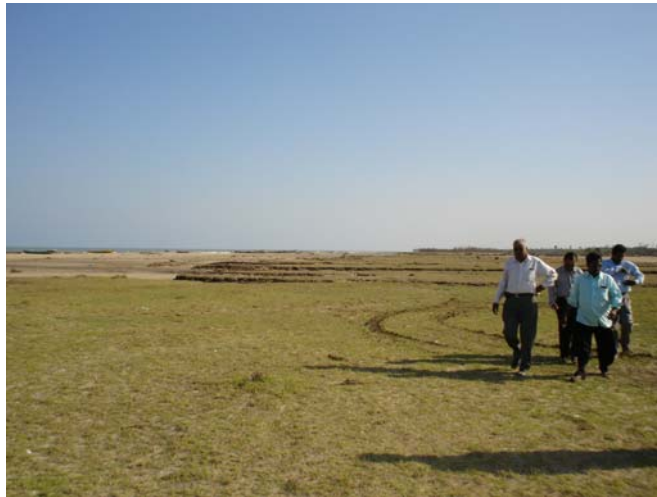
a distance of about 200 m. The shoreline is found to be stable and the beach south of this stretch is as shown in **photo 4.15**. Two long training walls for the improvement of the mouth of Nallar Straight cut should be taken up as shown in **fig 4.7**.

Photo 4.15. View showing beach South of Vellapallam

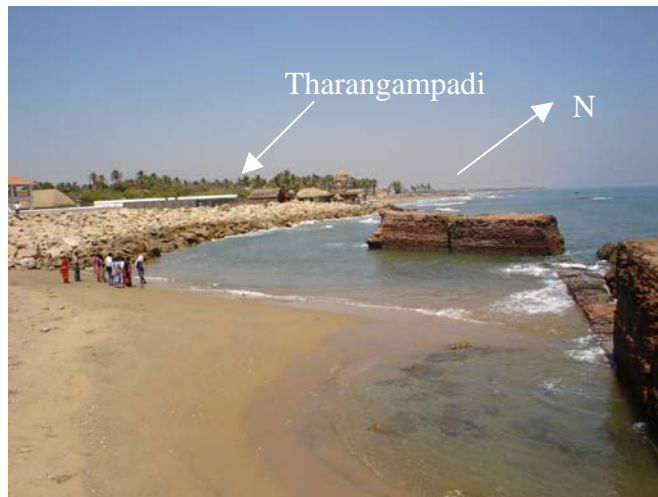
Photo 4.18. View showing erosion North of section A-A

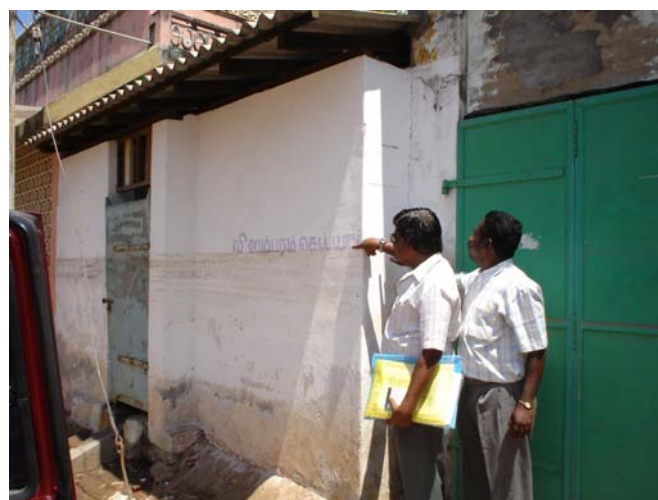
The village Sathankudi (N 11°01'52.7" E 79°51'19.6"), located North of the fort has suffered huge loss of life and dwelling units. The water has penetrated about a distance of about 750 m from the shoreline. The watermark due to tsunami on the compound wall is shown in **photo 4. 19**. A view of the damaged village of Sathankudi after having been leveled to some extent is shown in **photo 4.20**. The PWD has a proposal for construction of a seawall for a distance of about 850 m from the existing seawall. While, the construction of the seawall is recommended, the crest level has to be at + 4.35 m. In addition to the seawall, **a groin field consisting of 5 transition groins of average length of 100 m, with one or two groins to be bent to be formed as 'Thoondilvalivu'**. The above mentioned scheme is as shown in **fig. 4.10**. This will help the fishing community as there are number of boats. The Rubble mound seawall may be considered after construction of the groins and monitoring the shoreline changes. **In the barren land due to the damaged houses, plantations are recommended.**

Photo 4.19. The watermark on a compound wall at Sathankudi

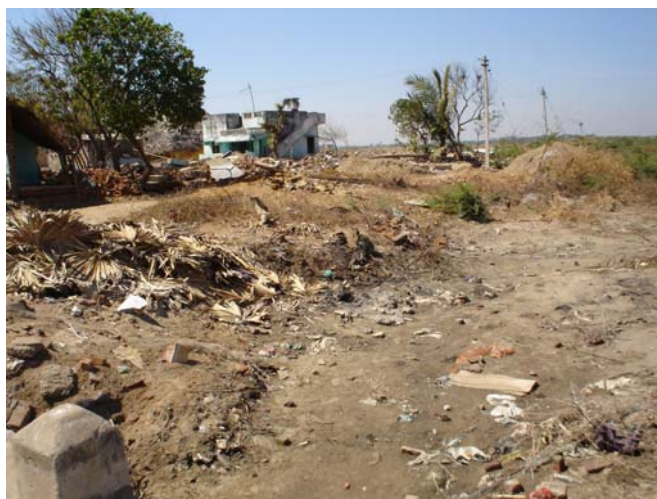
The entire village has been washed out and the people have totally abandoned their houses. Only plantations are recommended in this stretch of the coast shown in **photo 4.25**.

Photo 4.25. Abandoned houses at Pudukuppam

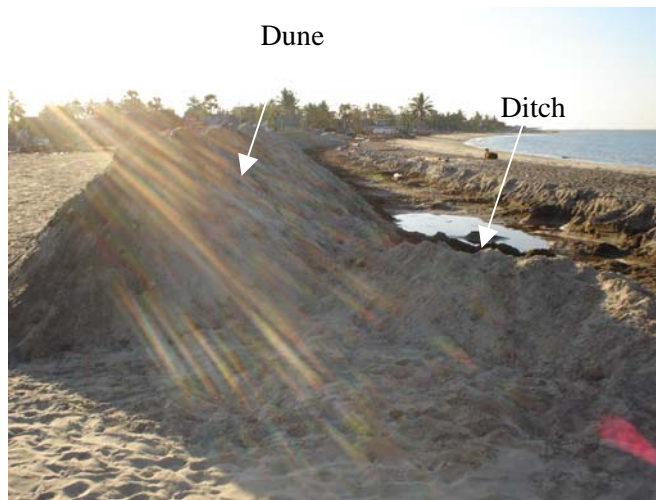
Photo 4.27. Dunes constructed by local people of Palayur
